# Technical Service Bulletin

SUBJECT:		No: <b>TSB-22-54-007</b>	
<b>POWER SEAT MEMORY FUNCTION INOPERATIVE</b>		DATE: <b>December 2022</b>	
		MODEL: <b>Certain 2022 Outlander</b>	
<b>CIRCULATE TO:</b>	<input type="checkbox"/> GENERAL MANAGER	<input checked="" type="checkbox"/> PARTS MANAGER	<input checked="" type="checkbox"/> TECHNICIAN
<input checked="" type="checkbox"/> SERVICE ADVISOR	<input checked="" type="checkbox"/> SERVICE MANAGER	<input checked="" type="checkbox"/> WARRANTY PROCESSOR	<input type="checkbox"/> SALES MANAGER

This Service Bulletin provides instructions to reprogram the AUTO DRIVE POS-ECU with the latest software.

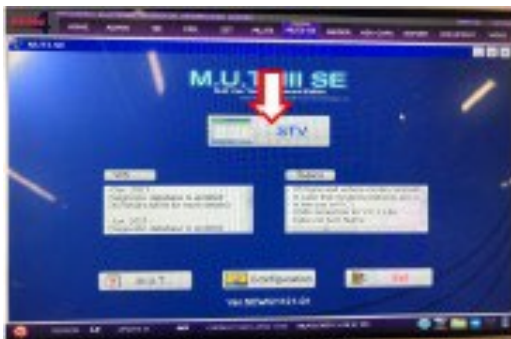
- a. Press the MUT-III SE STV icon.

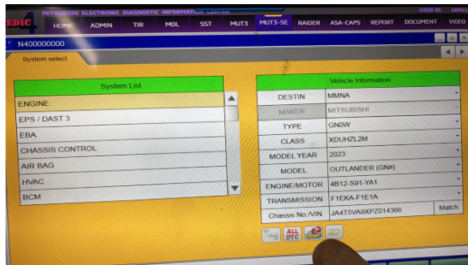
b. Press the Reprogramming button once the vehicle information is entered.

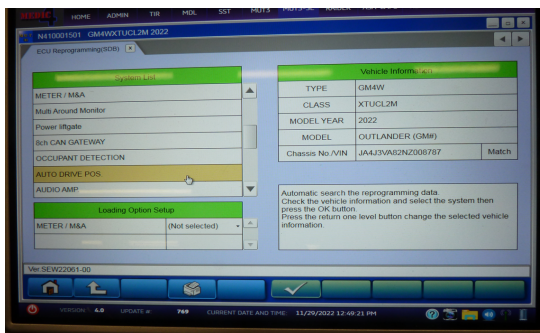
d. Select "AUTO DRIVE POS" from the System List and press the OK button.

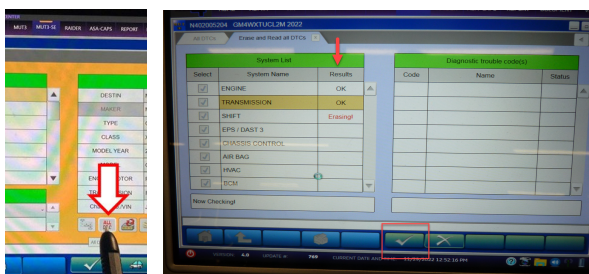
- h. Press "ALL DTC" button to initiate the "Erase and Read all DTCs". Press OK when complete.

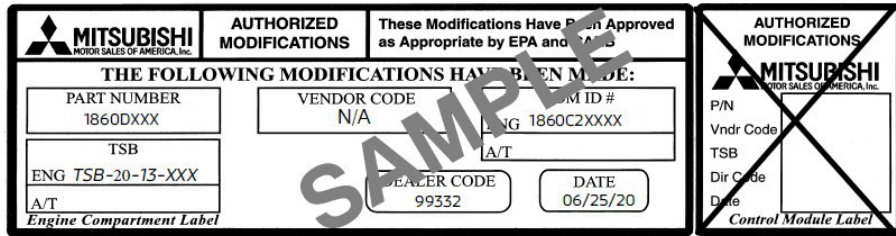
6. Using a ball-point pen, enter the appropriate ECU part number, Software Part Number (ROM ID#), this Technical Service Bulletin number, your dealer code, and the current date on the Engine Compartment/Control Module Label (p/n MSSF024G00). The Vendor Code is not applicable. The label is available from your facing PDC.
