Technical Service Bulletin

SUBJECT:		No:	TSB-22-13-004REV
WIRELESS CHARGER STOPS CHARGING WHEN USING IPHONE 12 OR LATER - REVISED		DATE:	December 2022
		MODEL:	2022-23 Outlander 2023 Outlander PHEV
CIRCULATE TO:	<input type="checkbox"/> GENERAL MANAGER	<input checked="" type="checkbox"/> PARTS MANAGER	<input checked="" type="checkbox"/> TECHNICIAN
<input checked="" type="checkbox"/> SERVICE ADVISOR	<input checked="" type="checkbox"/> SERVICE MANAGER	<input checked="" type="checkbox"/> WARRANTY PROCESSOR	<input type="checkbox"/> SALES MANAGER

This bulletin provides instructions to reprogram the wireless charger with the latest software.

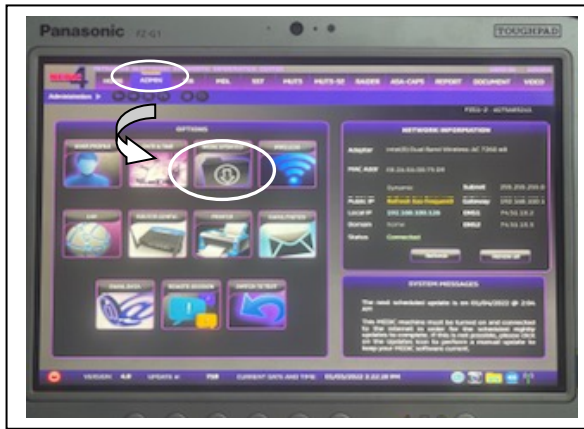
3. Select the MEDIC 3.5/4 Admin tab and click on "Updates".

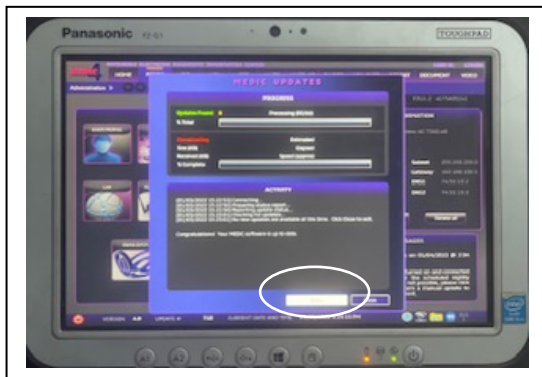
4. If the MEDIC update screen advises updates are available, click the "Begin" button. After all updates are complete, **GO TO THE REPROGRAMMING PROCEDURE.**

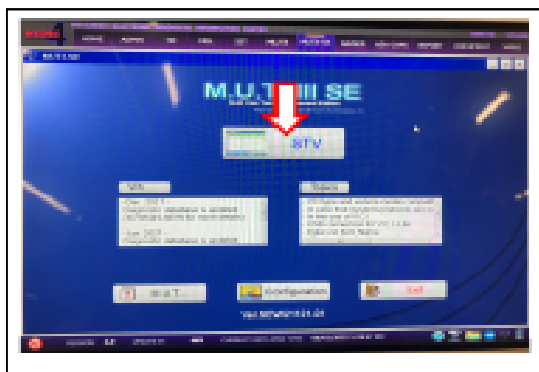
- a. Press the MUT-III SE STV icon.

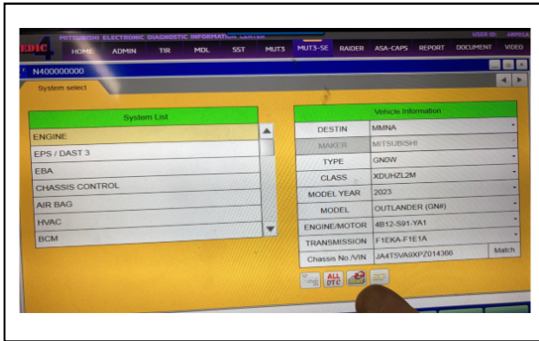
b. Press the Reprogramming button once the vehicle information is entered.

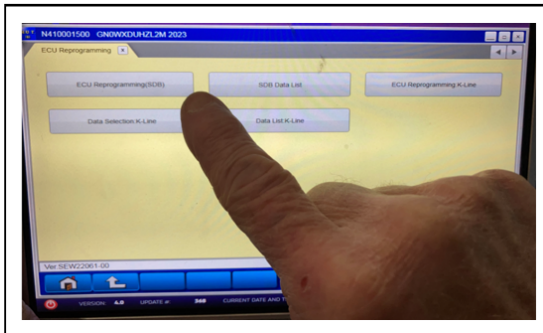
c. Press "ECU Reprogramming (SDB)" button.

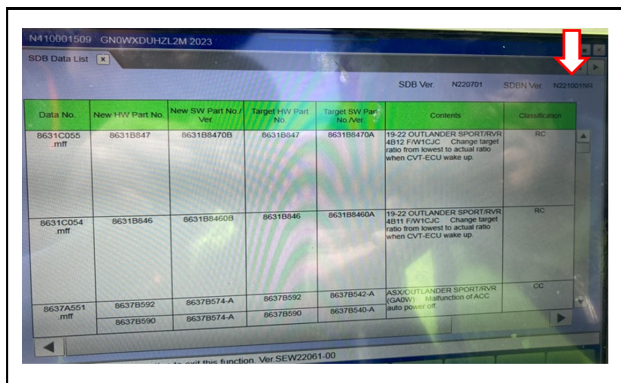
d. Confirm that the database number displayed in the upper right above the chart is **N221001NR** or higher.

- i. If the database number displayed on your MUT-III SE is **N221001NR** or greater, continue to the next section.
- ii. If the reprogramming database number displayed on your MUT-III SE is lower than **N221001NR**, then the MUT-III SE database needs to be updated.
- iii. Once the database number is confirmed, hit the Home button to go back to the System Select screen.

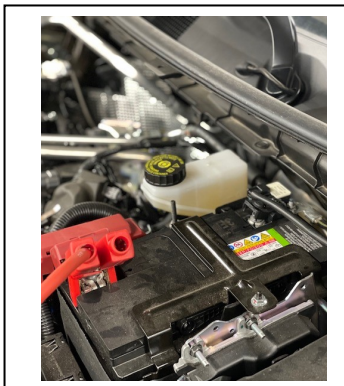
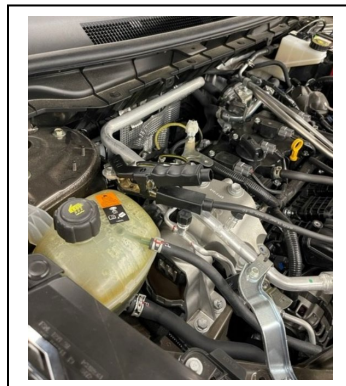
NOTE: Due to limited space it may be easiest to connect battery charger cable onto ground point.

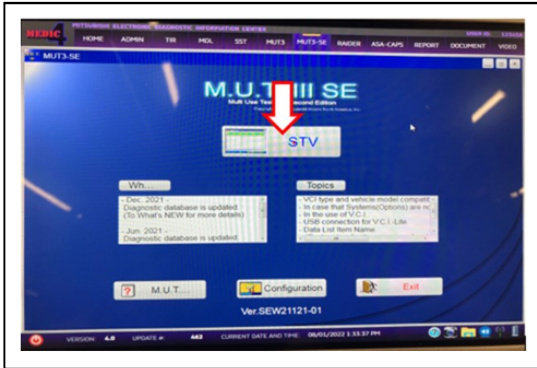
a. Press MUT-III SE STV icon.

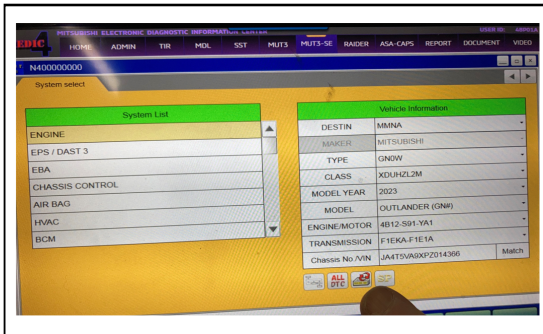
c. Press the reprogramming icon button.

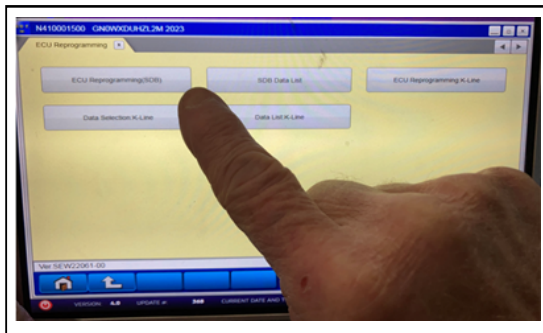
d. Press the "ECU reprogramming" (SDB) button.

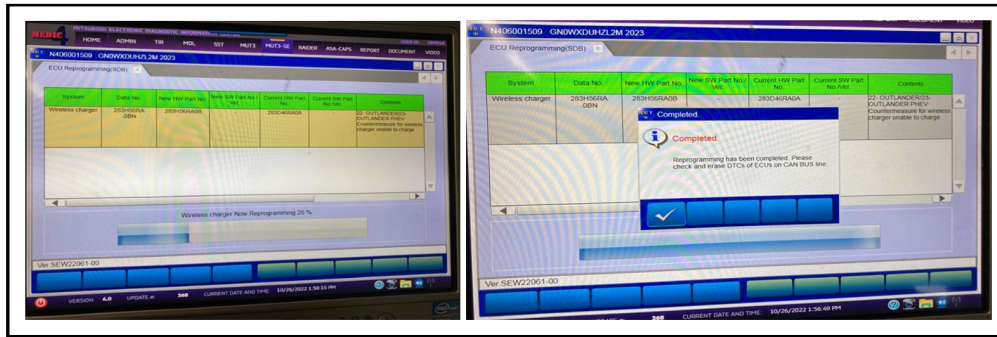
- h. Once the reprogramming is initiated the screen (shown below) will indicate the reprogramming progress. It may take 4-5 minutes to complete.

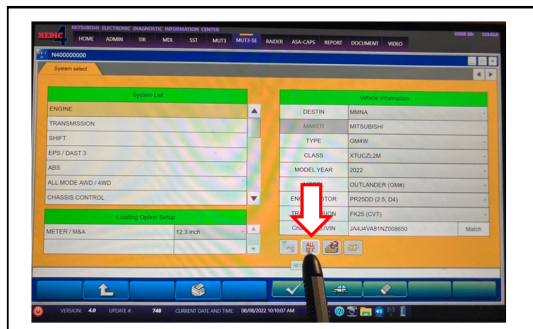
- j. Press "ALL DTC" button to initiate the "Erase and Read all DTCs". Press OK when complete.
