## Turbo Compound 2nd Generation - EGR And/Or DPF Diagnostic Trouble Codes (DTC), Diagnostic And Repair Information

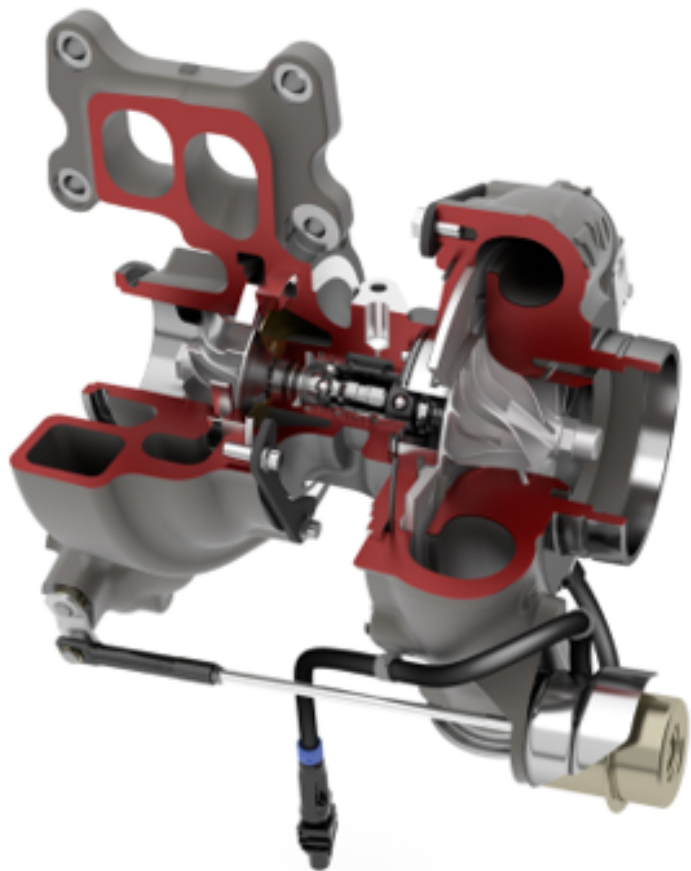
Vehicles equipped with a 2nd Generation Turbo-compound unit will have a turbocharger equipped with a wastegate as seen below.
