## LIMITED SERVICE CAMPAIGN K0P CUSTOMER SUPPORT PROGRAM 19TE12

### SAFETY CONNECT SYSTEM – VEHICLE LOCATION INACCURATE

2013 – 2019 MODEL YEAR 4RUNNER  
2011 – 2017 MODEL YEAR LAND CRUISER  
2013 – 2017 MODEL YEAR PRIUS  
2012 – 2017 MODEL YEAR PRIUS V  
2016 – 2017 MODEL YEAR MIRAI

**Updated 08/24/2020**

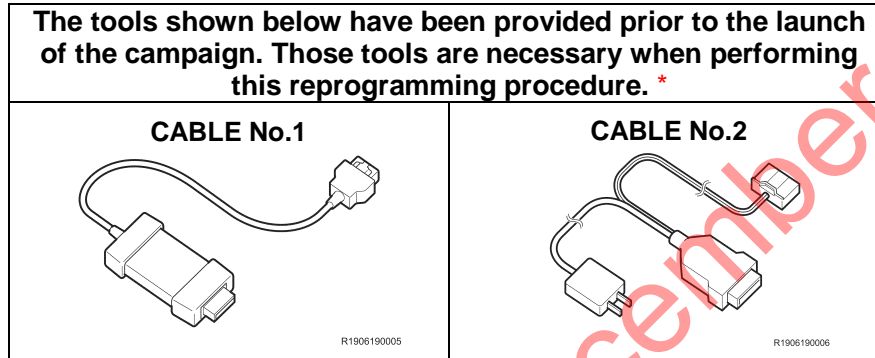
### B. CABLE No.1 & CABLE No.2

\* **DO NOT** use these tools except for this campaign.

- Turn the IG OFF.
- Using a Cable No.1 (provided tool), connect the Techstream to the vehicle.

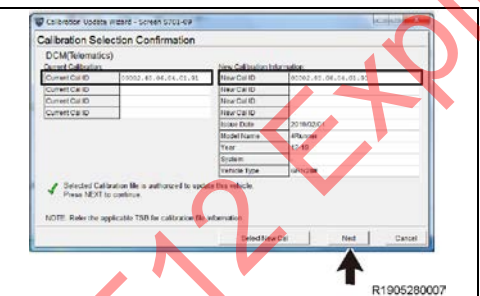
d) Confirm that "Current Cal ID" and "New Cal ID" are correct, and then click on "Next".

**NOTE: The calibration IDs will be displayed as shown on the left. Please make sure you DO NOT mistake where to check to confirm the IDs.**

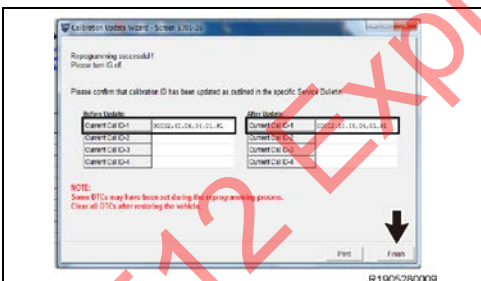
i) Click the "Next" button.

**NOTE:** It is **NOT** necessary to follow the instructions on the screen of Techstream.

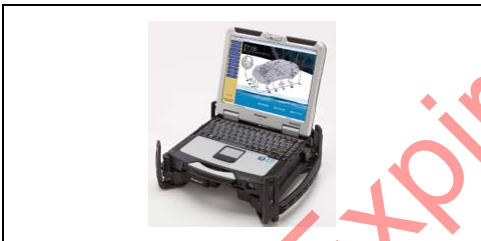
### 2. RESTORE THE VEHICLE (IF YOU REPROGRAM 12DCM)

- Reinstall the "D/C CUT FUSE" or "SHORT PIN".
- (Only 4RUNNER, PRIUS, PRIUS V).**
  - Disconnect cable from negative battery terminal.
  - Connect each connector of the front passenger seat. Refer to repair manual for installation. Depending on seat type, you may need to perform certain initializations (such as Zero Point Calibration) refer to the repair manual for details
  - Connect cable to negative battery terminal.
  - Some systems need to be initialized after the cable is reconnected. Refer to repair manual for initialization.
