## Product Update: 2016-2020 MDX PGM-FI Idle Stop Software Update

### AFFECTED VEHICLES

Year	Model	Trim	VIN Range
2016–2020	MDX	All (except Hybrid)	Check the iN VIN status for eligibility.

Update the PGM-FI Software.

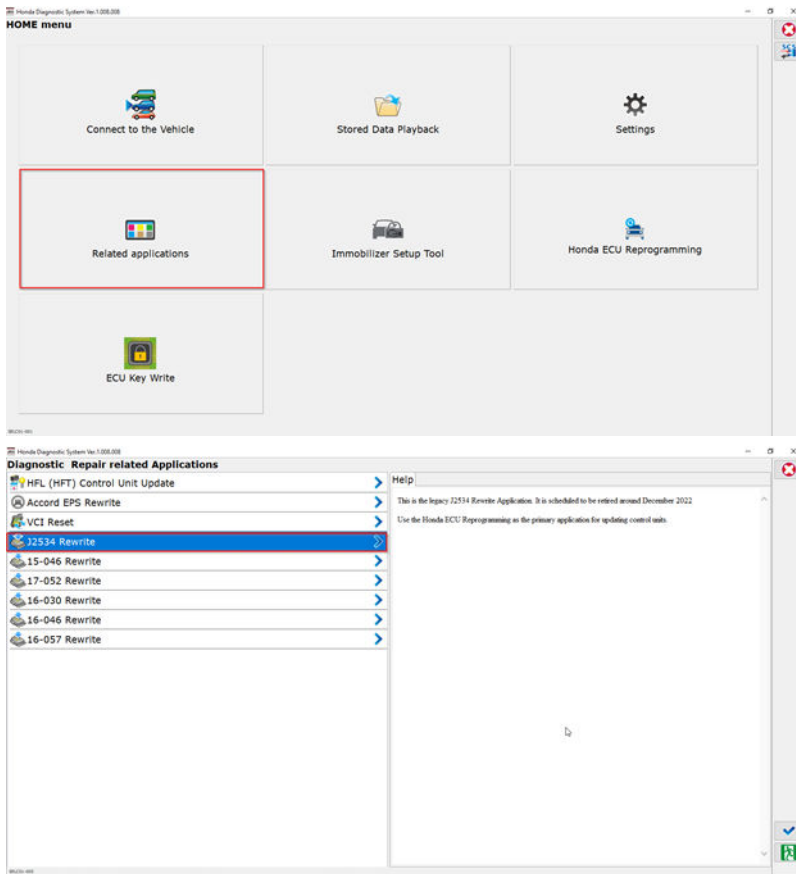
2. From the HOME menu, select the **J2534 Rewrite** under Related Applications”

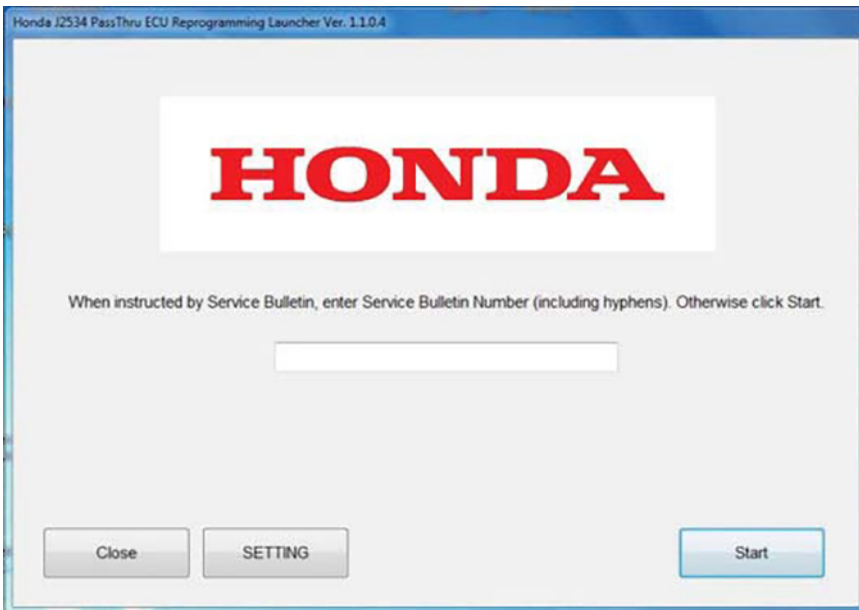
3. When prompted select **Start**, do not enter a service bulletin number.

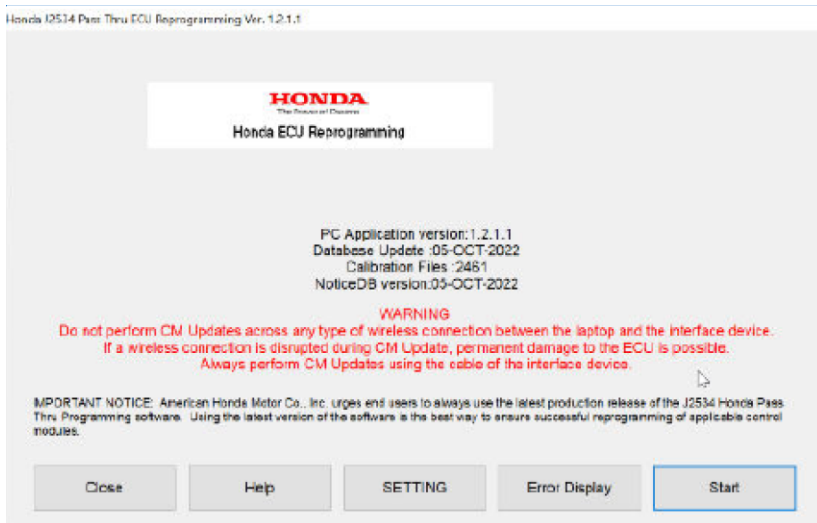
4. **Connect the i-HDS to the vehicle and select **Start** to begin reprogramming.**

Under SOFTWARE UPDATE PROCEDURE, the Step 4 image was updated and changed parking system to PGM-FI.

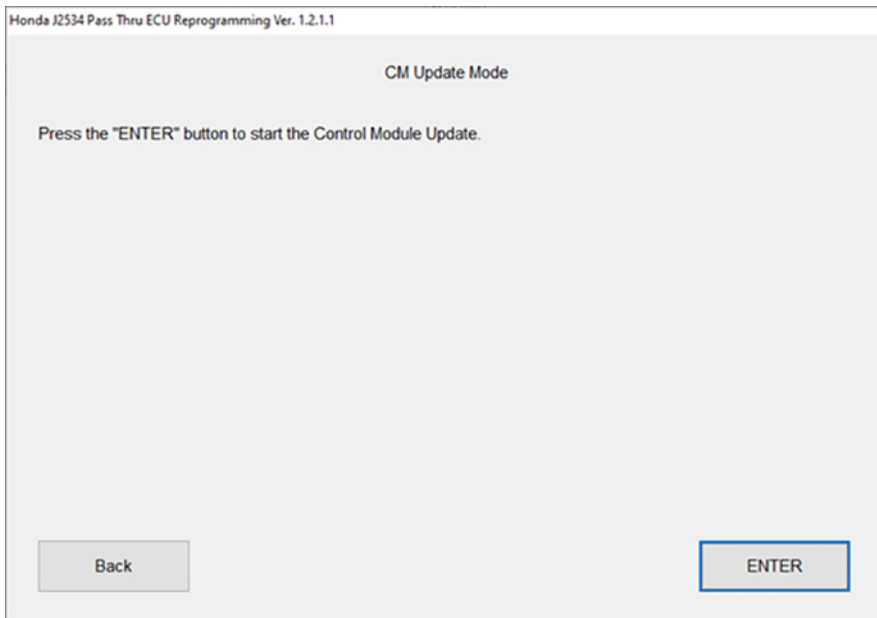
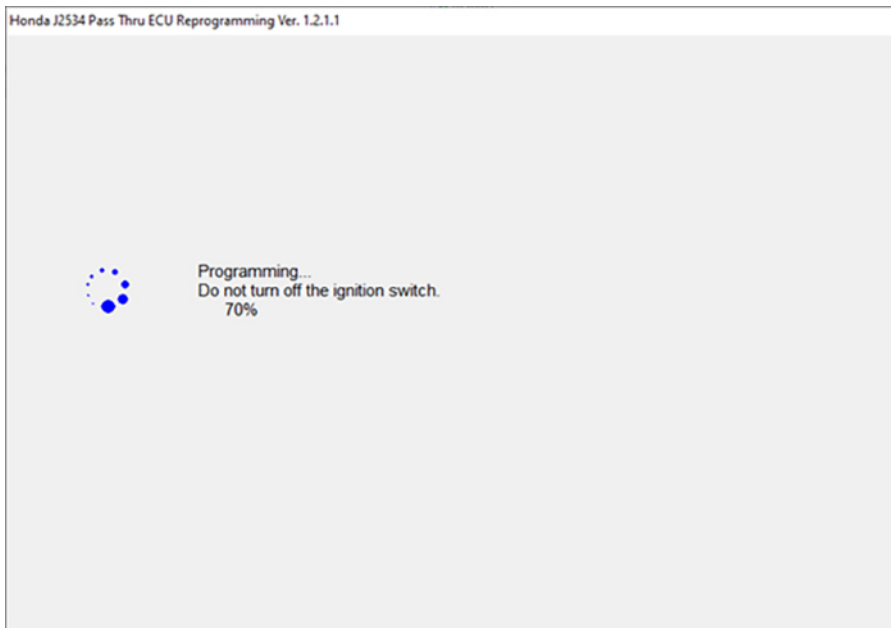
9. Select **ENTER** to begin reprogramming, and follow the screen prompts.

CM Update Mode

PGM-FI  
Completed.  
Turn the ignition switch OFF.

Turn the ignition switch ON within 60 seconds.

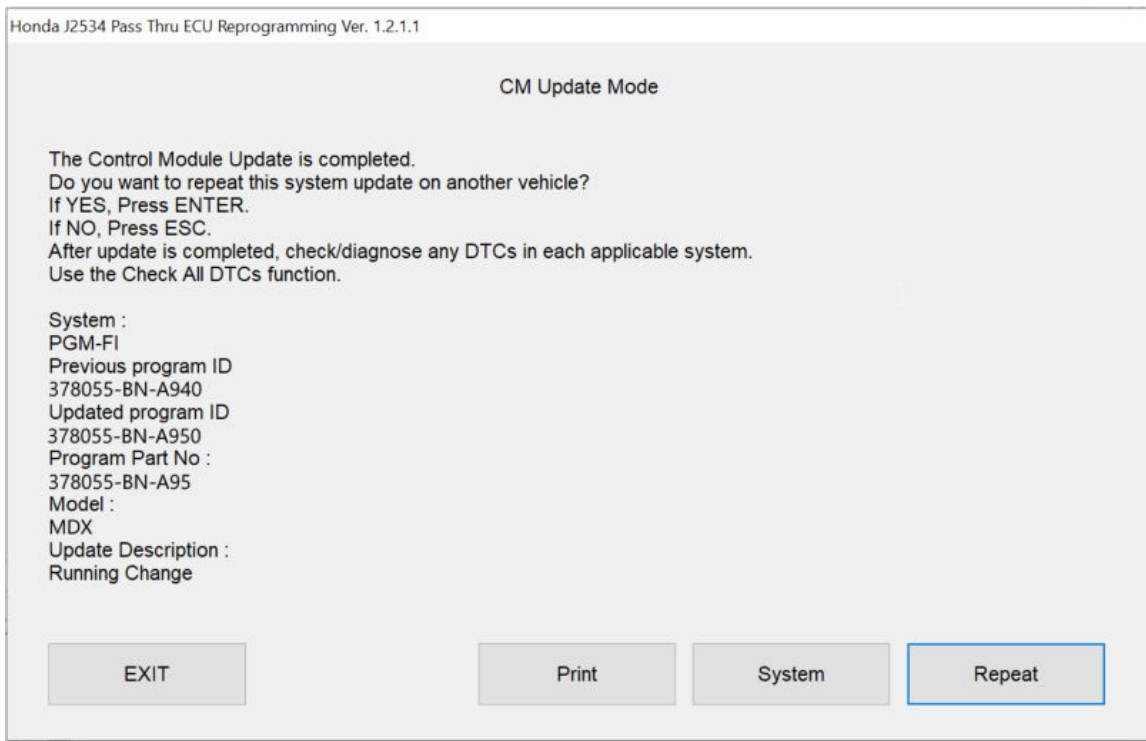
10. Once the module is updated, the following screen appears, then select **EXIT**.
