# Customer Satisfaction Program

## N212354520 Heated Vented Seats Retrofit - Front Seats Only

**Release Date:** February 2023

**Revision:** 06

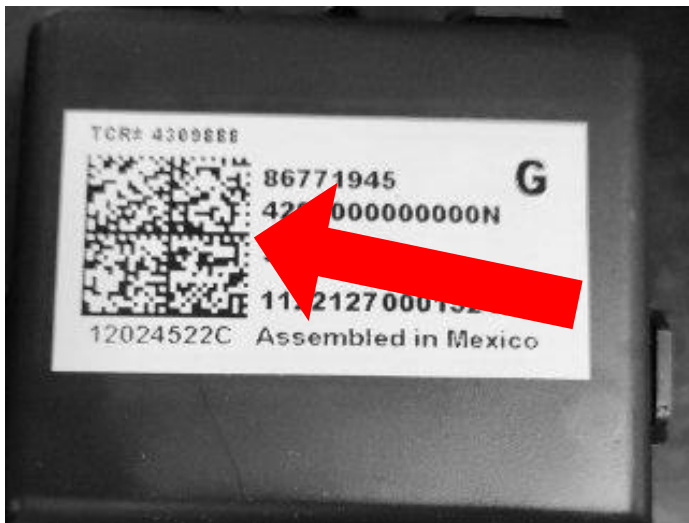
If the App is already loaded to your phone, simply:

1. Scan the VIN (door pillar QR code or windshield VIN barcode) and
2. Scan the new part (QR code) and
3. Check the information and if correct then, Submit.

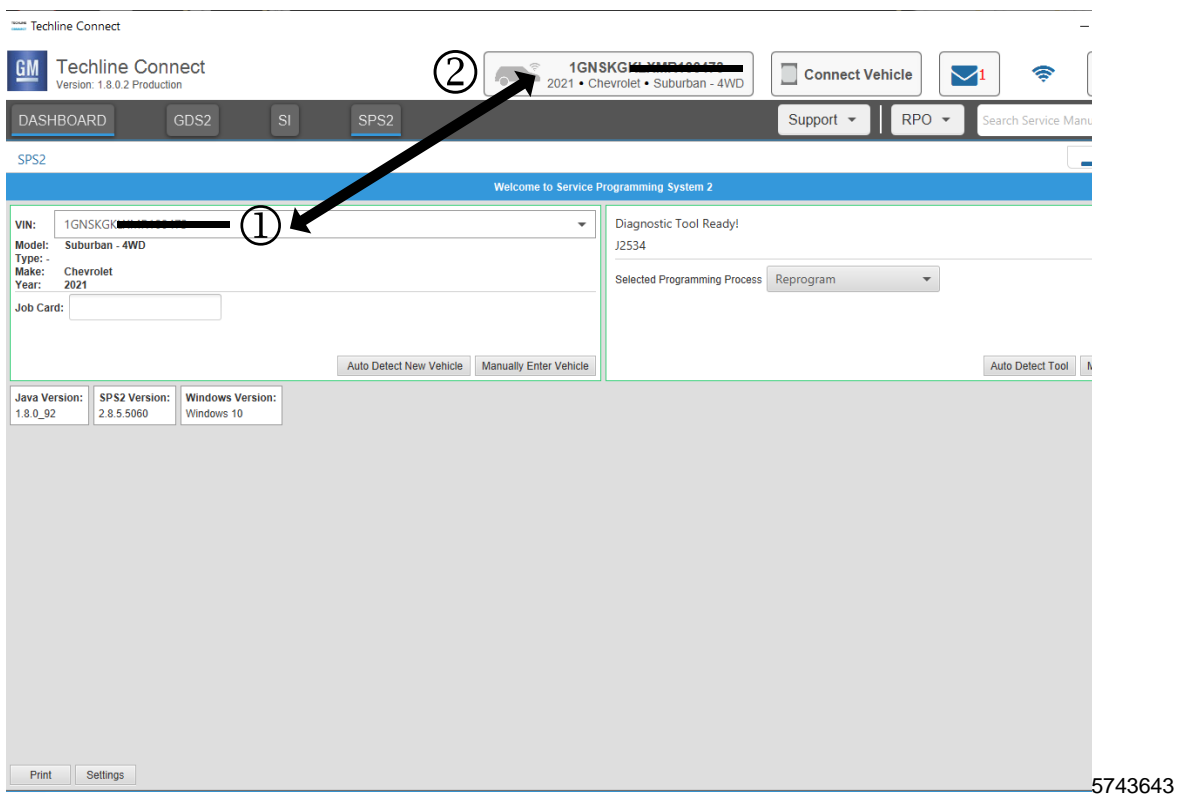
**Caution:** Be sure the VIN selected in the drop-down menu (1) is the same as the vehicle connected (2) before beginning programming.

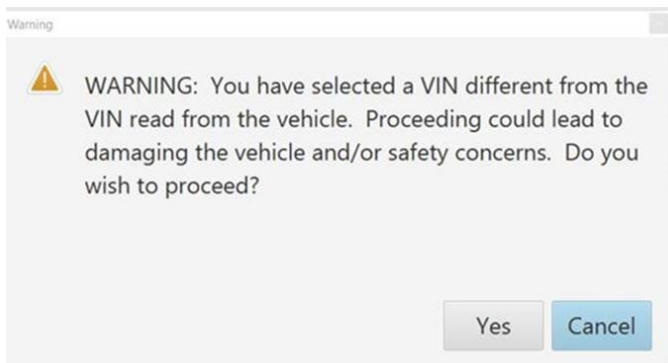
**Important:** If the vehicle VIN DOES NOT match, the message below will be shown.

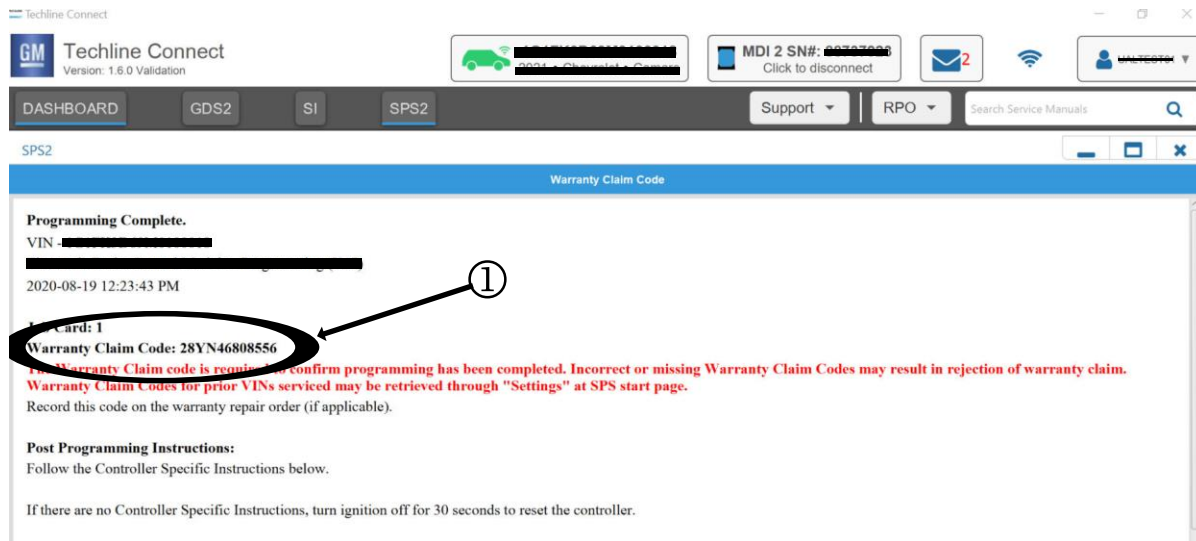
5644478

**Note:** The screenshot above is an example of module programming and may not be indicative of the specific module that is being programmed. Module selection and VIN information have been blacked out.
