Service Bulletin

Bulletin No.: 23-NA-014

Subject: Unable to Dismiss Turn By Turn Directions from the DIC

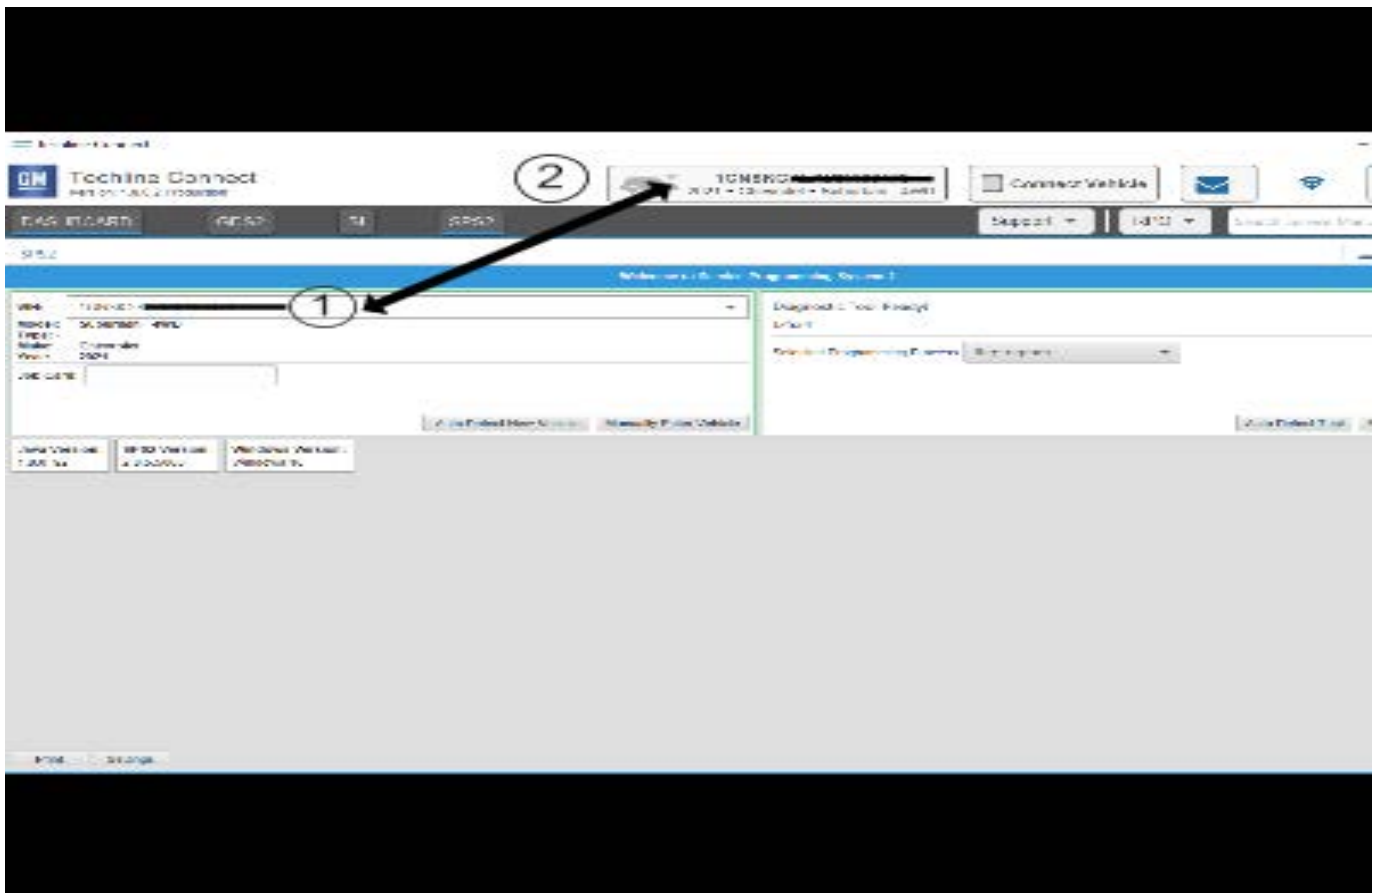
Caution: Be sure the VIN selected in the drop down menu (1) is the same as the vehicle connected (2) before beginning programming.

Important: Techline Connect screens shown above.
