ACC Warning Light Is On With DTC B2A60-96, C0041-14

Replaces 22-008, dated April 28, 2022. Supersedes 22-022, dated July 15, 2022, to revise the information highlighted in yellow.

AFFECTED VEHICLES

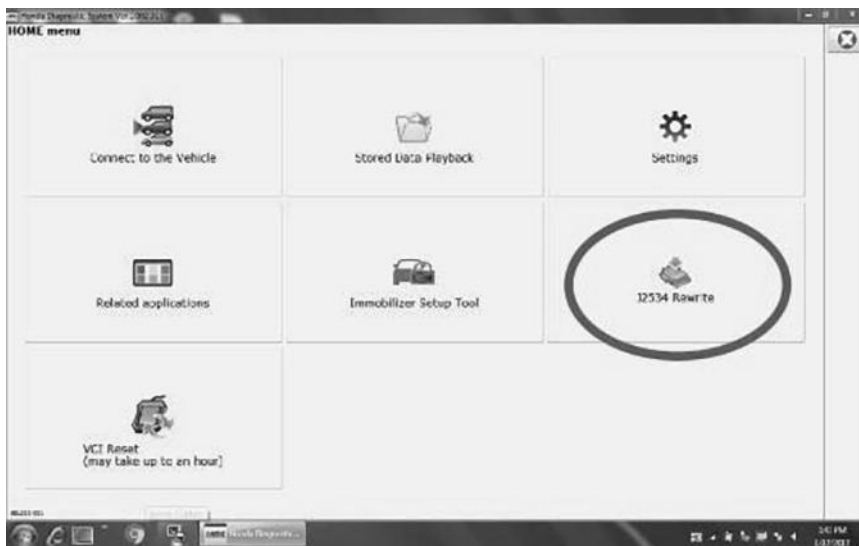
2. From the HOME menu, select the **J2534 Rewrite**.

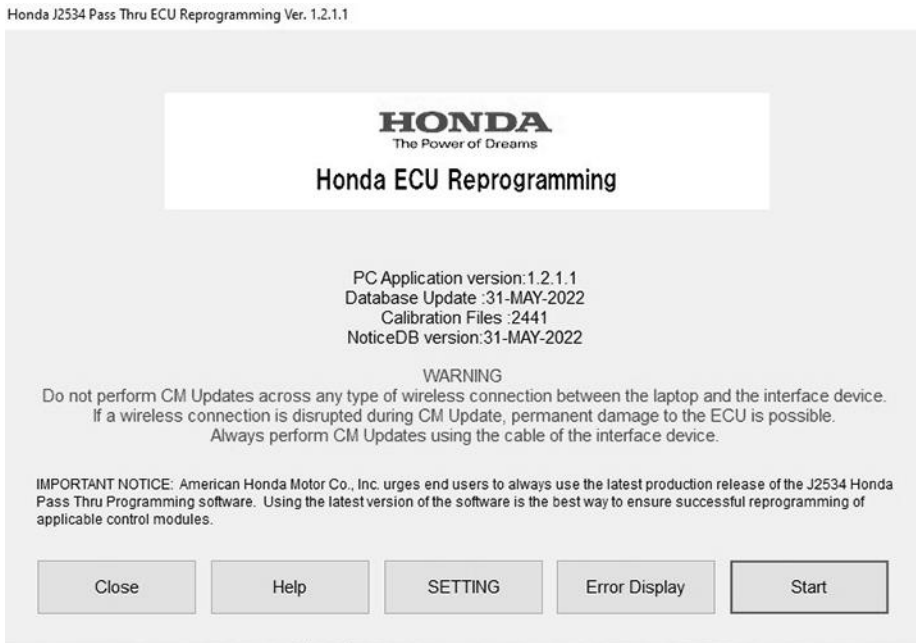
4. Connect the i-HDS to the vehicle and select **Start** to begin reprogramming.

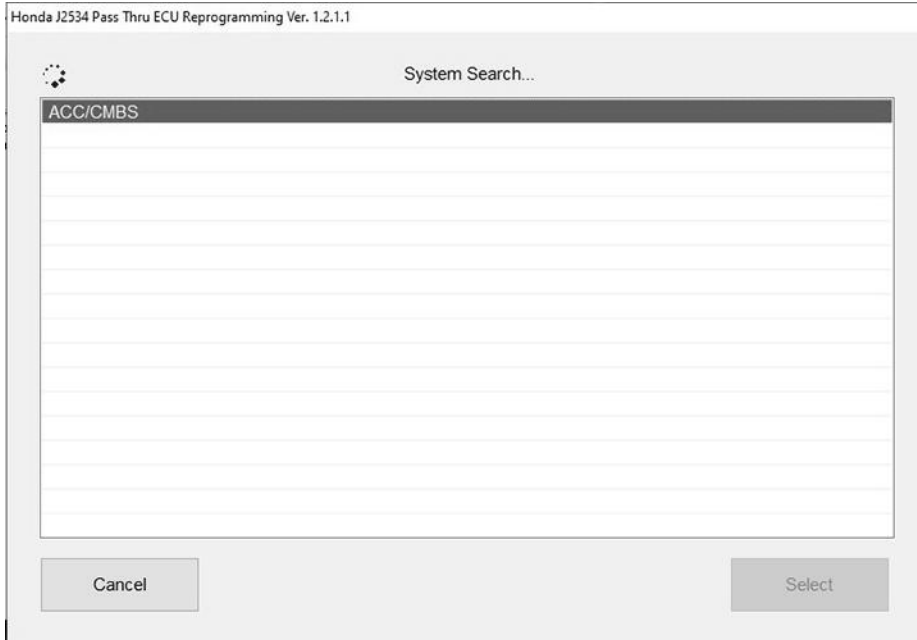
7. Select the **ACC/CMBS**, and then **Select**.

NOTE: Wait until vehicle communication has completed.

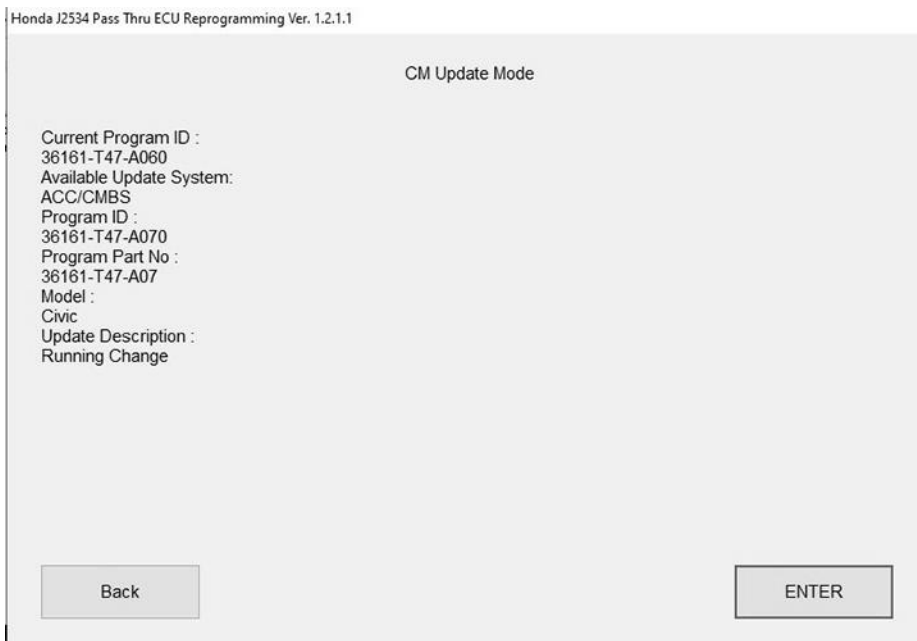
8. Confirm the update information, then select **ENTER** to proceed.

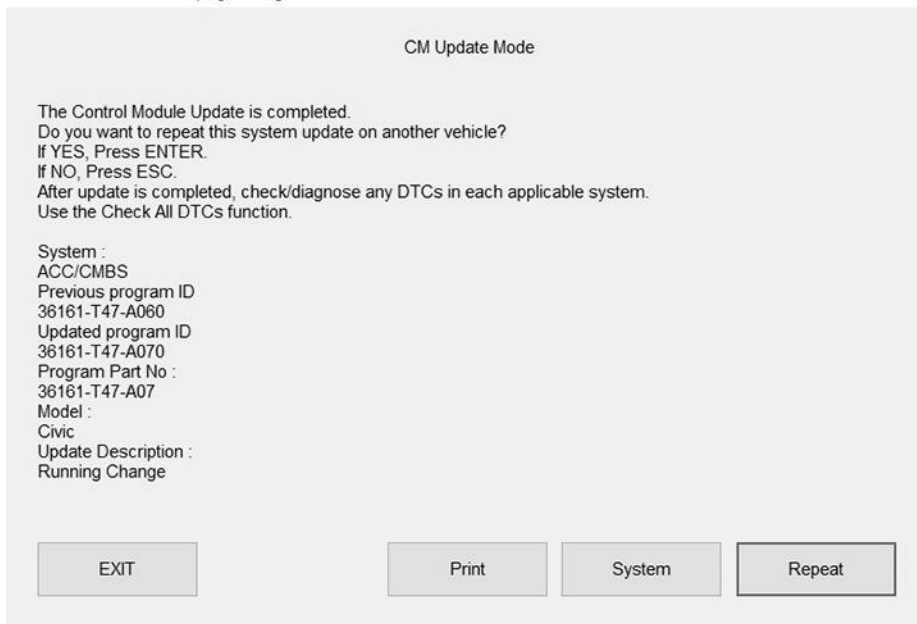
10. Once the module is updated, the following screen appears, then select **EXIT**.
