Service Action Code: 47S6

Subject Brake Servo Control Unit Software

On ID.4 vehicles built during a limited production period, the brake servo control unit was not equipped with the latest software in the factory.

Update brake servo control unit software.

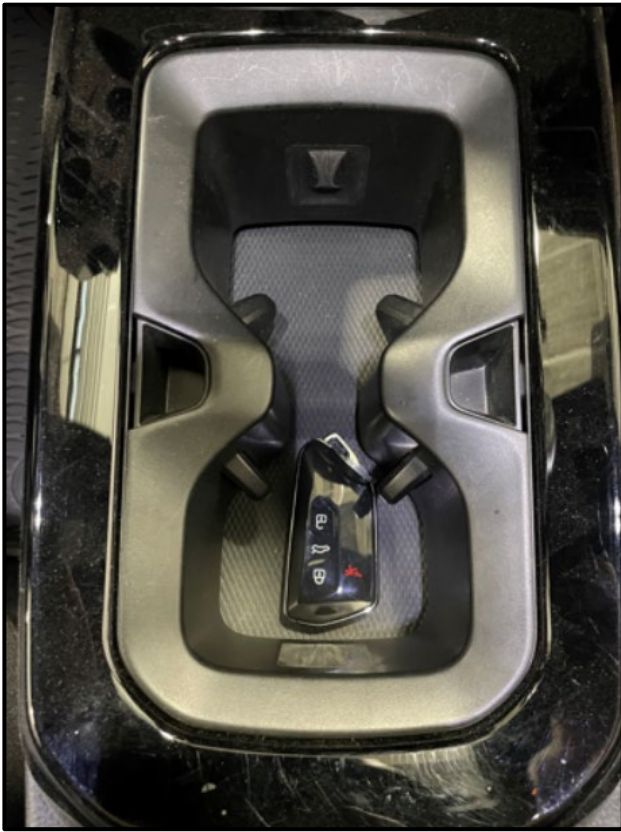
- Place the vehicle key over the reader coil in the center console cupholder.
- Any additional keys must be a minimum of 20 meters away from the vehicle.

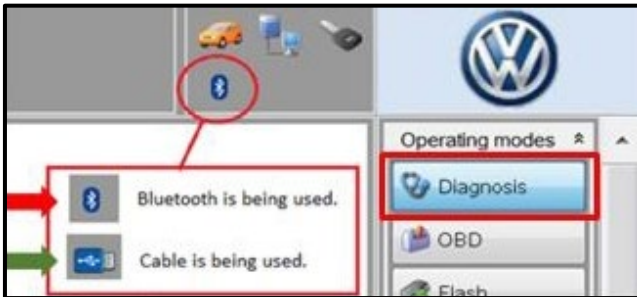
- Confirm that scan tool is communicating with the diagnostic head by USB <Green Arrow>.
 - If the Bluetooth symbol is shown <Red Arrow> then disconnect the diagnostic head from the vehicle and reconnect the USB cable to the diagnostic head and then reattach to the vehicle.
- Upon ODIS startup, verify the “Diagnosis” operating mode is selected <as shown>.

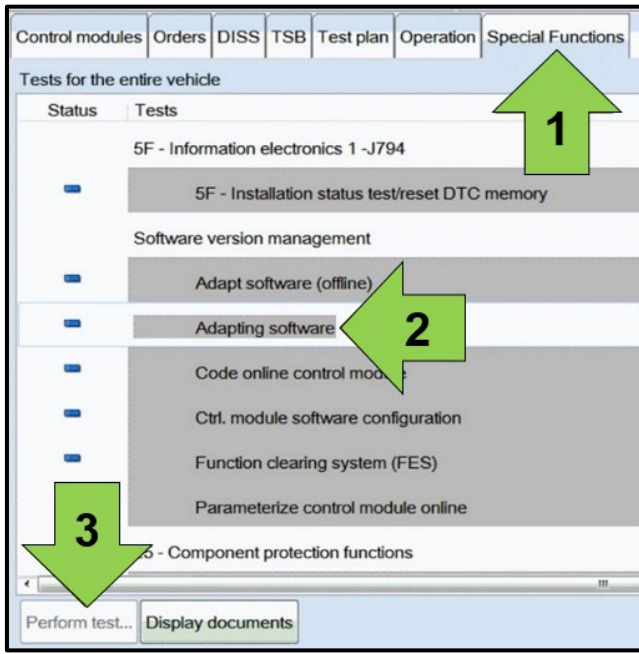
- Once the GFF scan is complete, select “Special functions” <arrow 1>, then “Adapting software” <arrow 2>, then select “Perform test” <arrow 3>.

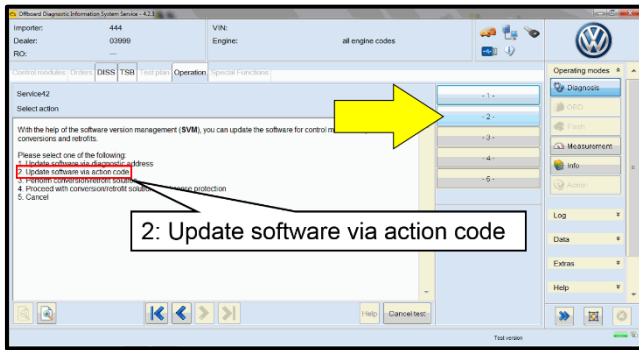
- Select the correct option to “Update software via action code” OR “Software update via measured code”.

NOTE
The different options to perform the SVM operation may vary based on model.

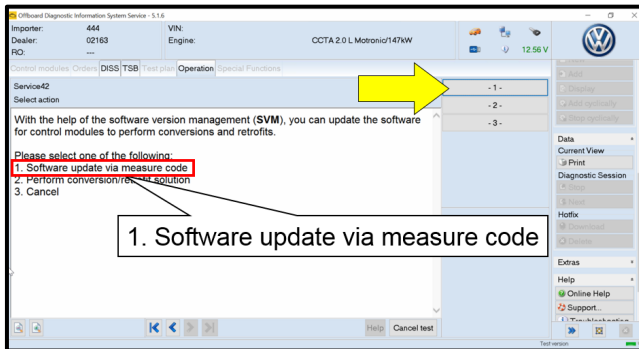
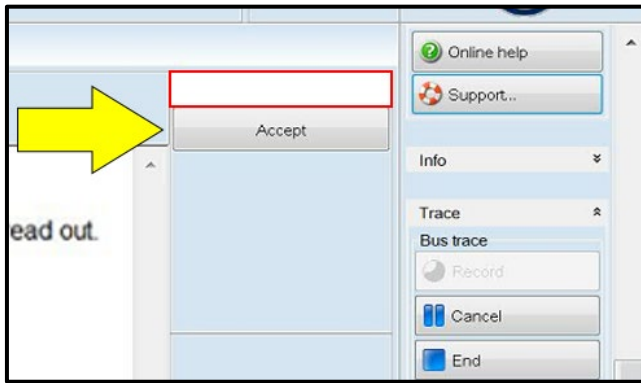
- Enter the corrective action code (SVM code) as listed below.

SVM code
48E5

- Select "Accept" <arrow> and follow the on screen prompts.
- Select Complete/Continue <arrow> after each operation is completed.

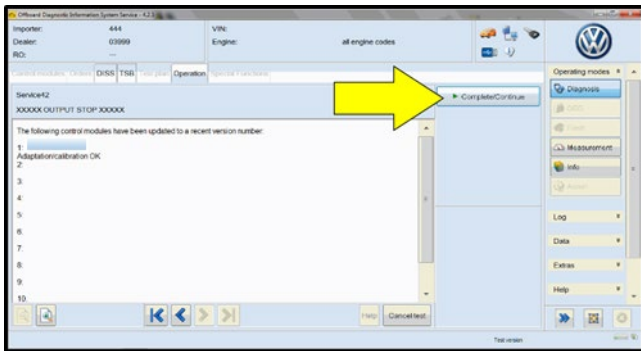
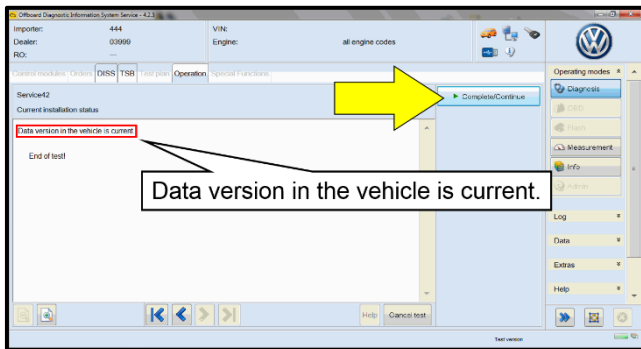
- When the SVM update is complete a confirmation message is displayed <as shown>.
- Select "Complete/Continue" <arrow>.

If the software in the vehicle is already current, a message may appear indicating this. If this occurs, complete the ODIS test plan and send the diagnostic protocol online.

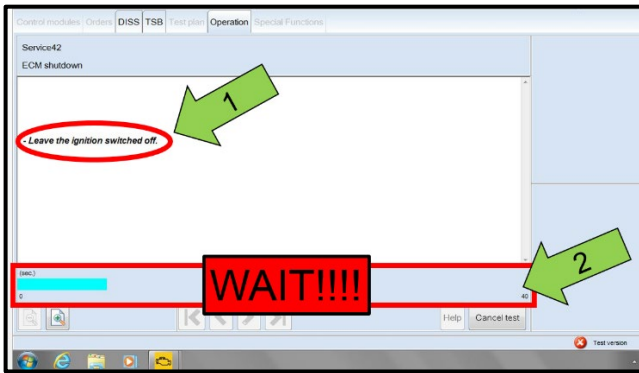
- It is **IMPERATIVE** that **ALL** of the ignition cycle on/off delay requests are fulfilled in their entirety during this flash process <arrow 1>.
- Failing to wait for the ignition on/off timing cycle to complete (progress bar and countdown timer <arrow 2>) before cycling the ignition on/off **MAY** damage a control module.
- Damage to control modules as a result of failing to wait the specified time displayed by the progress bar and countdown timer <arrow 2> are **NOT** covered under this action.

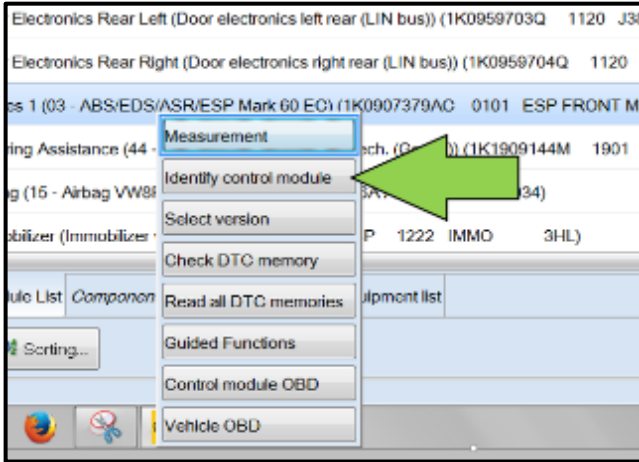
- After the software update is completed and before sending the GFF Log Online:
 - Select the “Control Module” tab.
 - Scroll down and right click on the module that was updated (**0023**).
 - Select “Identify Control Module” <arrow>.

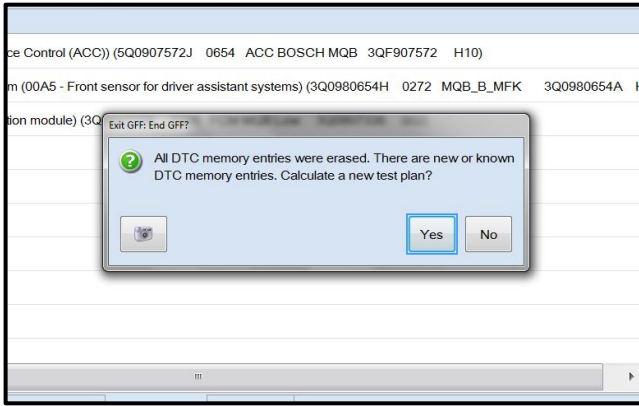
- Exit GFF and send diagnostic protocol online when prompted.
