Technical Service Bulletin

GROUP BODY ELECTRICAL	NUMBER 23-BE-002H
DATE February, 2023	MODEL(S) VELOSTER N (JSN)

SUBJECT: BCW SOFTWARE UPGRADE – JS N BCW LOGIC IMPROVEMENT

Description: This bulletin provides information to upgrade the BCW (Blind-spot Collision Warning) software for certain 2019-22MY Veloster N (JSN) vehicles (see Applicable Vehicles below).

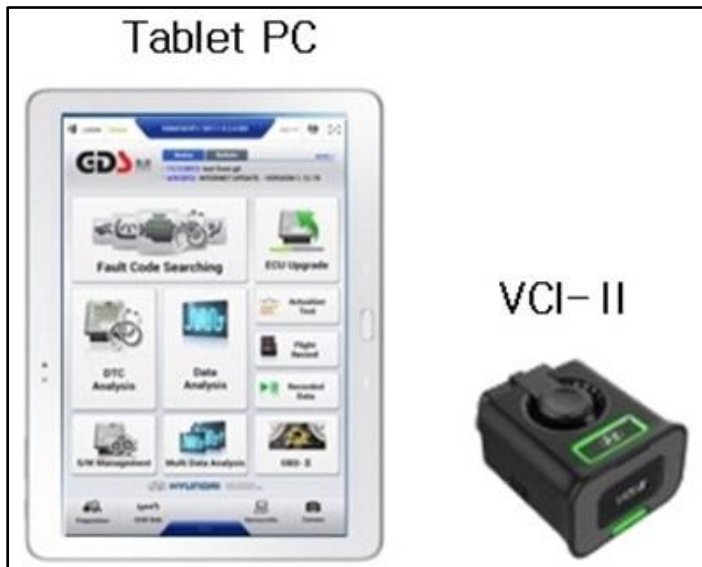
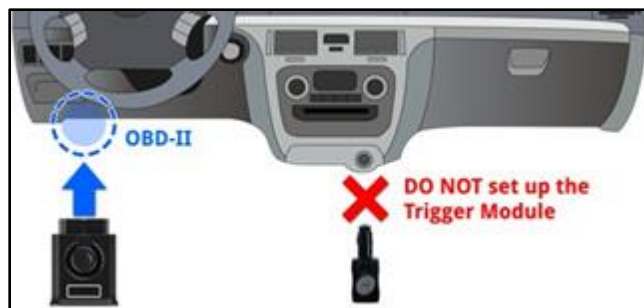
Before the software update, make sure the battery of the Tablet PC is sufficiently charged. The update can be performed via Wifi or using the USB cable between the tablet and VCI-II.

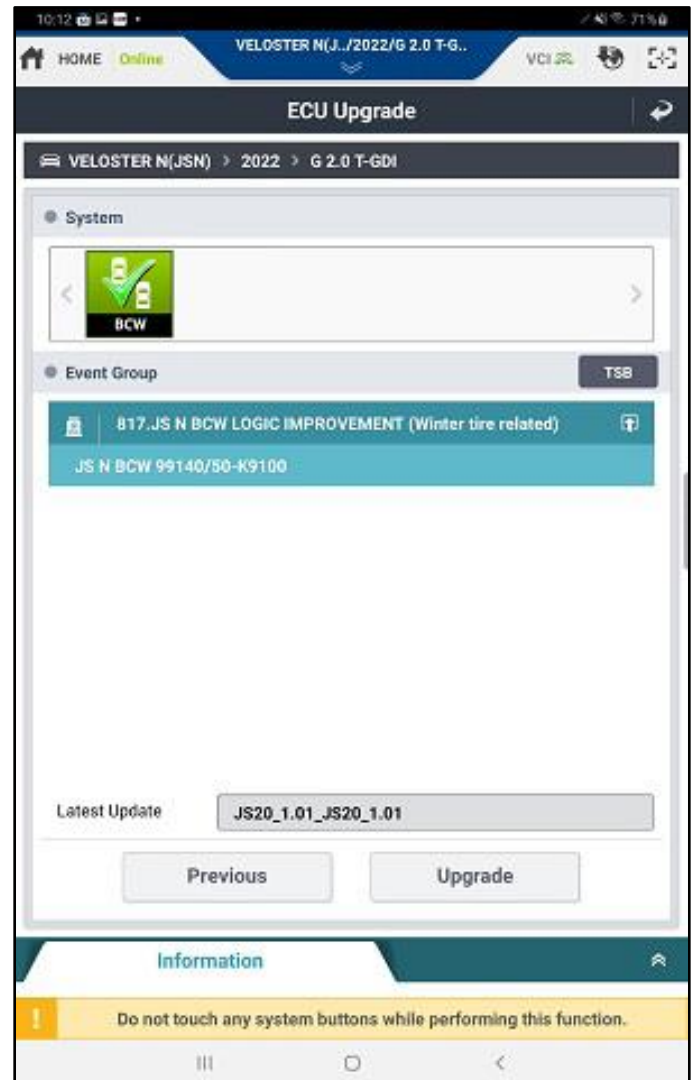
- **MANUAL GDS-MOBILE UPGRADE PROCEDURE**

(Only if Auto Update is unsuccessful)

1. Select Manual Mode then select the upgrade event.

2. Select the control unit part number from the ROM ID list above, then click OK.
3. Enter **9100** into the password field.
4. Select OK if the results show the battery voltage is correct.
5. Wait for the upgrade to finish.
