# Service Bulletin

Bulletin No.: 22-NA-150

**Subject: Malfunction Indicator Lamp (MIL) Illuminated, Service Emission System and/or DEF Level Low Message on Driver Information Center (DIC), DEF Level Sensor Reading Incorrectly, DEF Level Sensor Being Erratic, DEF Level Sensor Stuck**

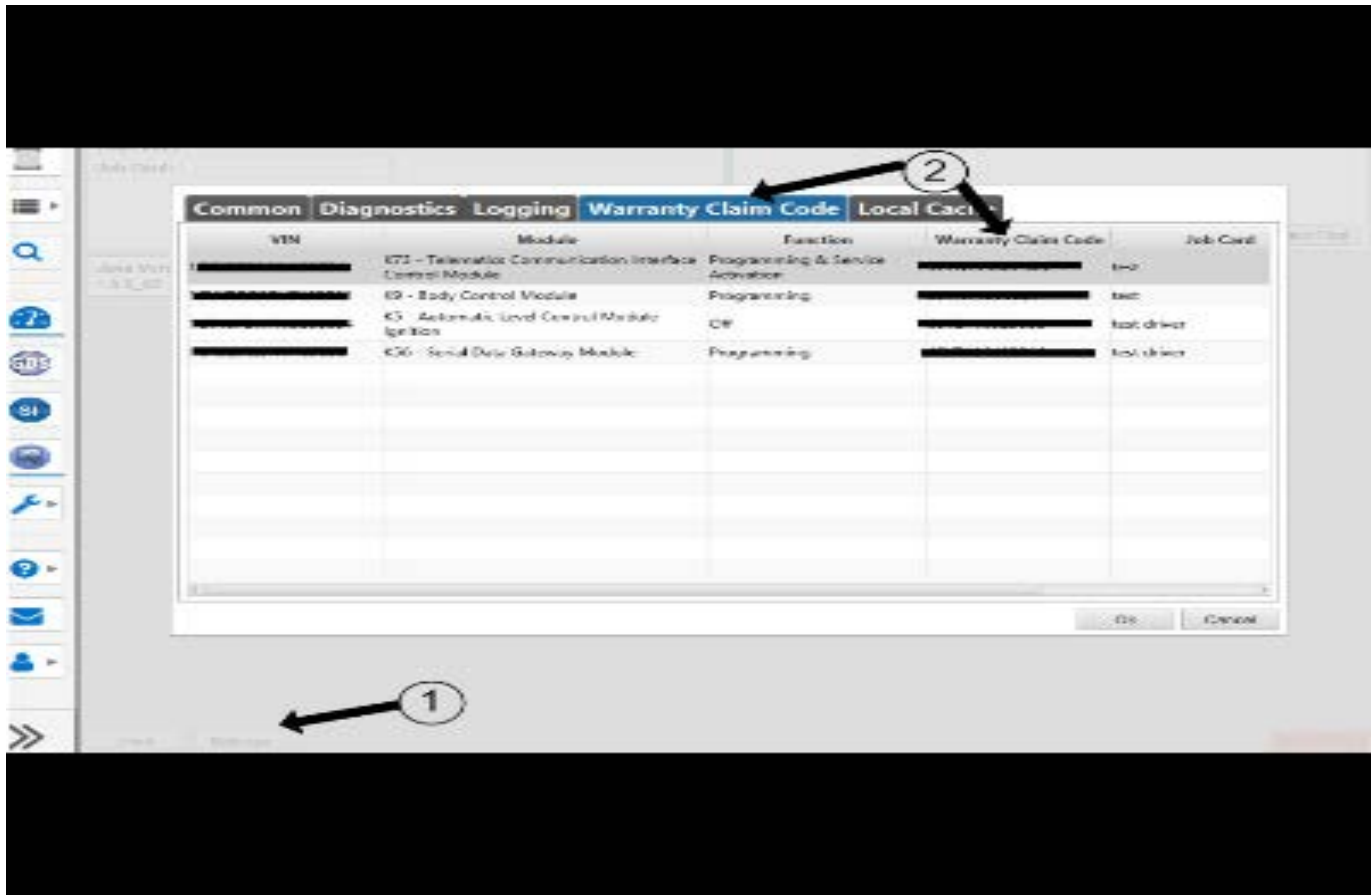
6125774

If the Warranty Claim Code was not recorded on the Job Card, the code can be retrieved in the SPS2 system as follows:
