# Service Bulletin

Bulletin No.: 22-NA-253

**Subject: Cluster RPO UDV 162.1 Software Update – Multiple Updates**

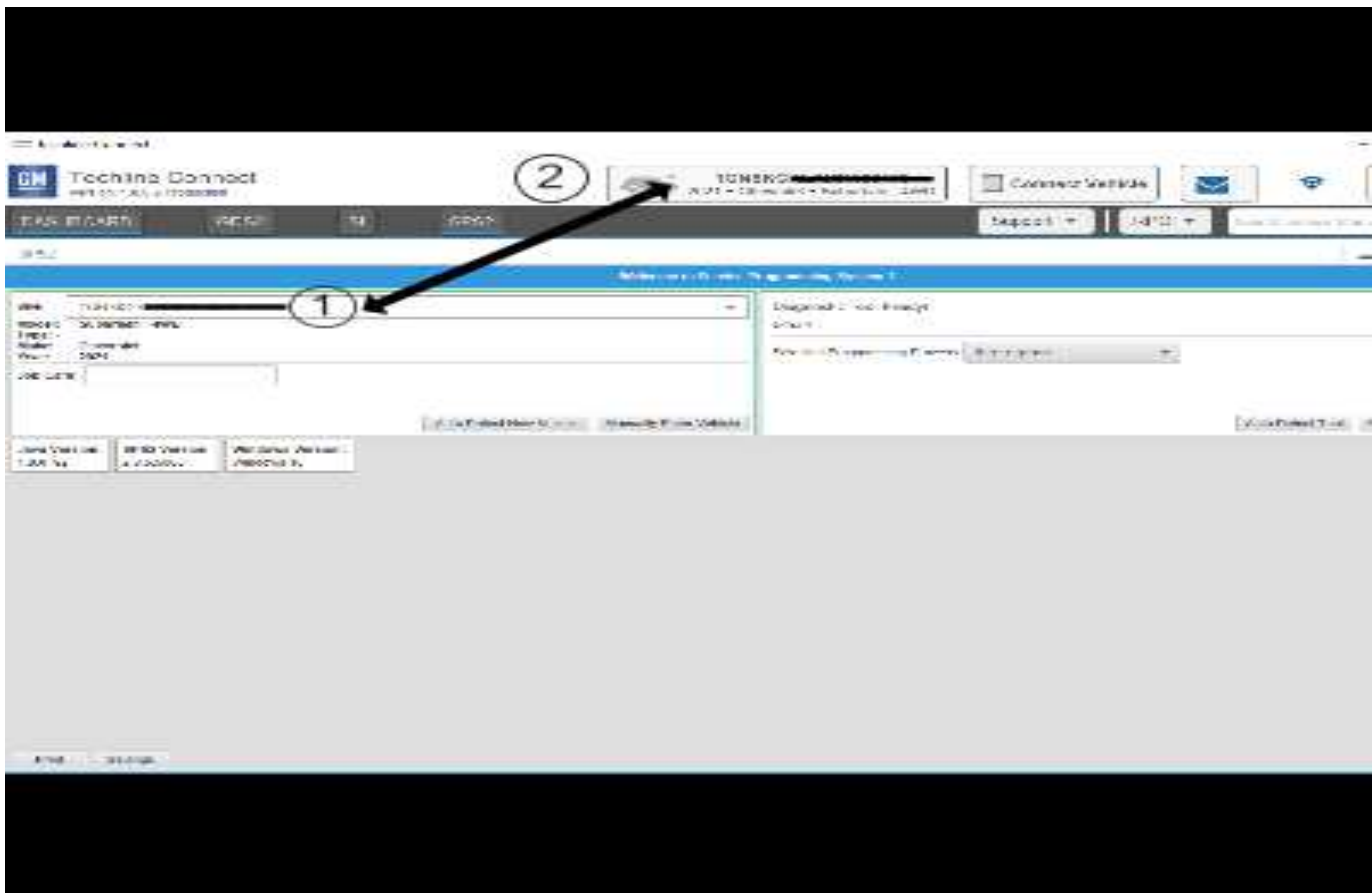
**Caution:** Be sure the VIN selected in the drop down menu (1) is the same as the vehicle connected (2) before beginning programming.

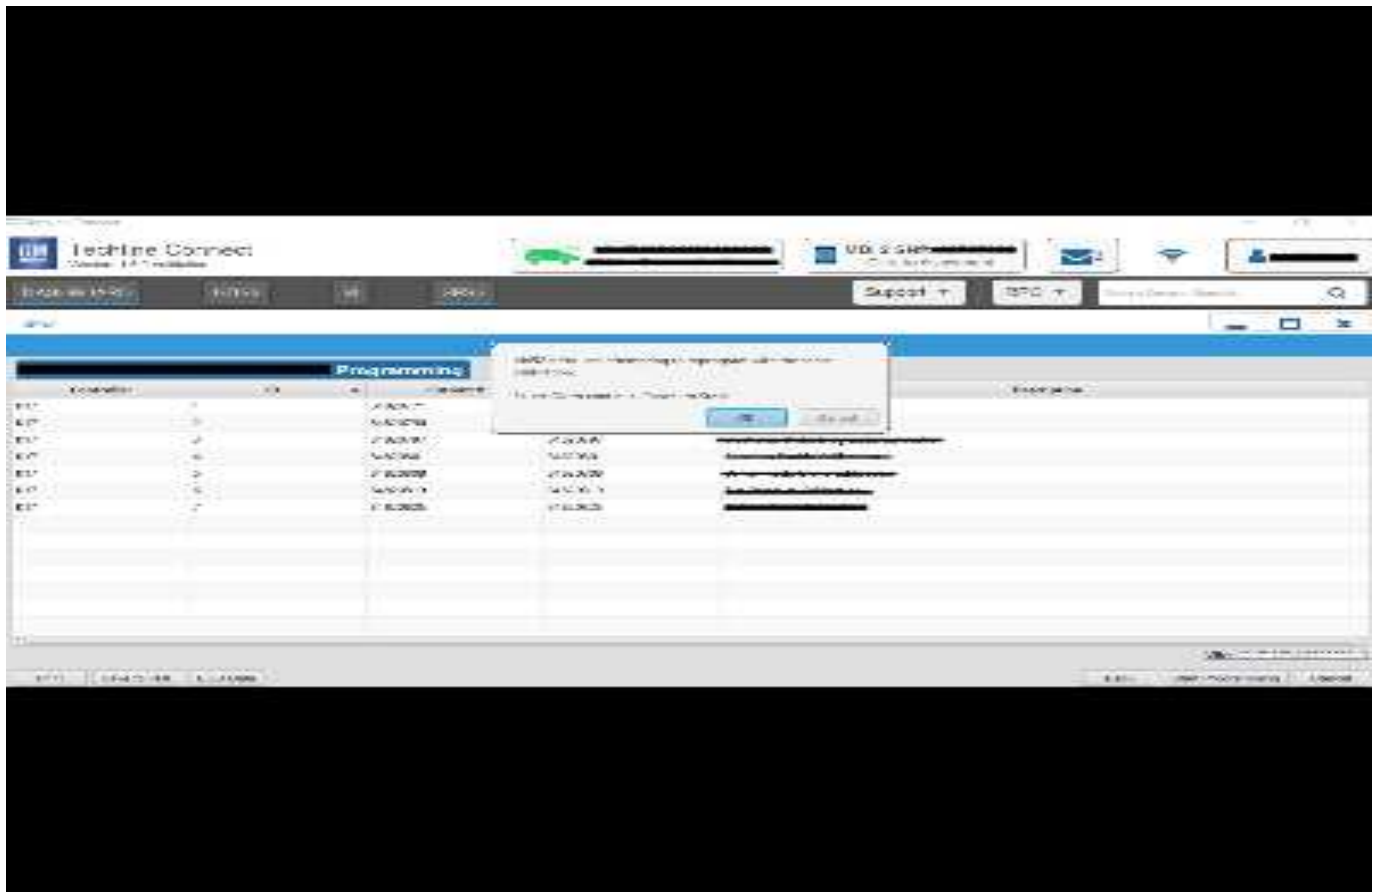
5644477

**Important:** Techline Connect screens shown above.
