Preliminary Information

PIP5903 MIL On With DTC P0299

Brand:	Model:	Model Years:	VIN:		Engine:	Transmissions:
			from	to		
Buick	Encore GX	2022 - 2023	All	All	1.3 L3T	All
Chevrolet	Trailblazer	2022 - 2023	All	All	1.3 L3T	All

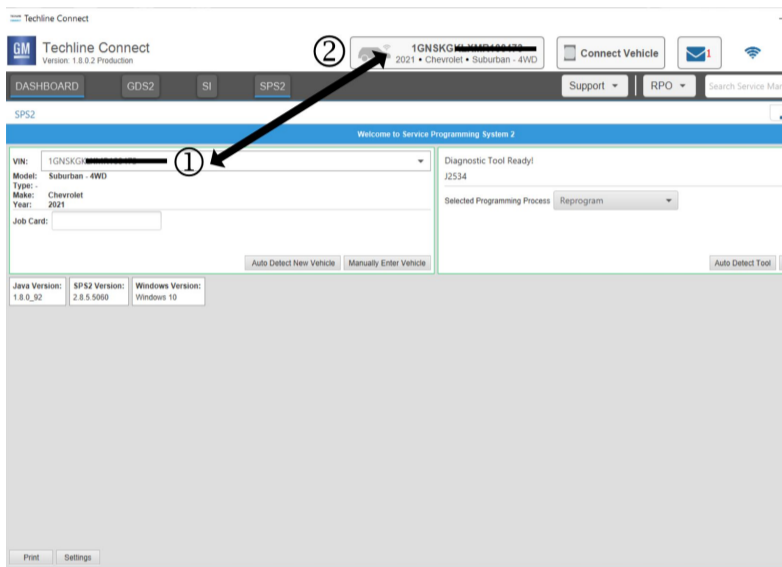
Caution: Be sure the VIN selected in the drop down menu (1) is the same as the vehicle connected (2) before beginning programming.

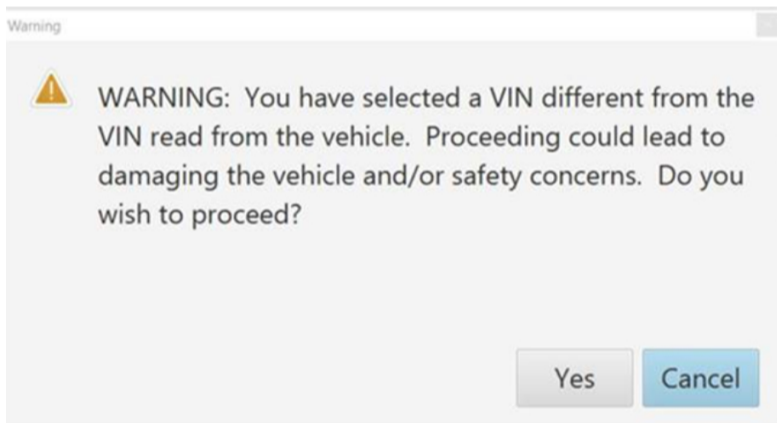
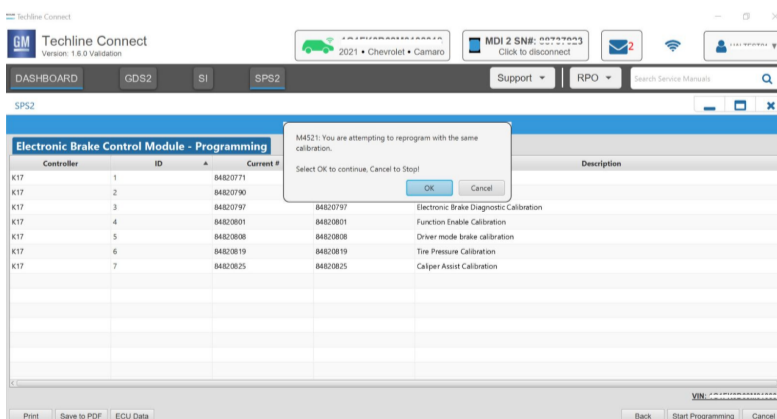
Important: If the vehicle VIN DOES NOT match, the message below will be shown

Important: Techline Connect screens shown above.

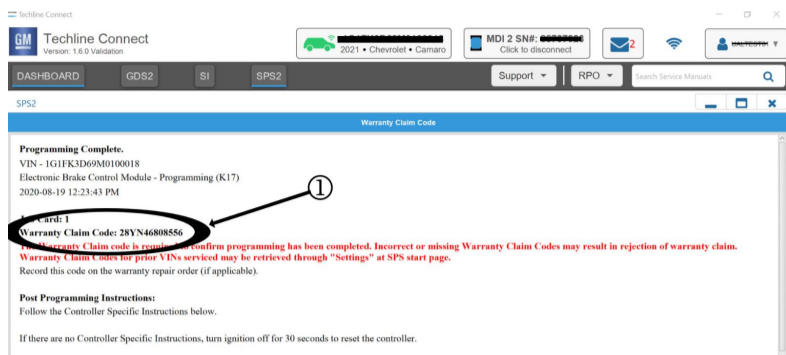
Note: The screenshot above is an example of module programming and may not be indicative of the specific module that is being programmed. Module selection and VIN information have been blacked out.

Important: To avoid warranty transaction rejections, you **MUST** record the warranty claim code provided on the Warranty Claim Code (WCC) screen shown above on the job card. Refer to callout 1 above for the location of the WCC on the screen.

Important: If the same calibration/software warning is noted on the TLC Summary screen, select OK and follow screen instructions. After a successful programming event, the WCC is located in the Service Programming System dialogue box of the SPS Summary screen. No further action is required. Refer to the Warranty section of the bulletin.
