## Technical Service Bulletin

<b>GROUP</b> BODY ELECTRICAL	<b>NUMBER</b> 23-BE-004G
<b>DATE</b> MARCH, 2023	<b>MODEL(S)</b> GV80 (JX1)

**SUBJECT:** GV80 POWER TAILGATE CONTROL (PTGM) LOGIC IMPROVEMENT

**Description:** Certain 2021-2023MY GV80 (JX1) vehicles may exhibit a poorly closing power tailgate due to improper latching when closing which may cause the liftgate warning chime to come on.

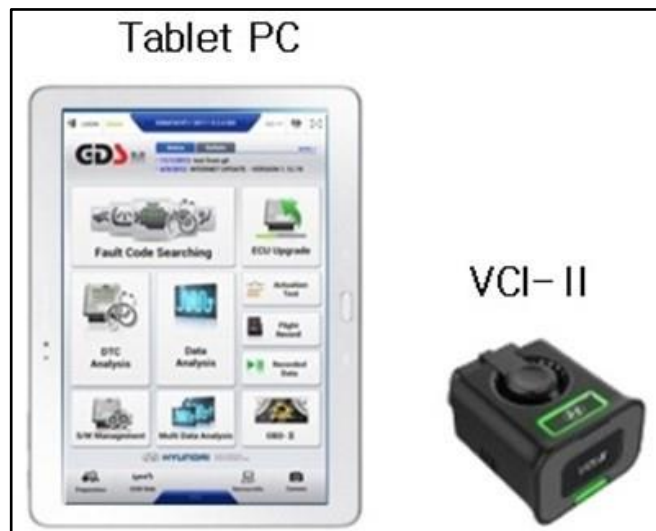
ECU upgrade function on GDS-Mobile is basically operating in wireless communication and Wi-Fi direct. Also, it is possible to be performing via USB cable between Tablet PC and VCI-II.

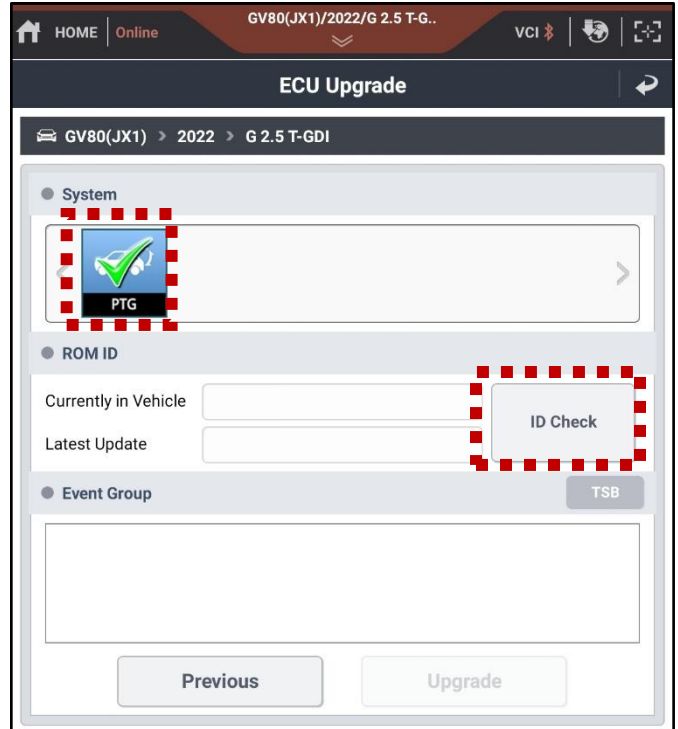
3. Select the PTG system and select **ID check** to check the vehicle's current ROM ID.

Check the current ROM ID version and compare it to the ROM ID Information Table before attempting to perform the software update.

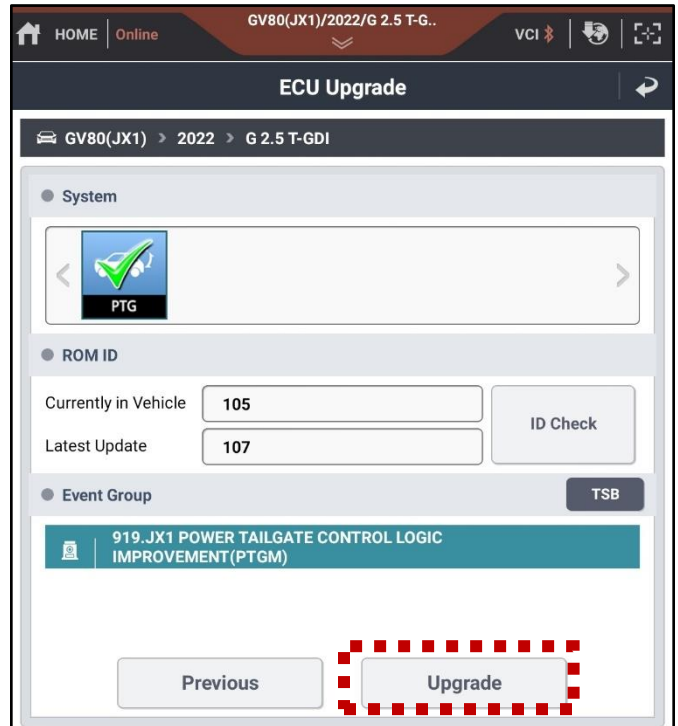
4. Select **Upgrade** after confirming correct Event is selected:

**#919.JX1 POWER TAILGATE CONTROL LOGIC IMPROVEMENT(PTGM)**

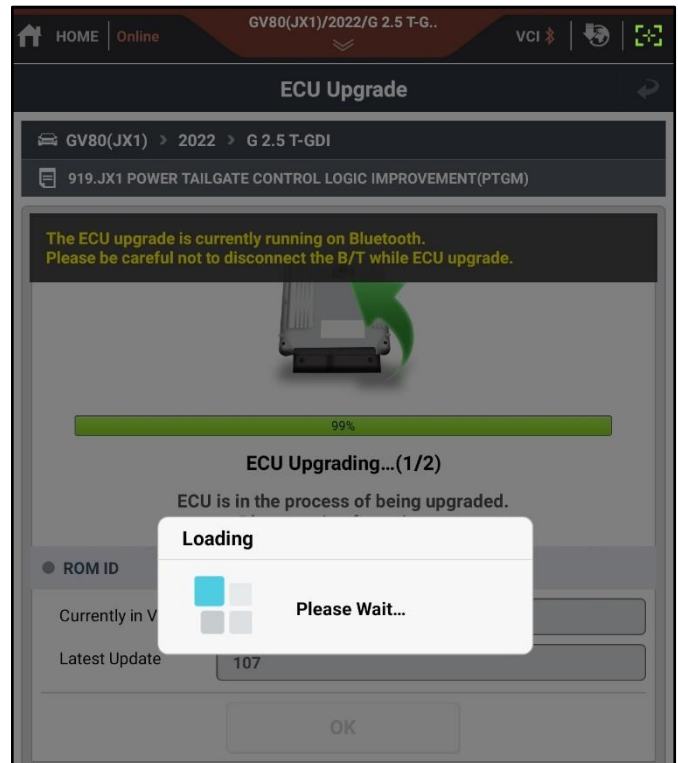
6. Upgrade (1/2) will begin, and the progress of the upgrade will appear on the bar graph.

Upgrade (1/2) will occur until 100% is reached on the bar graph.

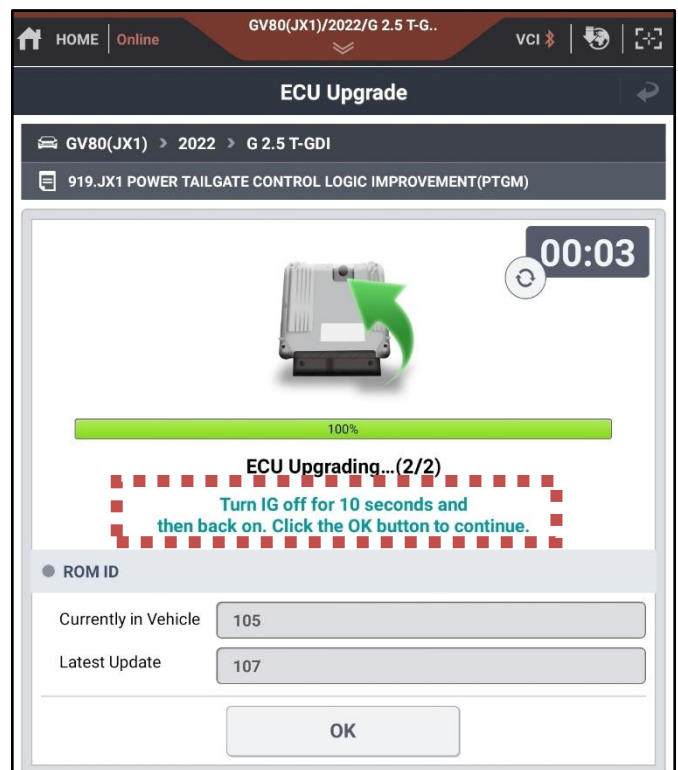
8. When upgrade reaches 100%, follow GDS instructions to "Turn IG off for 10 seconds and then back on. Click the **OK** button to continue."

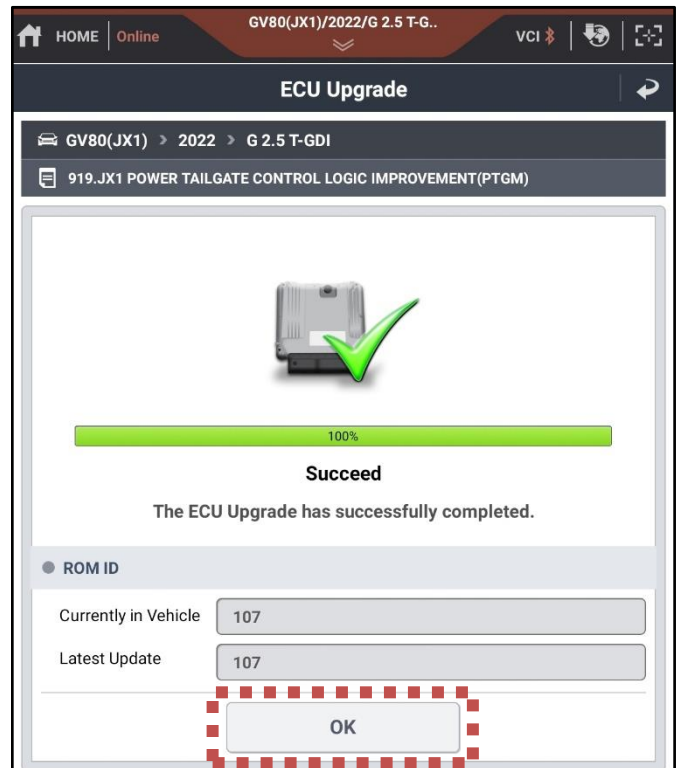
9. Click **OK** on the final screen, which indicates upgrade is complete.

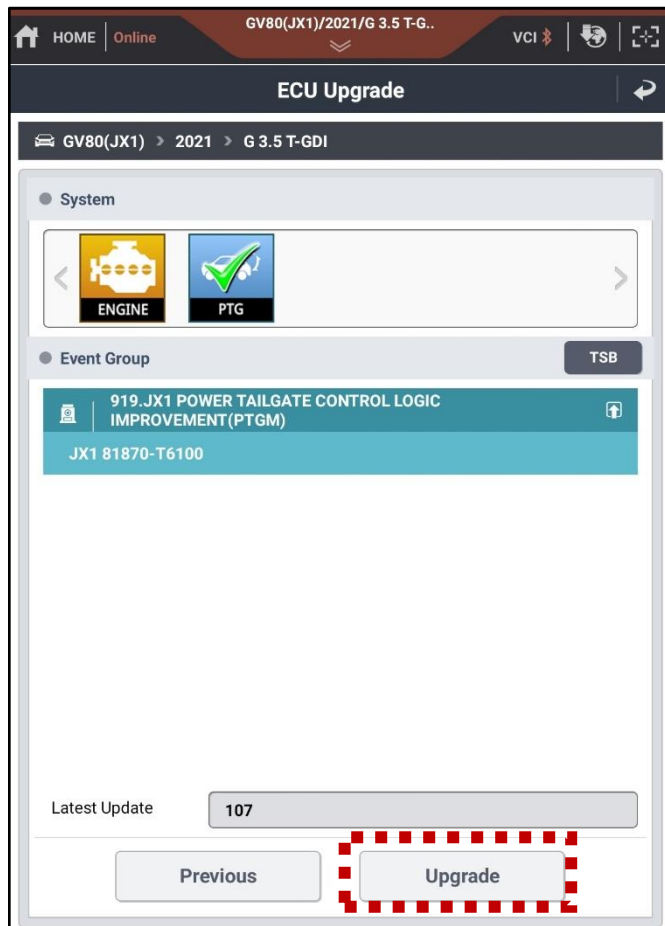
12. Select PTG and confirm the event and part number with reference to the above ROM ID Information Table and tab Upgrade.

**#919.JX1 POWER TAILGATE CONTROL LOGIC IMPROVEMENT(PTGM)**

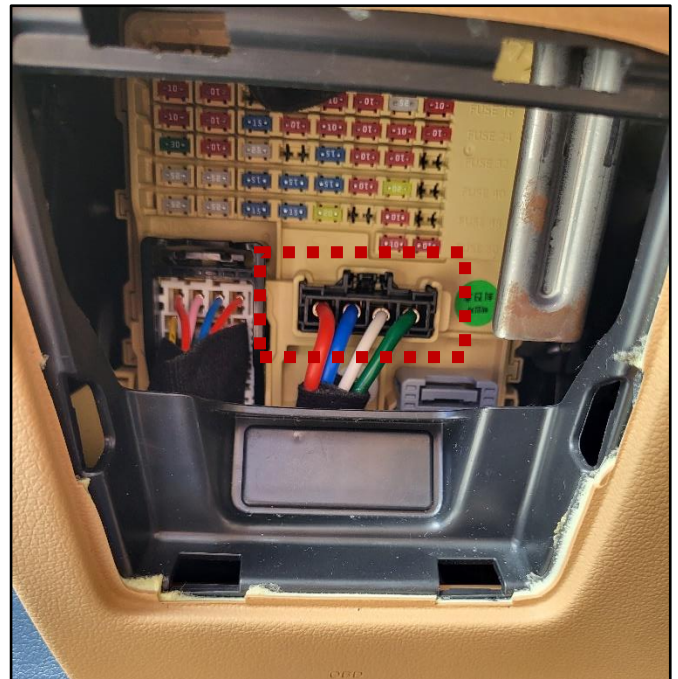
20. **After upgrade, remove power connector of indoor fuse box, and reconnect it after 5 seconds.**

Check if any incidental Diagnostic Trouble Codes (DTC) have been created by the upgrade and clear the DTC(s) present.

Start the engine to confirm proper operation of the vehicle and check power tailgate is operational.
