TECHNICAL SERVICE BULLETIN

AN23-006 ITB23-010 March 8, 2023

SOFTWARE UPDATE FOR INFOTAINMENT ISSUES

APPLIED VEHICLES: 2016-2023 Q50 (V37)

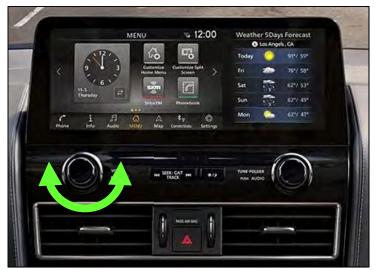
Figure 20 Figure 21

29. Press and hold the **MENU** button on the IT Commander (Figure 20) and turn the AV Control Unit volume knob (Figure 21) left-right-left at the same time.
