# Technical Service Bulletin

SUBJECT:		NO: <b>TSB-23-23-003</b>	
<b>SHIFT BY WIRE CONTROL (SCU) SOFTWARE UPDATE WHEN REPLACING TCM</b>		DATE: <b>March 2023</b>	
		MODEL: <b>2022-23 Outlander</b>	
<b>CIRCULATE TO:</b>	<input type="checkbox"/> GENERAL MANAGER	<input checked="" type="checkbox"/> PARTS MANAGER	<input checked="" type="checkbox"/> TECHNICIAN
<input checked="" type="checkbox"/> SERVICE ADVISOR	<input checked="" type="checkbox"/> SERVICE MANAGER	<input checked="" type="checkbox"/> WARRANTY PROCESSOR	<input type="checkbox"/> SALES MANAGER

This bulletin provides instructions to update the software for the SCU (Shift by Wire Control Unit) when the TCM (Transmission Control Module) is replaced.

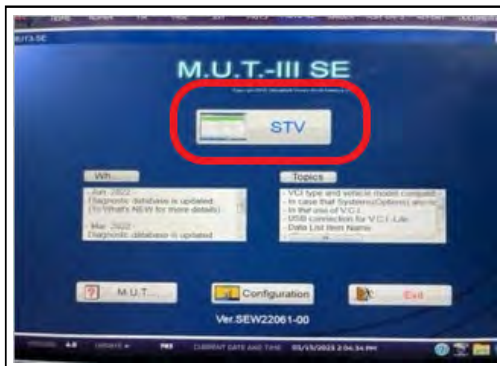
- a. Press the MUT-III SE STV icon.

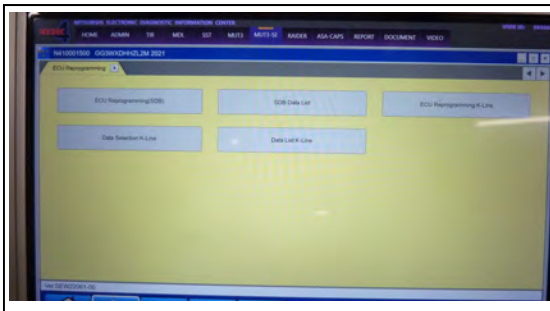
c. Press "ECU Reprogramming (SDB)" button.

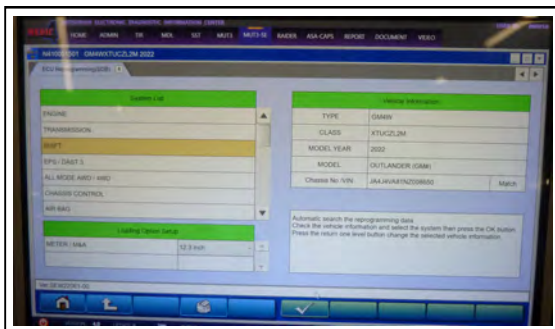
d. Verify the vehicle information and select the system Shift" followed by the OK button.

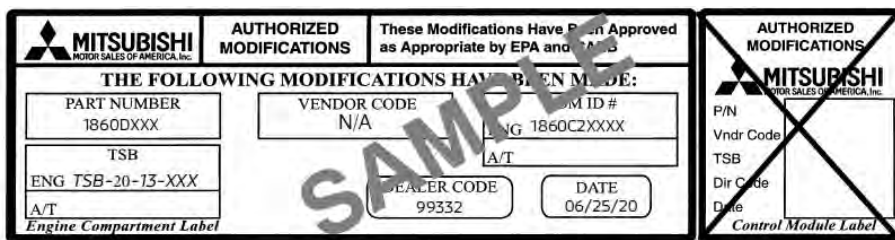
3. Using a ball-point pen, enter the appropriate ECU part number, Software Part Number (ROM ID#), this Technical Service Bulletin number, your dealer code, and the current date on the Engine Compartment/Control Module Label (p/n MSSF024G00). The Vendor Code is not applicable. The label is available from your facing PDC.
