Service Bulletin

Bulletin No.: 21-NA-184

Subject: Window Regulator – Replace Power Window Regulator Electronics

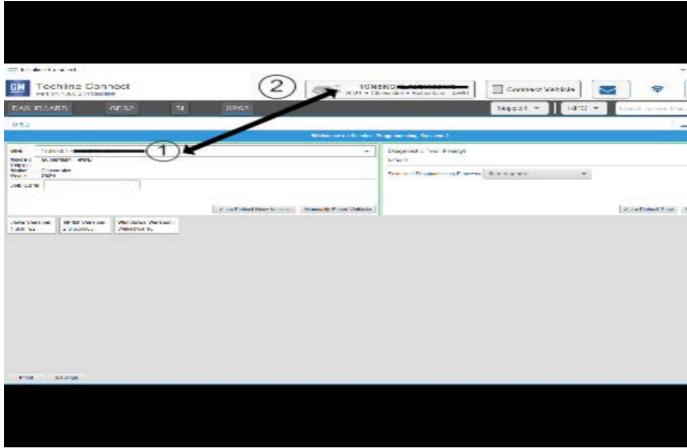
5743643

Caution: Be sure the VIN selected in the drop down menu (1) is the same as the vehicle connected (2) before beginning programming.

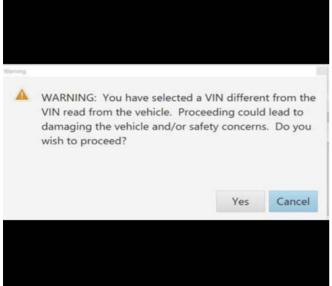
5877000

Important: If the vehicle VIN DOES NOT match, the message below will be shown.

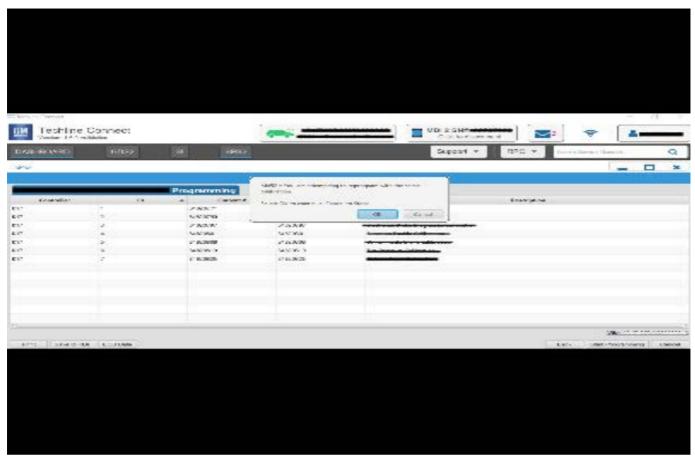
5644477

Important: Techline Connect and TIS2WEB screens shown above.

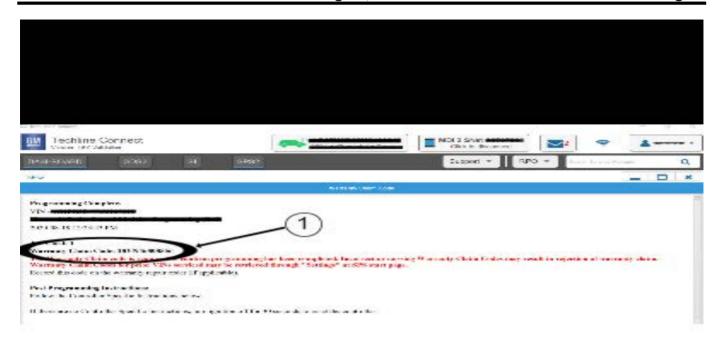
5644478

Note: The screenshots above are an example of module programming and may not be indicative of the specific module that is being programmed. Module selection and VIN information have been blacked out.

Important: To avoid warranty transaction rejections, you **MUST** record the warranty claim code provided on the SPS Warranty Claim Code (WCC) screen shown above on the job card. Refer to callout 1 above for the location of the WCC on the SPS screen.

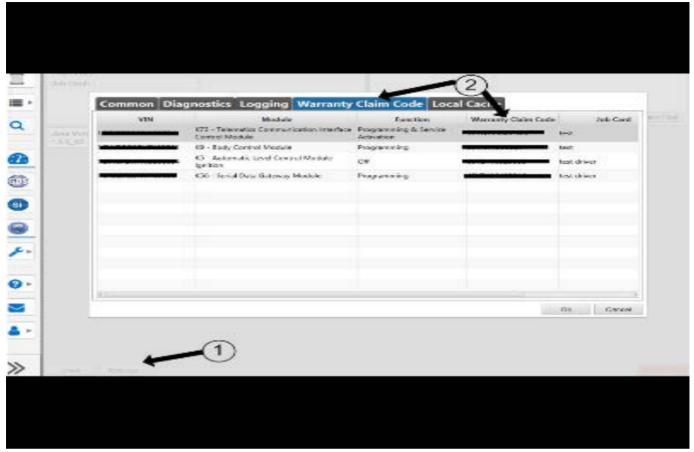
6125774

Warranty Claim Code Information Retrieval

If the Warranty Claim Code was not recorded on the Job Card, the code can be retrieved in the SPS2 system as follows:

The VIN, Warranty Claim Code and Date/Time will be listed on a roster of recent programming events. If the code is retrievable, dealers should resubmit the transaction making sure to include the code in the SPS Warranty Claim Code field.
