# Service Bulletin

Bulletin No.: 23-NA-053

**Subject: Radio Software Version U168 Update**

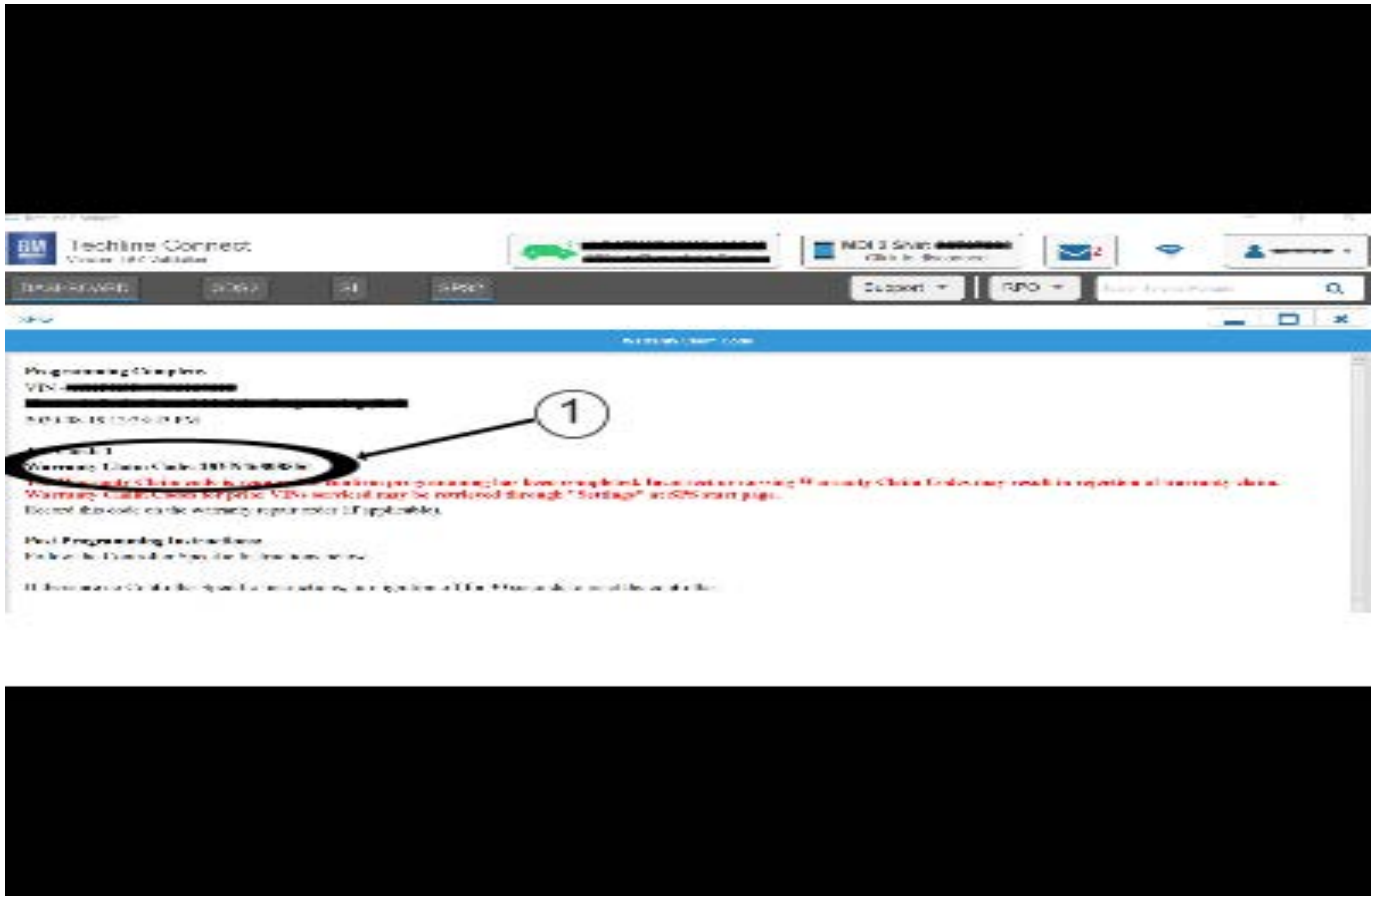
5644478

**Note:** The screenshot above is an example of module programming and may not be indicative of the specific module that is being programmed. Module selection and VIN information have been blacked out.
