Replacement ECU Software Configure Process

Service Category Steering

Section Power Assist Systems

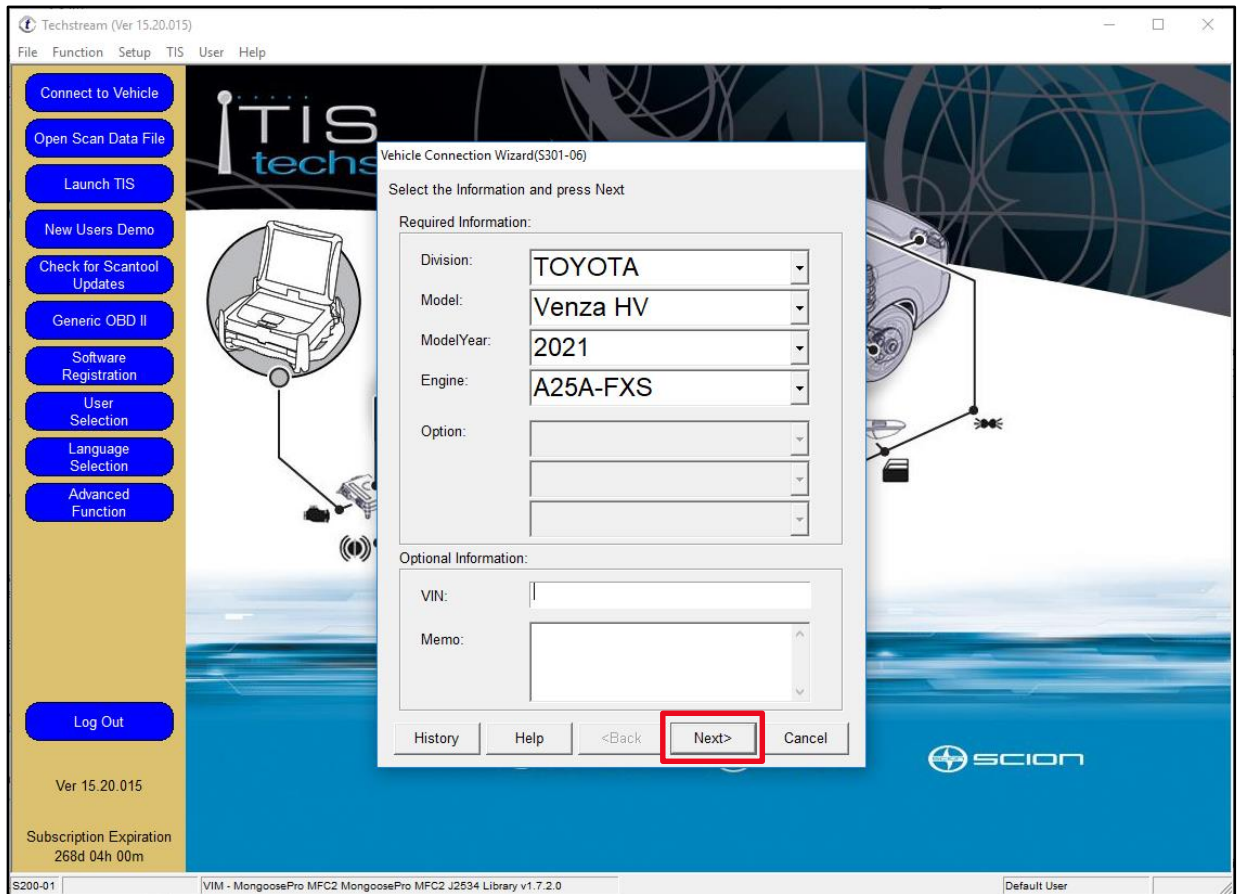
Figure 1.

1. AFTER ECU replacement, connect Techstream, select the applicable vehicle and options, and select Next.

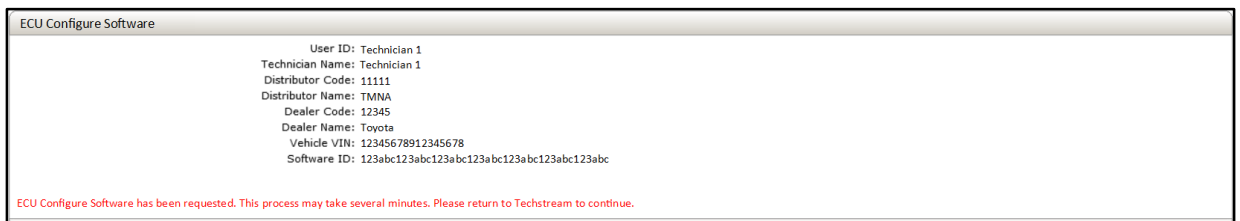
Figure 5.

5. When the ECU Configure Software confirmation screen is displayed, return to Techstream.

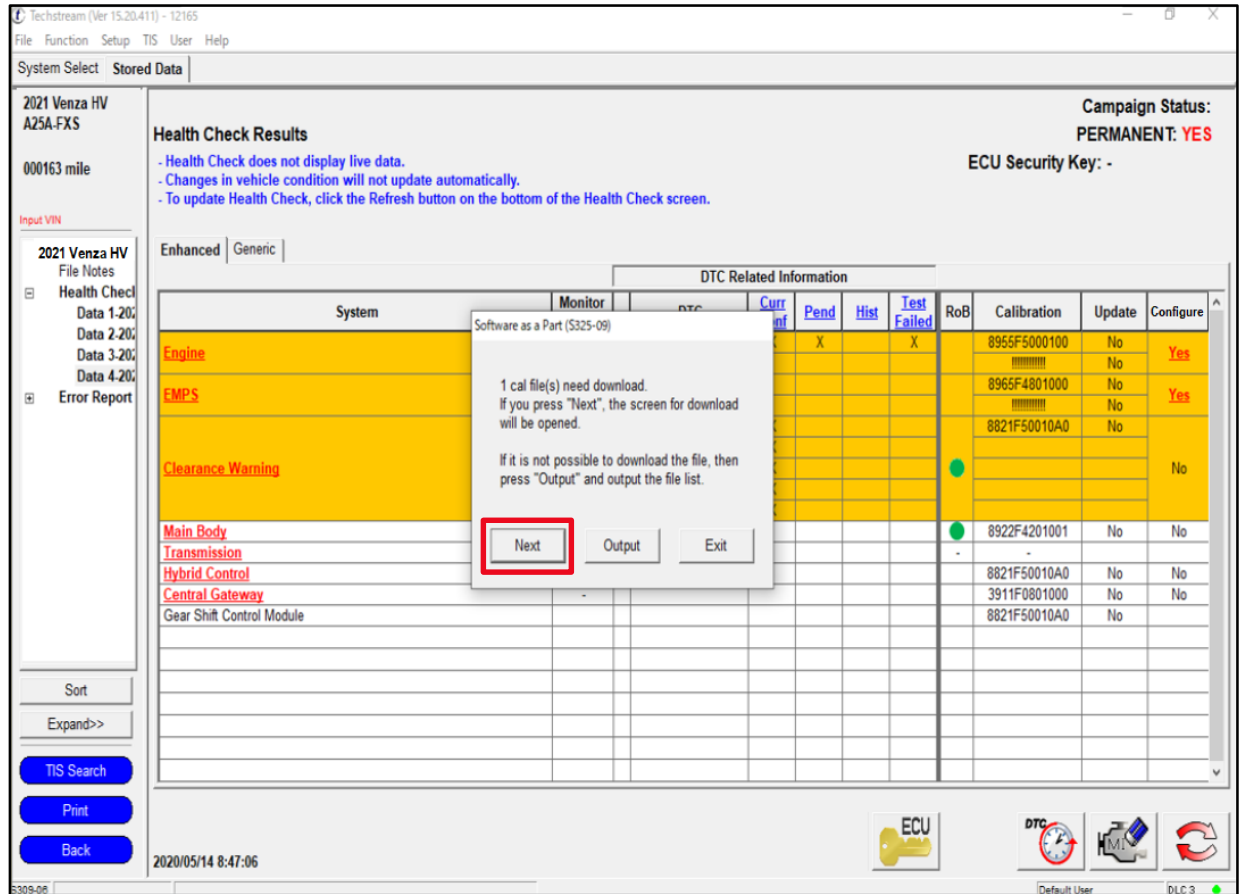
Figure 6.

6. Has the configuration software been previously downloaded?
 - **YES** — Continue to step 7.
 - **NO** — Select Next as shown in the figure below and continue to step 7.

NOTE
 Selecting Output will display a list of the required configuration software for each ECU. This feature is available to print the list of required ECU software when needed.

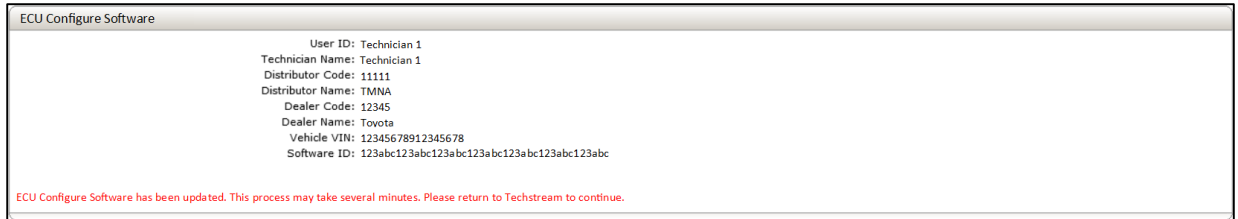
Figure 10.

- Return to Techstream when the ECU Configure Software confirmation displays, as shown below.

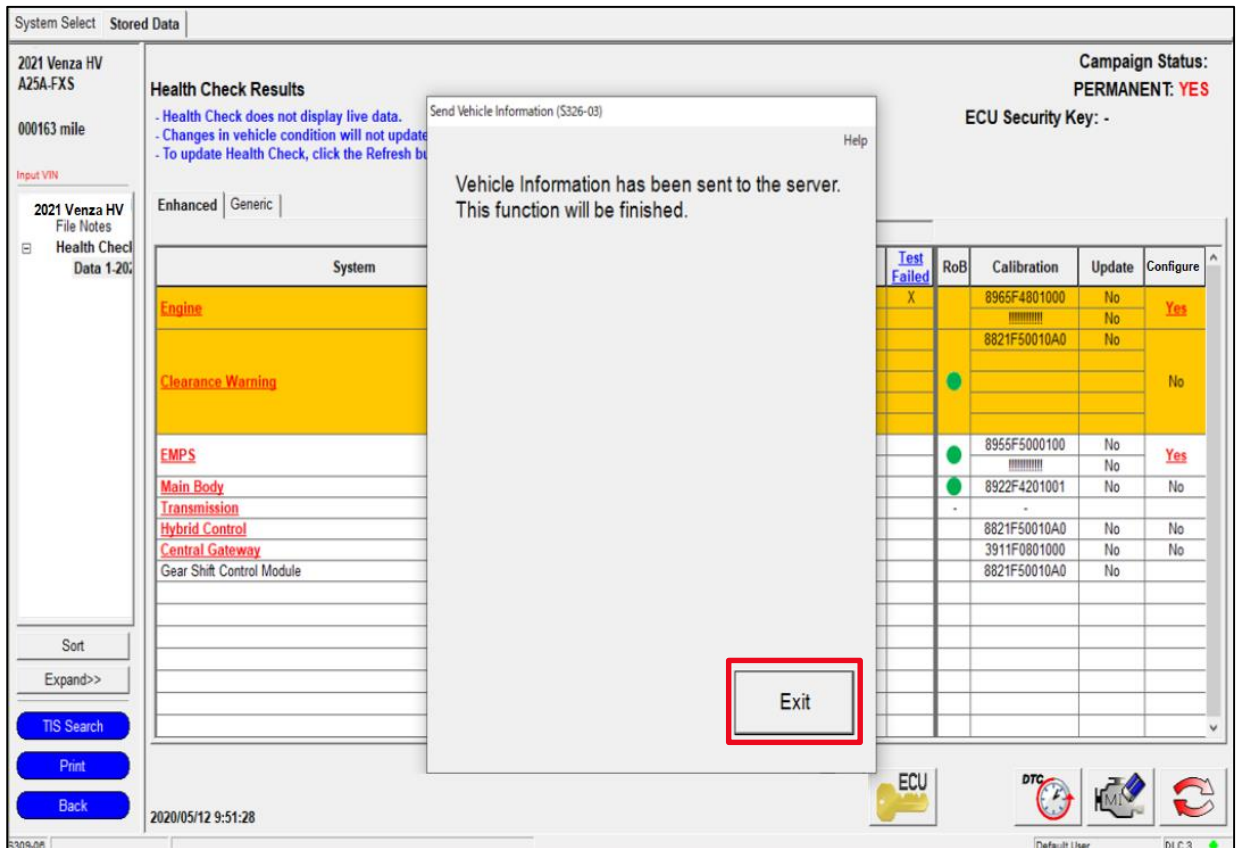
Figure 11.

- Once Vehicle Information has been sent to TIS, select Exit, clear any DTCs that may have been set, and perform a final Health Check to confirm no additional software updates are available.
