GLOBAL SAFETY FIELD INVESTIGATIONS
DCS6583
URGENT - DISTRIBUTE IMMEDIATELY

Subject: REVISION: N222375790-04 - Customer Satisfaction Program
Park Assist Retrofit
Population Update

Models: 2022 – 2023 Cadillac CT4
2022 – 2023 Cadillac CT5
2022 Cadillac Escalade/Escalade ESV
2022 – 2023 Chevrolet Corvette
2022 Chevrolet Silverado 1500 New
2022 GMC Sierra 1500 New

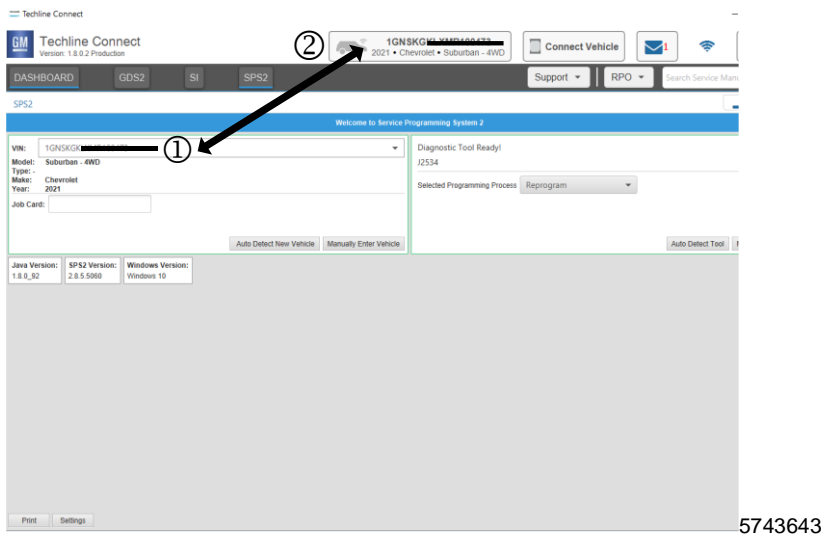
Caution: Be sure the VIN selected in the drop down menu (1) is the same as the vehicle connected (2) before beginning programming.

- The Body Control Module (BCM) is the master module (for GEM vehicles) that TLC reads to determine the VIN of the vehicle. If the VIN read from the vehicle by TLC does not match the VIN plate of the vehicle, the BCM also needs to be reprogrammed with the correct VIN, software and calibrations that match the vehicle's VIN plate.

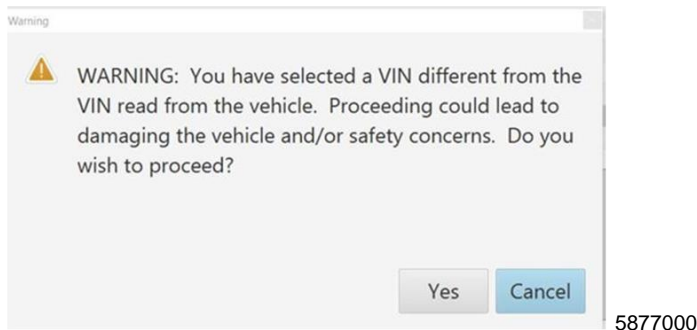
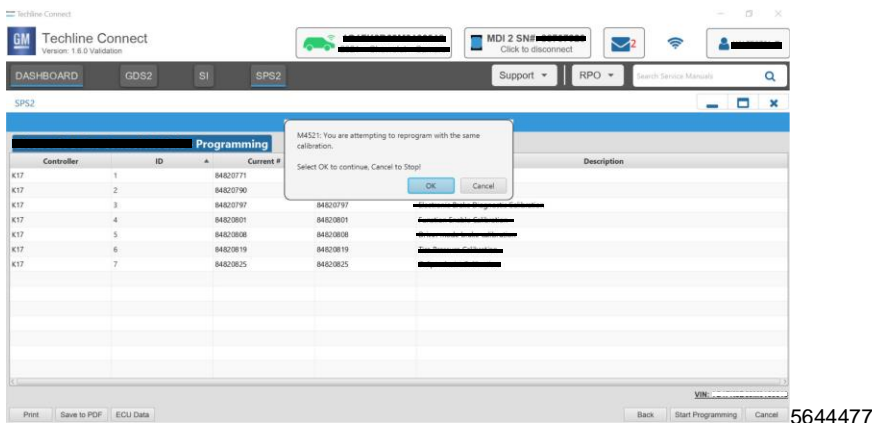
Important: If the vehicle VIN DOES NOT match, the message below will be shown.

Important: Techline Connect screens shown above.

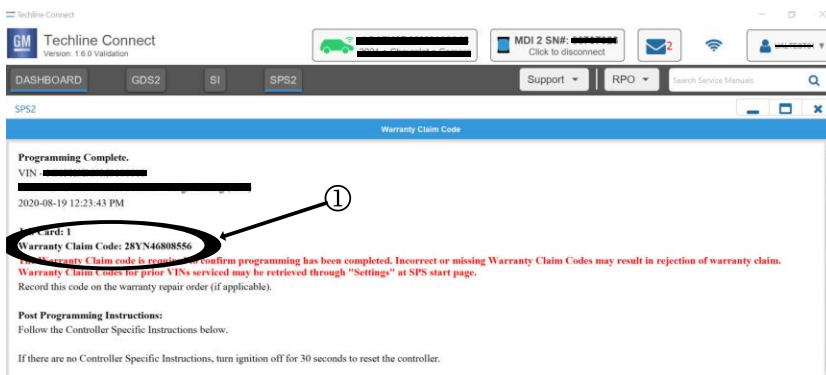
4. Perform “setup” on the Serial Data Gateway Module. Select “Setup” on the SPS Supported Controllers screen and follow the on-screen instructions. Refer to *K56 Serial Data Gateway Module: Programming and Setup* in SI.

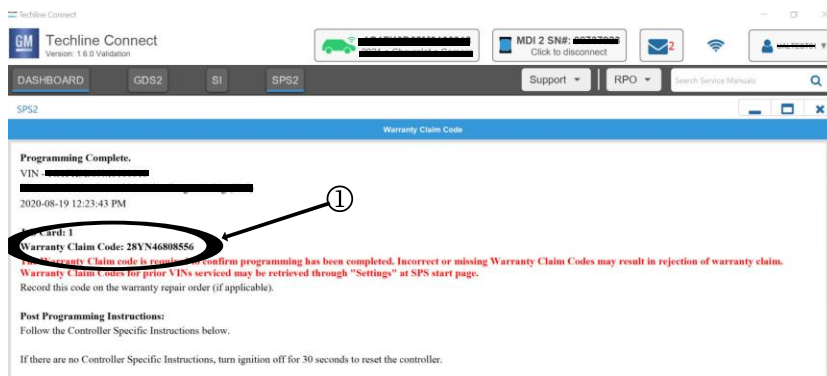
5. Perform “setup” on the Serial Data Gateway Module. Select “Setup” on the SPS Supported Controllers screen and follow the on-screen instructions. Refer to *K56 Serial Data Gateway Module: Programming and Setup* in SI.

Note: The screenshot above is an example of module programming and may not be indicative of the specific module that is being programmed. Module selection and VIN information have been blacked out.

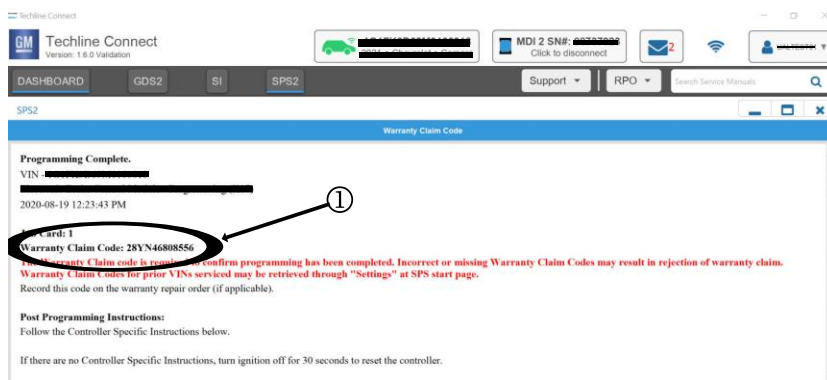
5. Perform “setup” on the Serial Data Gateway Module. Select “Setup” on the SPS Supported Controllers screen and follow the on-screen instructions. Refer to *K56 Serial Data Gateway Module: Programming and Setup* in SI.

Note: The screenshot above is an example of module programming and may not be indicative of the specific module that is being programmed. Module selection and VIN information have been blacked out.

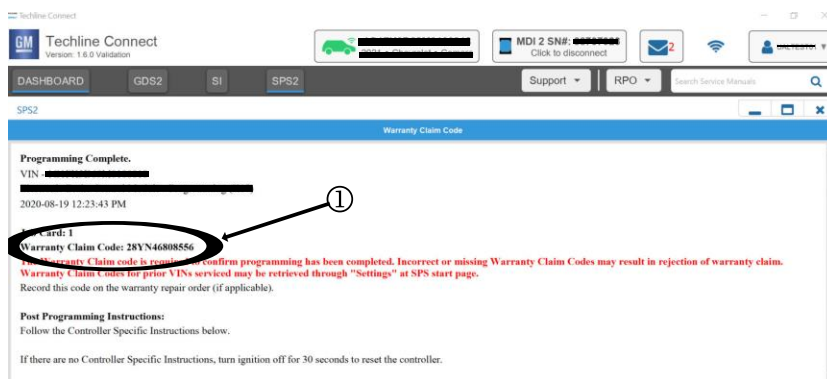
6. Perform “setup” on the Serial Data Gateway Module. Select “Setup” on the SPS Supported Controllers screen and follow the on-screen instructions. Refer to *K56 Serial Data Gateway Module: Programming and Setup* in SI.

Note: The screenshot above is an example of module programming and may not be indicative of the specific module that is being programmed. Module selection and VIN information have been blacked out.

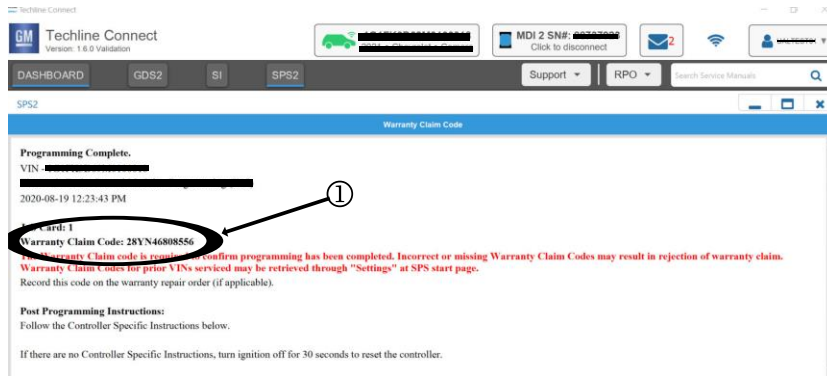
5. Perform “setup” on the Serial Data Gateway Module. Select “Setup” on the SPS Supported Controllers screen and follow the on-screen instructions. Refer to *K56 Serial Data Gateway Module: Programming and Setup* in SI.

Note: The screenshot above is an example of module programming and may not be indicative of the specific module that is being programmed. Module selection and VIN information have been blacked out.
