Service Bulletin

Bulletin No.: 23-NA-082

Subject: Information for Vehicles Having Rear Park Assist Button But Rear Park Assist Does Not Function

Brand:	Model:	Model Year:		VIN Breakpoint:		Engine:	Transmission:
		from	to	from	to		
Chevrolet	Blazer	2023	2023	—	—	—	—

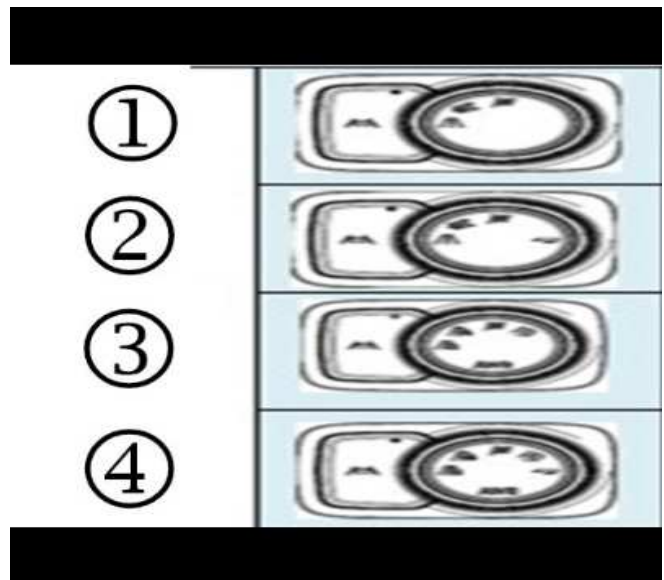
6328900

Remove the front floor console trim to remove the ride control switch. Refer to *Front Floor Console Trim Plate Replacement* in SI.
