Technical Service Bulletin

87 Air distribution or heating/cooling adjustments inoperative - B109209, B174F09, B109009, B116909, B108C09, B10B709

87 23 42 2070449/1 May 30, 2023.

Model(s)	Year	VIN Range	Vehicle-Specific Equipment
e-tron GT, and RS e-tron GT	2023 – 2024	All	Not Applicable

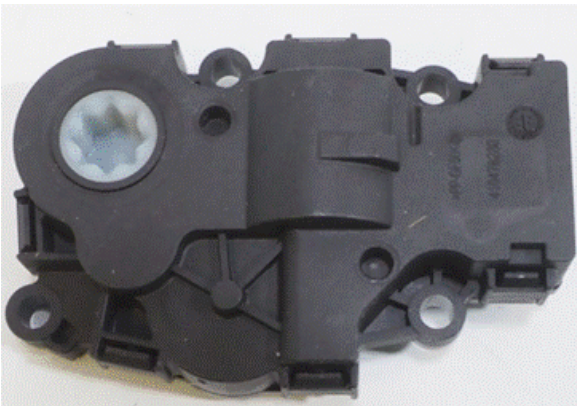
<p>Motor for adjustment</p>	Quantity necessary

1. Replace the affected control door motor(s).
2. Run **SVM code 08A033**.
3. After the update, the control door motor end stop adaptation must be performed using the function “Addressing the A/C system actuators” in GFF.
