01-18-12 - Software Version Management

Release date: 6/27/2023

This Technical Bulletin details the general process for carrying out a Software Version Management (SVM) software update for any Technical Bulletin (TSB) / Update.

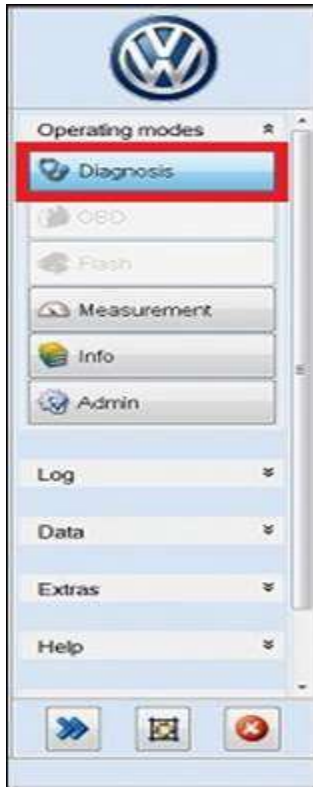
Figure 1

6. On ODIS Service application start up, make sure to select “Diagnosis” under Operating modes and not “Flash” (Figure 1).

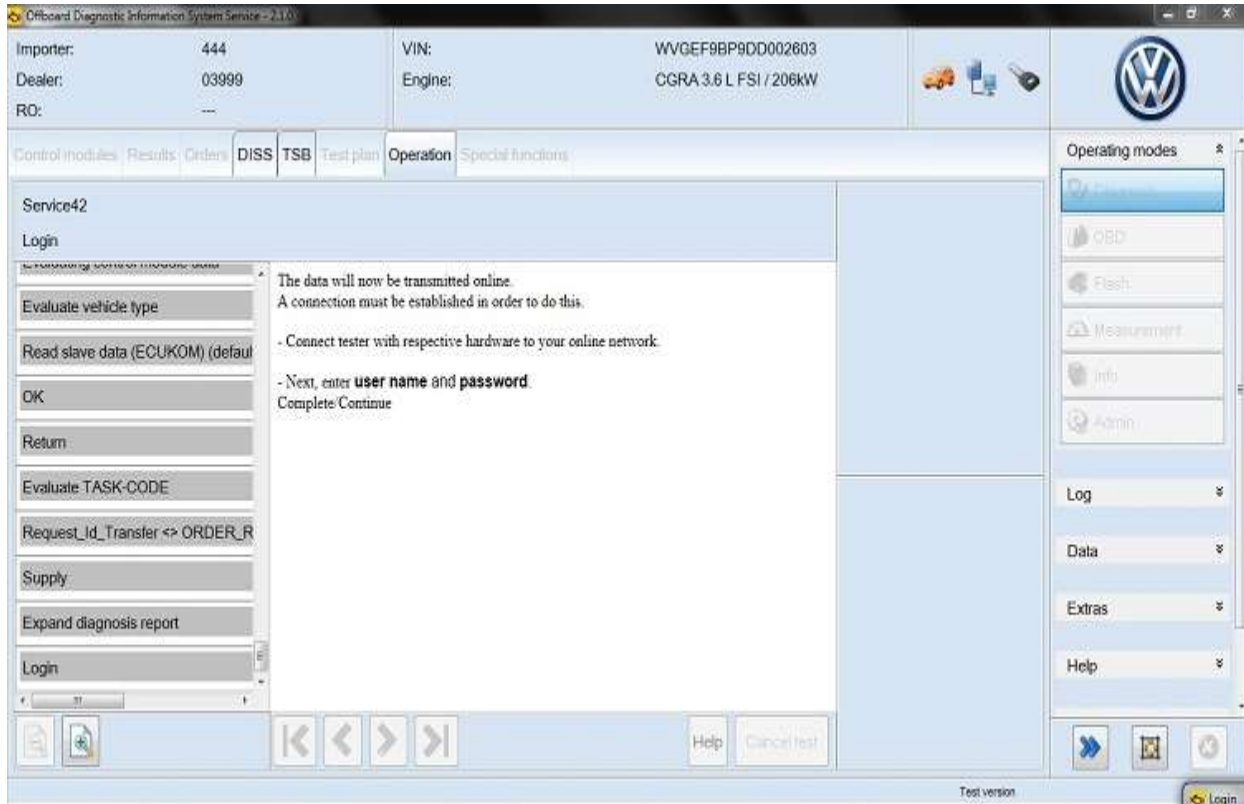
Figure 4

10. Enter your GeKo ID when requested. This will allow data to be transmitted to the SVM server and will provide instructions on how to continue the procedure (Figure 4).

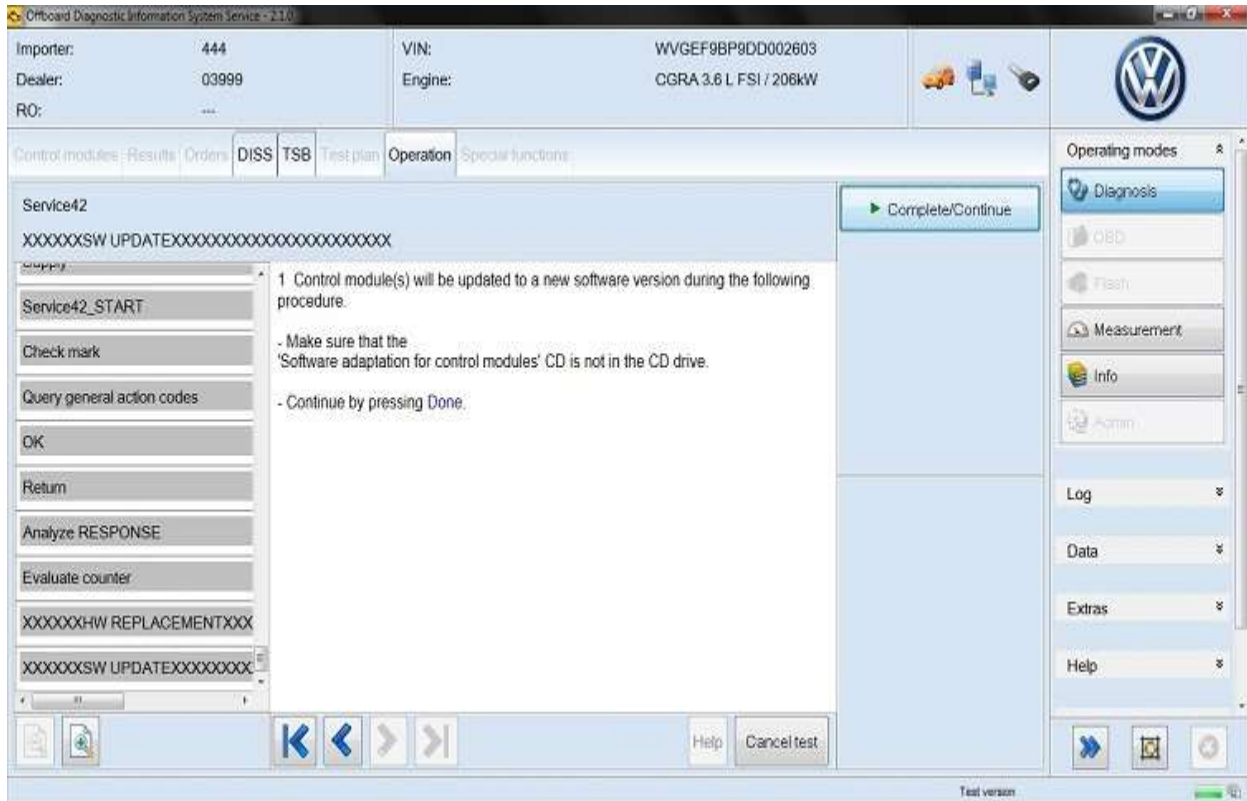
Figure 5

11. The procedure may include one, or any combination of the following comments for one or more control modules as specified in the Technical Bulletin/Update (Figure 5):

- Update a Control Module (flash)
- Code or Adapt a Control Module

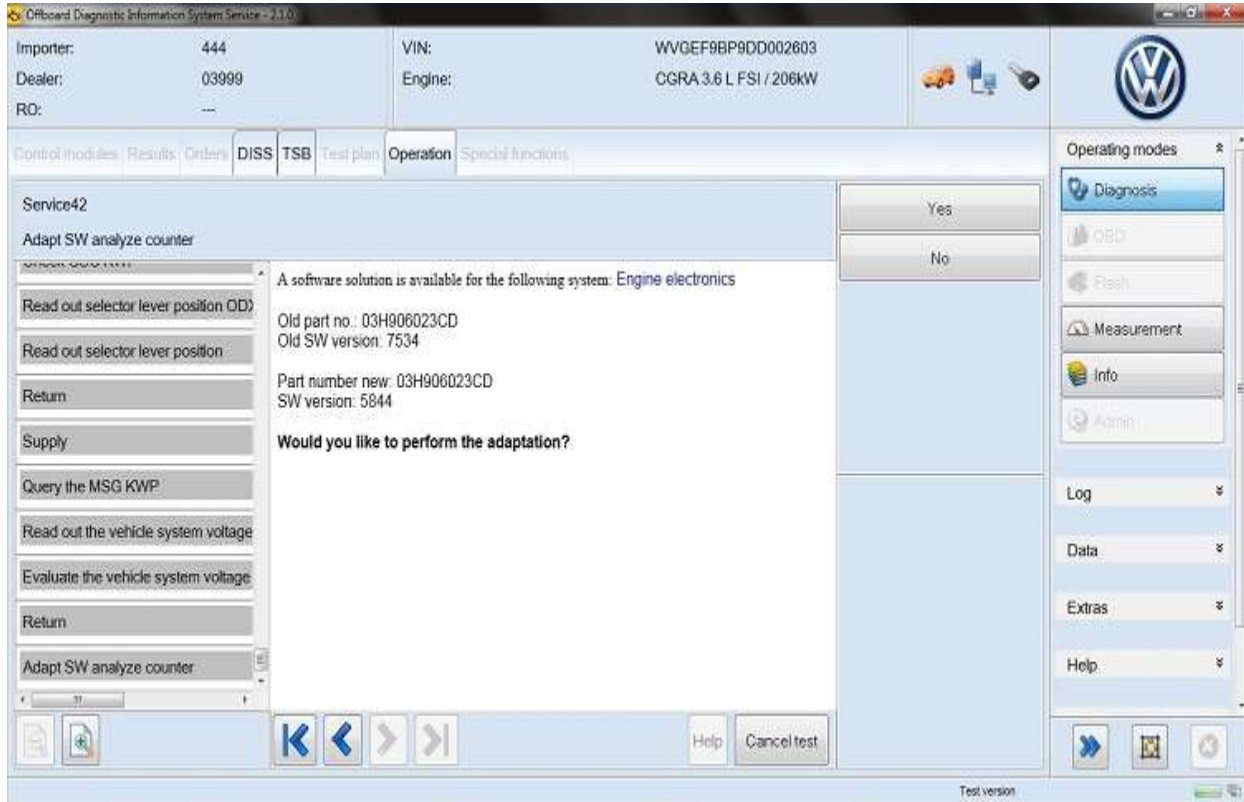
Figure 6

12. Select "Yes" to perform adaptation (Figure 6).

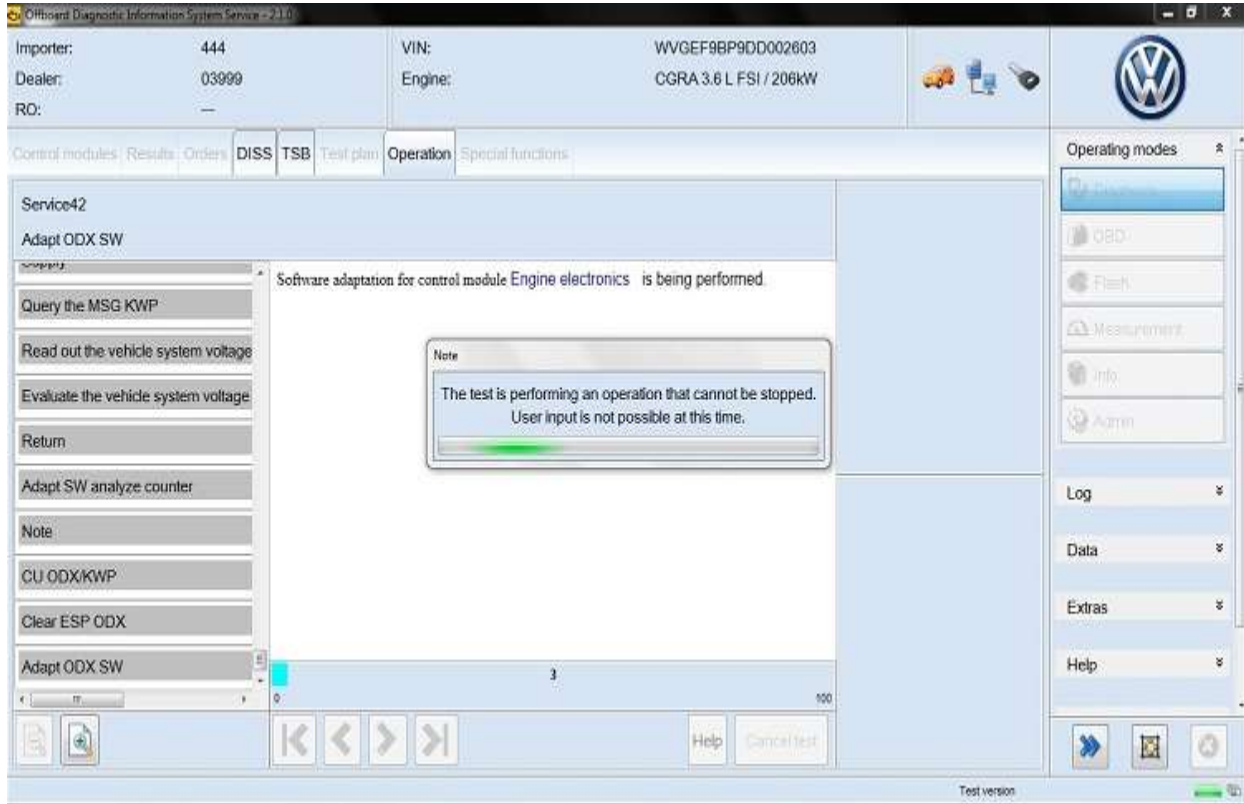
Figure 7

13. Software adaptation is being performed (Figure 7).

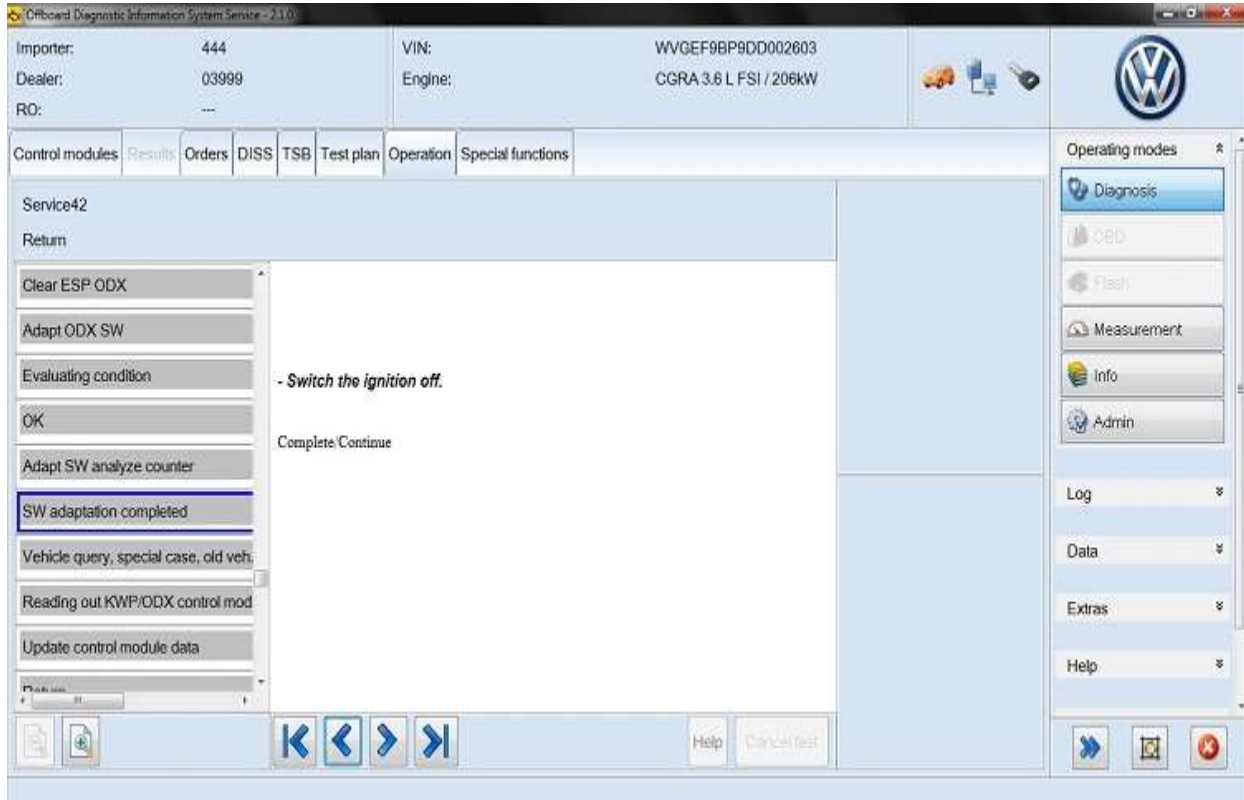
Figure 8

14. When the adaptation completes, switch the ignition OFF (Figure 8).

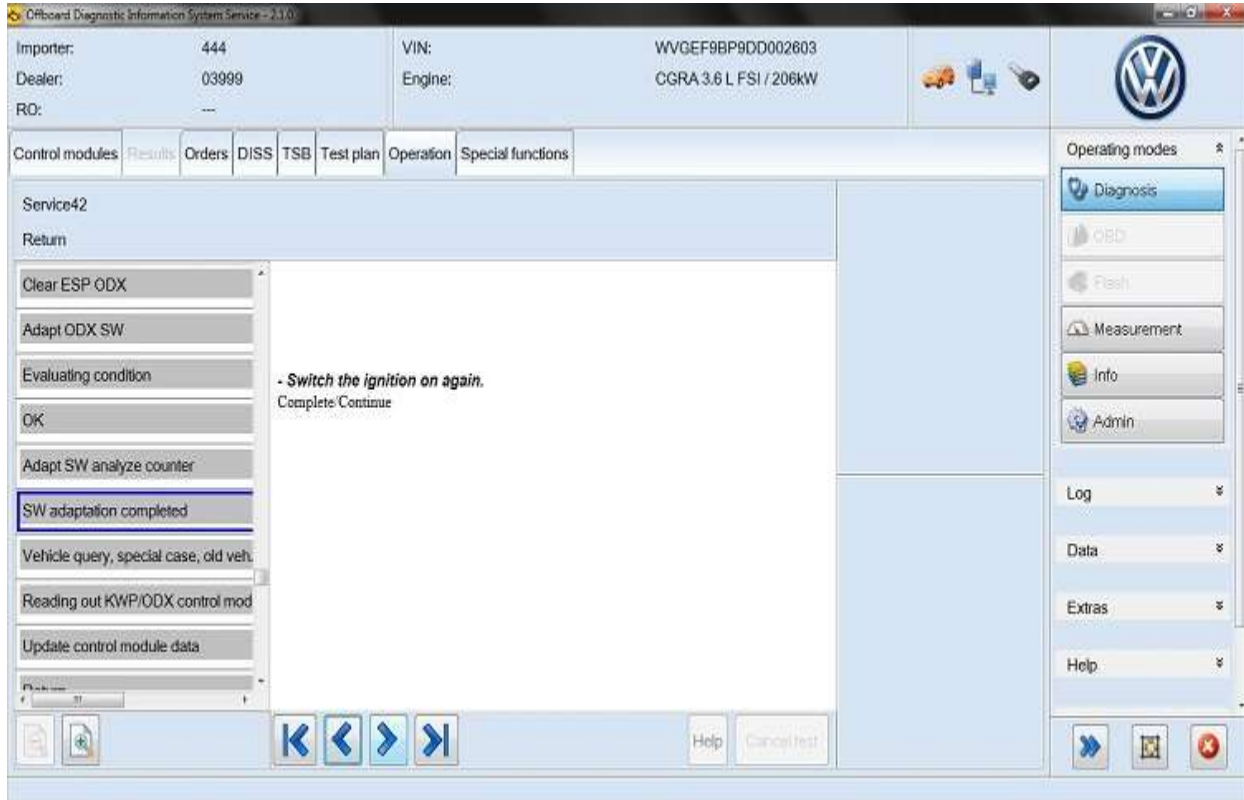
Figure 9

15. When prompted, switch the ignition ON (Figure 9).

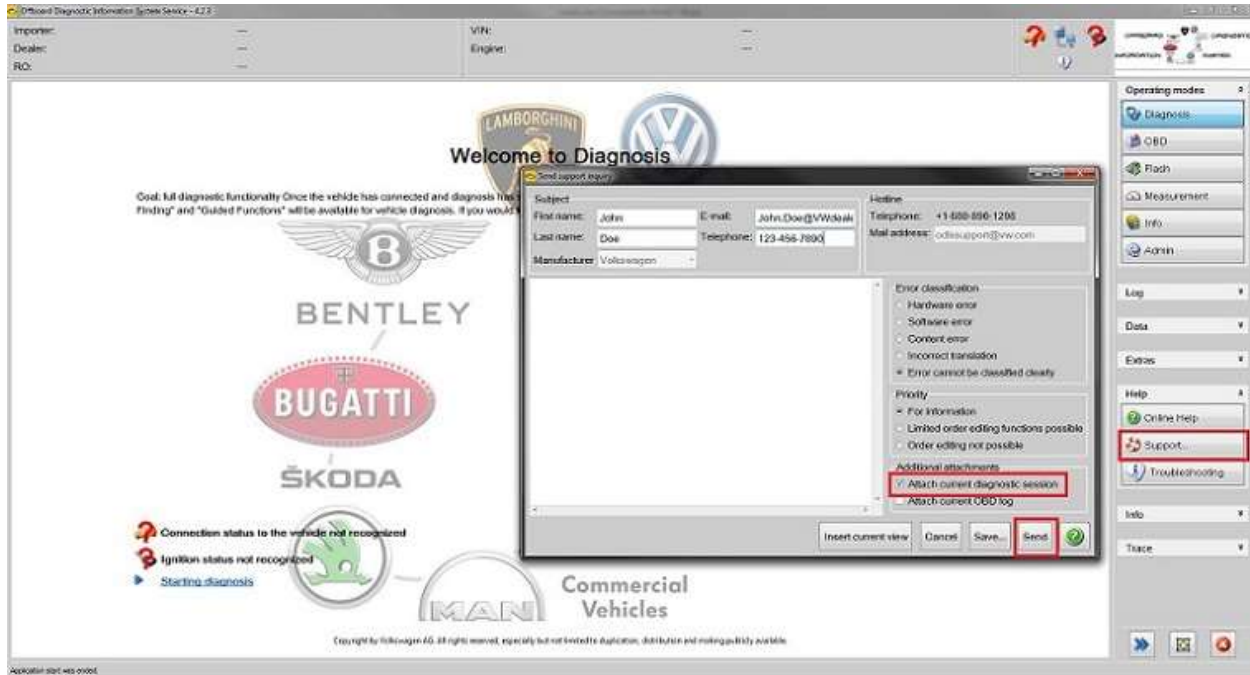
Figure 11

Any other ERP Codes encountered during the SVM process that cause a stop in work need an ODIS Service application feedback sent to Support (see figure 11).

When sending an ODIS Service application feedback please ensure the option “Attach current diagnostic session” is selected.
