# Head Unit Software Update (Denso)

A head unit software update is now available for 2022 – 2023 model year GR86 vehicles equipped with Toyota Multimedia software version 10 or earlier. The software can be updated to version 11 with a USB update. This software update addresses following items:

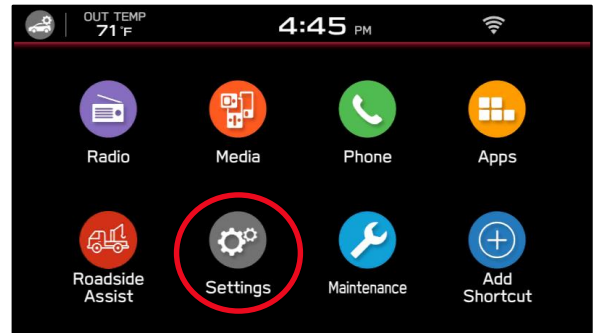
**Figure 1.**

1. Select Settings.

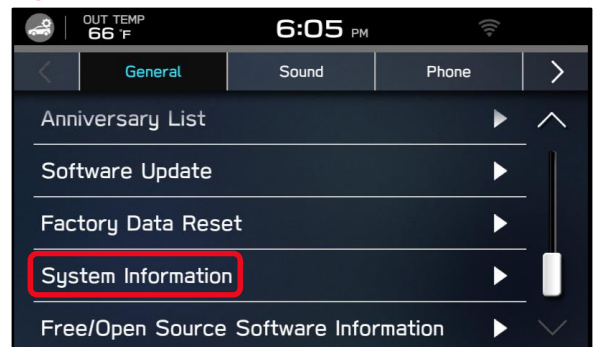
**Figure 2.**

2. Under the General tab, select System Information.

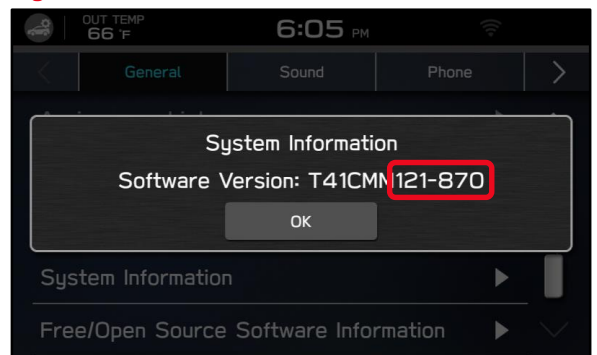
**Figure 3.**

3. Compare the last six digits of the Software Version number against Table 1.

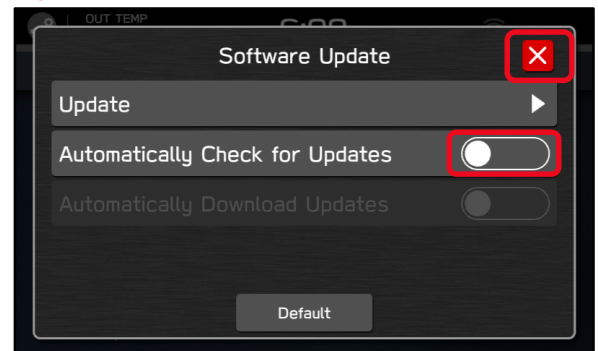
**Figure 5.**

1. Go to *Settings – General – Software Update* and confirm that *Automatically Check for Updates* is toggled OFF. Click the red X to close the screen.

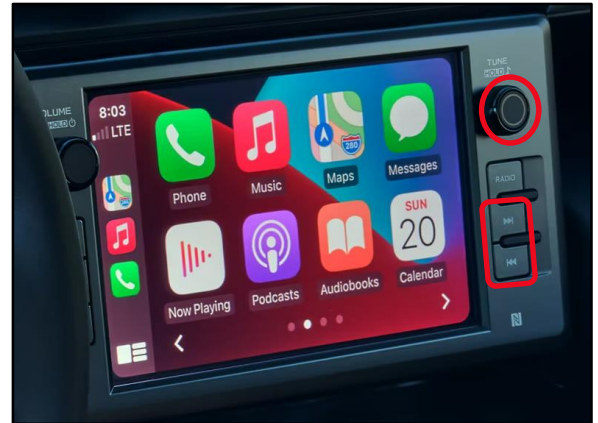
**Figure 6.**

2. Enter dealership mode by pushing the TUNE knob six times, while simultaneously pressing both SEEK switches.

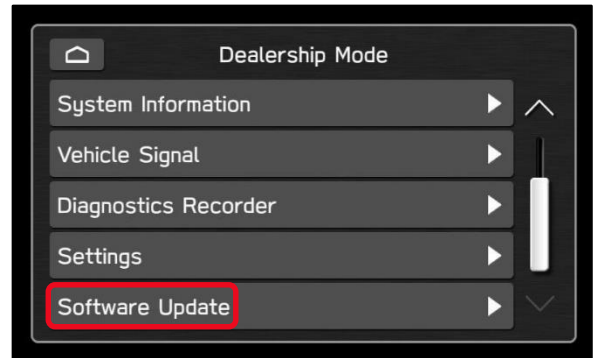
**Figure 7.**

3. Select Software Update.

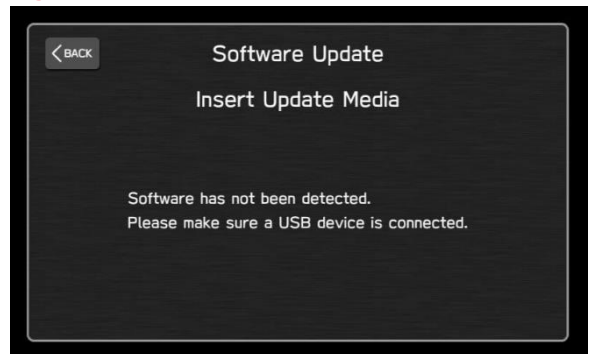
**Figure 8.**

4. Insert the prepared USB flash drive AFTER the Insert Update Media screen appears.

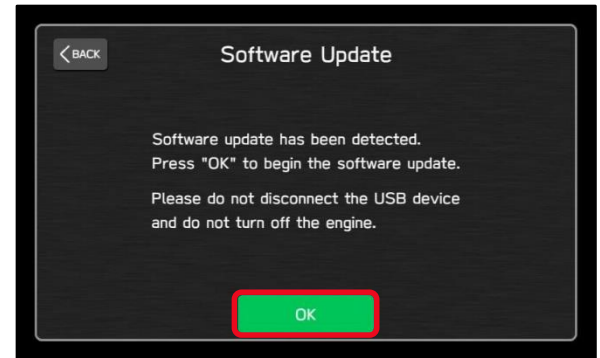
**Figure 9.**

5. Select OK.

If the screen displays a “Software Loading Unsuccessful” message, confirm the USB device has been properly formatted, the software on the device matches the system being reprogrammed, and try again.

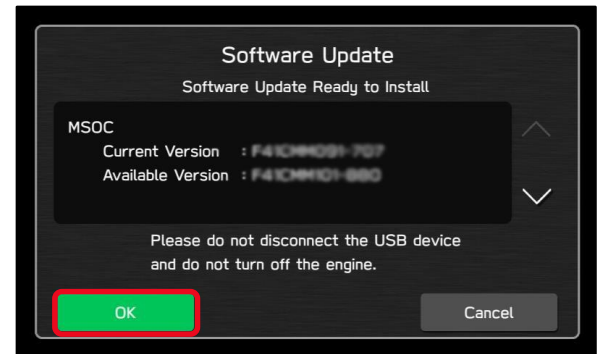
**Figure 10.**

6. Confirm the Available Version is T47CMM132-180 for 2022 model year or TG1CMM130-680 for 2023 model year.
7. Select OK to begin the software update.

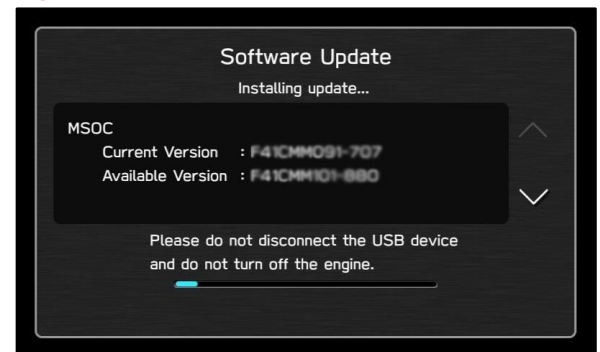
**Figure 11.**

8. Wait for the update to complete. This can take 5 – 10 minutes.

Do NOT turn the engine OFF during the software update.

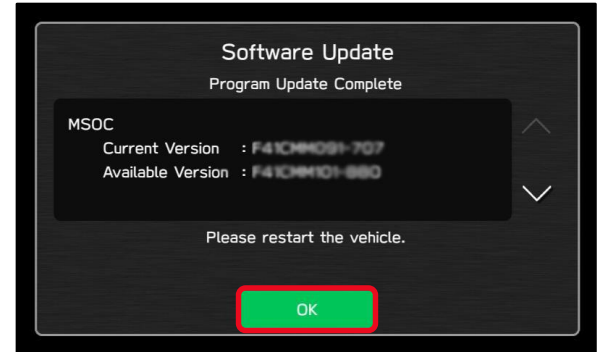
**Figure 12.**

9. Select OK after the update is complete.

If the screen says “incomplete” instead of “complete” continue to the next step and check the software version at the end of this process to confirm if the latest version is now installed. If the version is the latest, the repair is complete. If not, start the USB update process again.

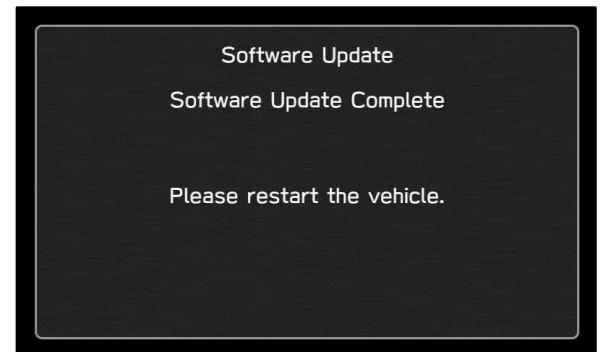
**Figure 13.**

10. After the screen shown in Figure 13 appears, perform the following procedure:
  - Turn the engine OFF.
  - Open the driver door.
  - Close the driver door.
  - Wait three minutes.
  - Open the driver door.
  - Turn the engine ON.
  - Check the software version to confirm the latest is installed.
  - USB update is complete.

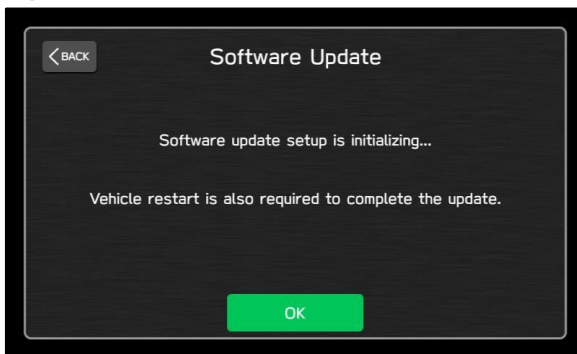
**Figure 14.**

11. Does the screen shown in Figure 14 appear?
  - **YES** — Wait for up to 15 minutes for initialization to complete. After initialization is complete Figure 15 appears. Then, repeat step 10.
  - **NO** — Continue to step 12.

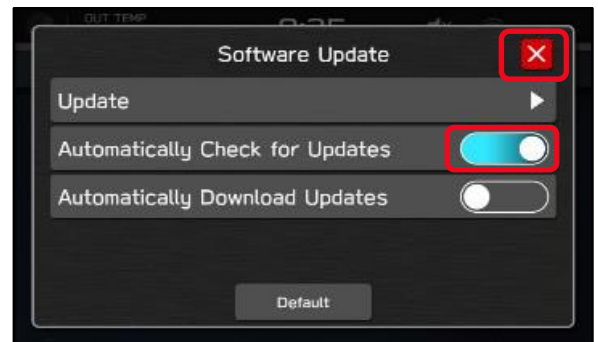
**Figure 16.**

12. Go to *Settings – General – Software Update* and confirm that *Automatically Check for Updates* is toggled ON. Click the red X to close the screen.
