TO: Mercedes-Benz Dealer Principals, General Managers, Sales Managers, Service Managers, Parts Managers	FROM: Gregory Gunther, Senior Manager, Vehicle Compliance and Analysis, Engineering Services
RE: Service Campaign Launch Notification Update Software for Various Control Units – Wave 1 MY22-23 EQS (297 platform)	DATE: August 22, 2023

IMPORTANT SERVICE CAMPAIGN LAUNCH

Service Campaign Launch Notification		August 22, 2023
Campaign No. :	Campaign Desc. :	Update Software for Various Control Units – Wave 1
2023070020	23P5499320	
<p>This is to notify you of the Service Campaign Launch to update the software for various control units in 2,015 Model Year (“MY”) 2022-2023 EQS (297 platform) vehicles. The vehicles will be visible and flagged in VMI as “OPEN” on August 22, 2023.</p>		
Background		
Issue	<p>Mercedes-Benz AG (“MBAG”), the manufacturer of Mercedes-Benz vehicles, has determined that on certain MY 2022-2023 EQS (297 platform) vehicles, the software for various control units does not meet current specifications. An extensive optimization update will be implemented on the affected vehicles. Also, a special procedure has already been implemented in Xentry. The software updates wi

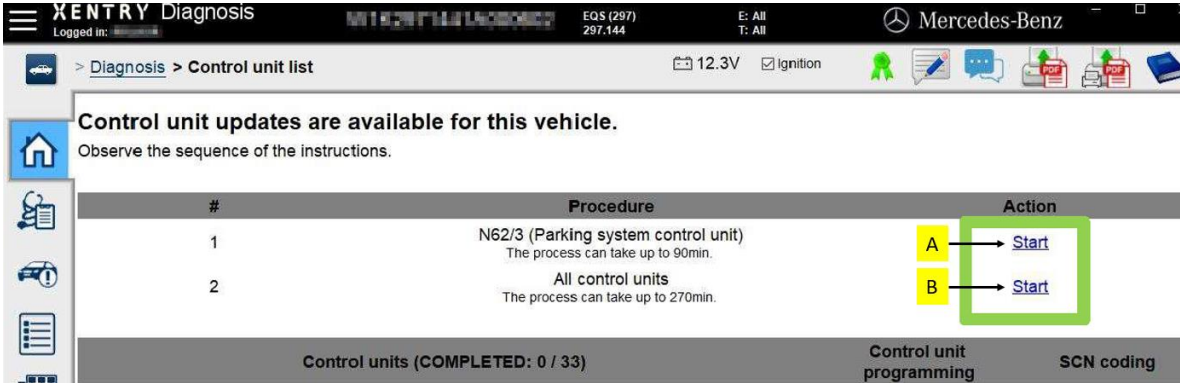
Figure 2

XENTRY Diagnosis
 Logged in: [User Name] EQS (297) 297.144 E: All T: All Mercedes-Benz

> Diagnosis > Control unit list 12.3V Ignition

Control unit updates are available for this vehicle.
 Observe the sequence of the instructions.

To do this, select and start menu item **#1 - N62/3 (Parking system control unit)**, (A, Figure 2).

To do this, select and start menu item **#2 - (All control units)**, (B, Figure 2).

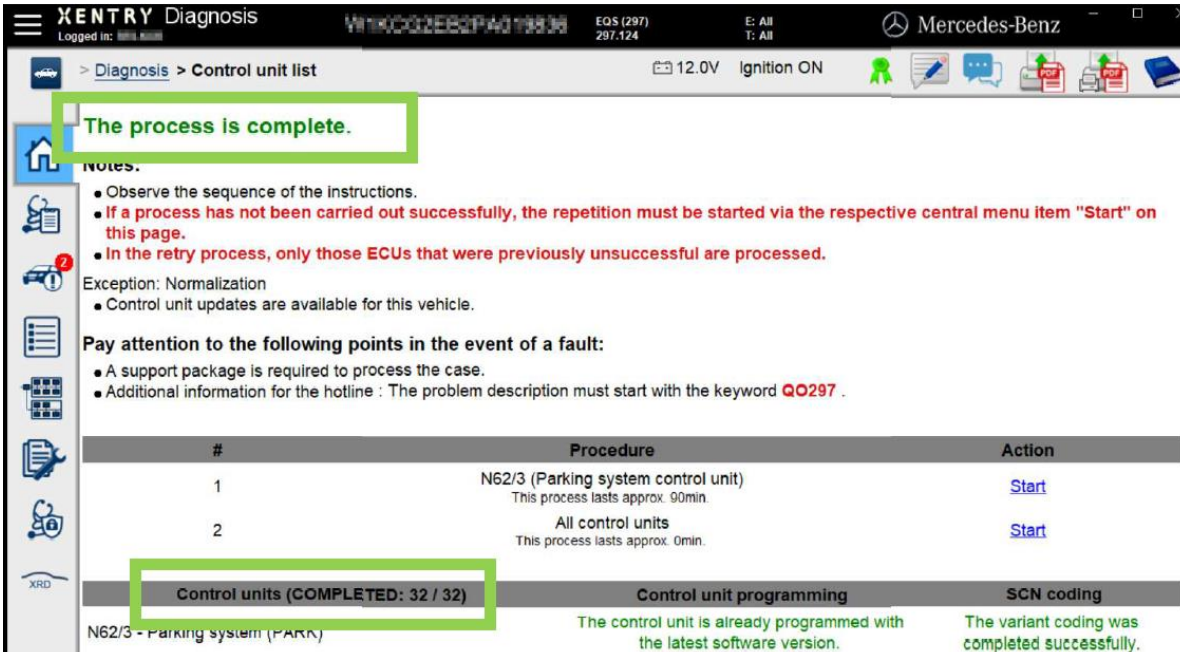
Figure 3

3. Verify all control units are completed (Figure 3), repeat **Work Procedure step 2** as needed.

XENTRY Diagnosis
 Logged in: [User Name] EQS (297) 297.124 E: All T: All Mercedes-Benz

> Diagnosis > Control unit list 12.0V Ignition ON
