TECHNICAL SERVICE BULLETIN

| Classification: AN23-006B | Reference: ITB23-010B | Date: August 1, 2023 |

SOFTWARE UPDATE FOR INFOTAINMENT ISSUES

| APPLIED VEHICLES: | 2016-2023 Q50 (V37) |

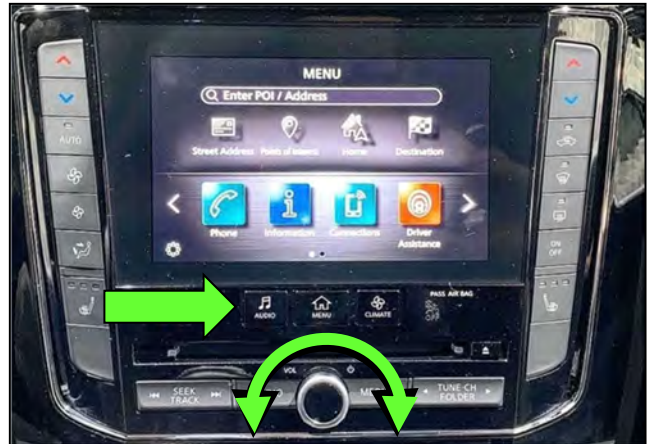
Figure 2

1. Press and hold the **AUDIO** button while, at the same time, rotating the volume knob left-right-left.

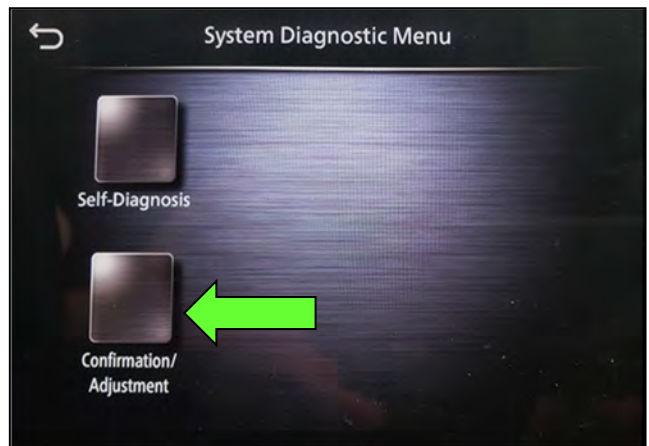
Figure 3

2. Select **Confirmation/Adjustment**.

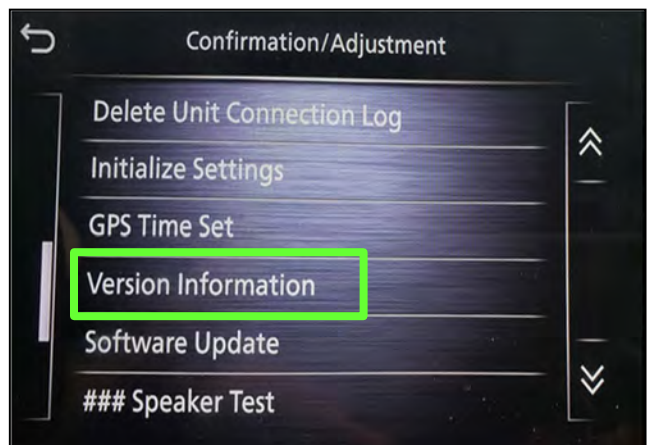
Figure 4

3. Select **Version Information**.

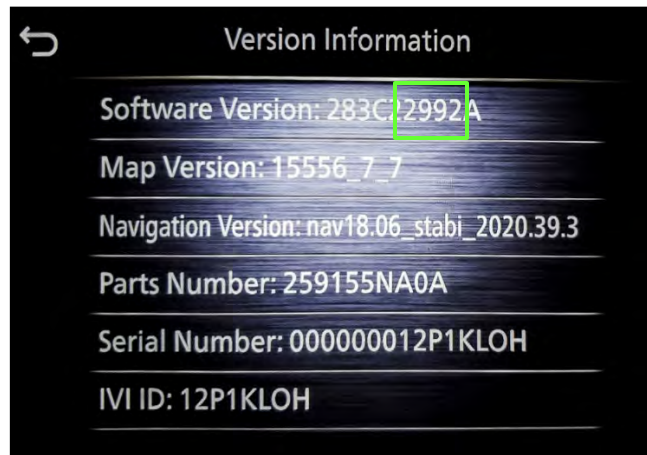
Figure 5

4. Confirm the **Software Version**.

- If the **Software Version** (characters 6-9, as shown in Figure 5) is not the latest software version listed in the vehicle table, select the back icon and continue to step 5.
- If the **Software Version** is the latest software version listed in the vehicle table, an update is not available. Select the back icon and skip to **CLAIMS INFORMATION** on the last page.

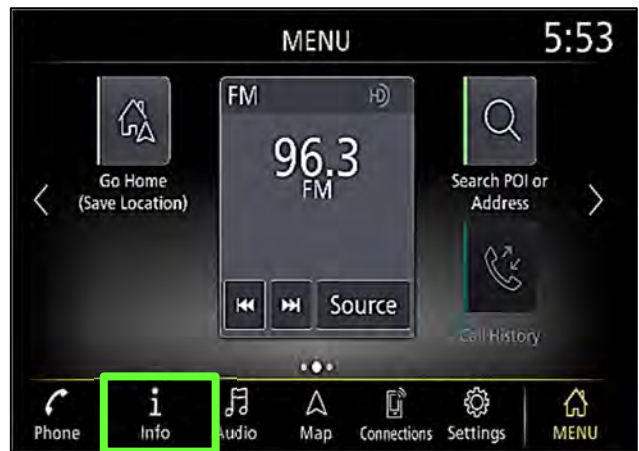
Figure 6

- Starting from the HOME screen (Figure 6), select **Info**.

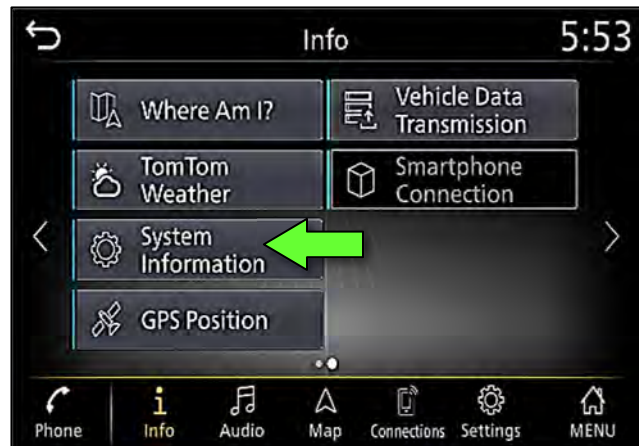
Figure 7

- Select **System Information**.

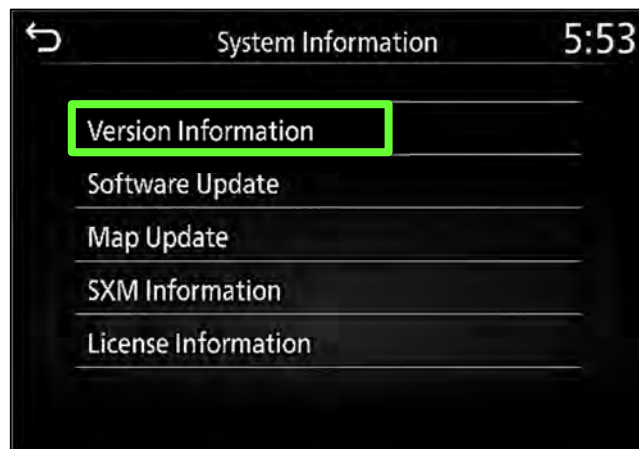
Figure 8

- Select **Version Information**.

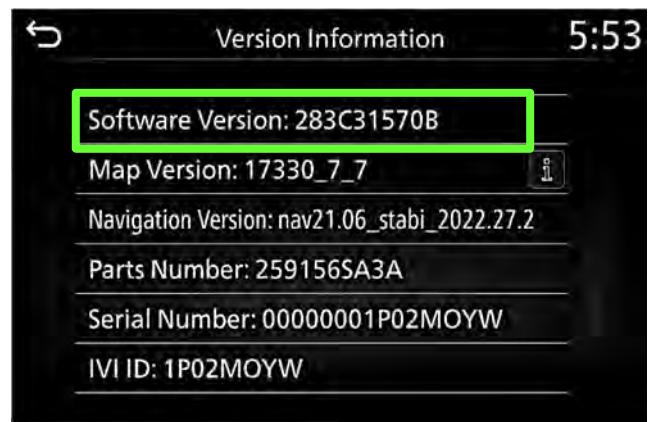
Figure 9

9. Confirm the **Software Version**.
 - If the **Software Version** is not the latest software version listed in the vehicle table, select the back icon and continue to step 10.
 - If the **Software Version** is the latest software version listed in the vehicle table, an update is not available. Select the back icon and skip to **CLAIMS INFORMATION** on the last page.

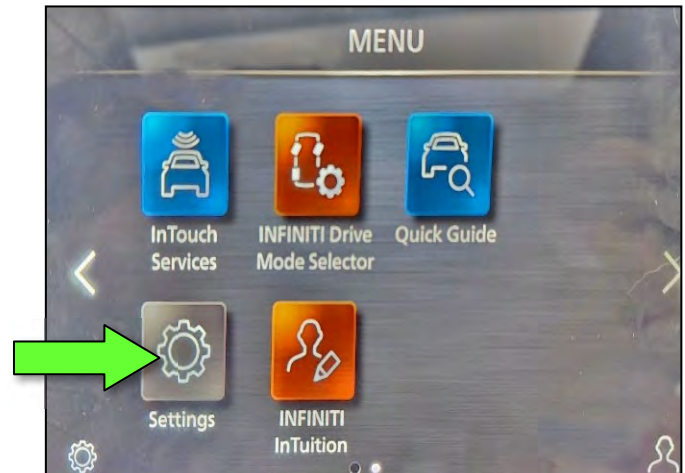
Figure 10

- a. From the **MENU** screen, select **Settings**.

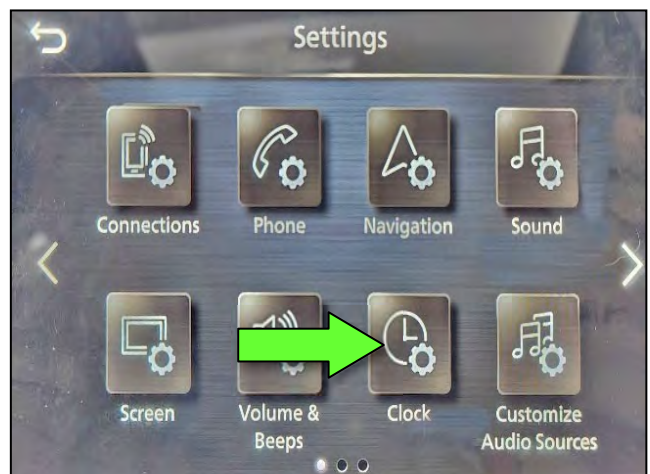
Figure 11

- b. Select **Clock**.

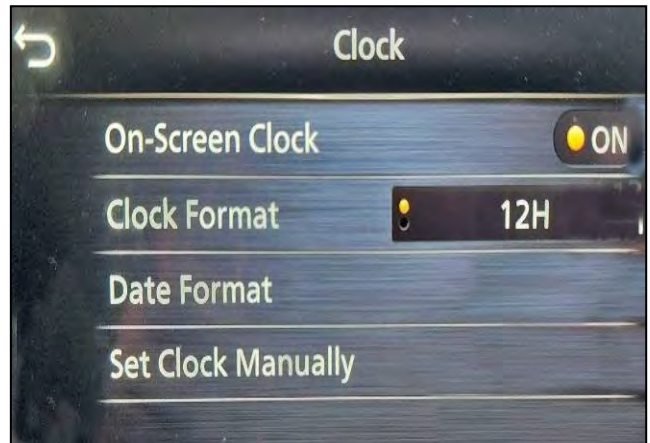
Figure 12

- c. Record all the clock settings.
 - o For vehicles without navigation:
 - **On-Screen Clock**
 - ON/OFF
 - **Clock Format**
 - 12H/24H
 - **Date Format**
 - Select **Date Format** to view and record settings.
 - **Set Clock Manually**
 - Select **Set Clock Manually** to view and record settings.

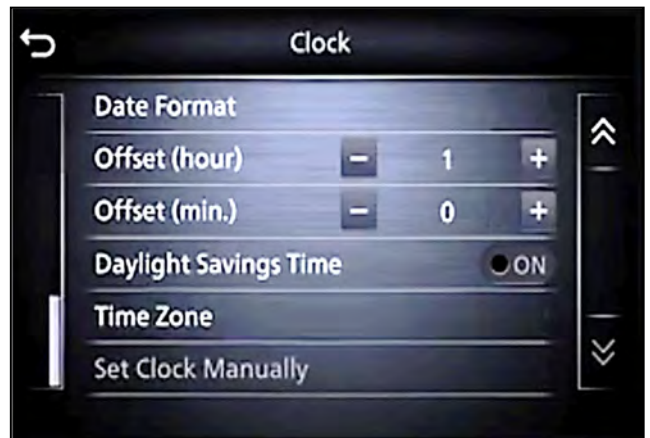
Figure 13

- o For vehicles with navigation:
 - **On-Screen Clock** (not shown)
 - ON/OFF
 - **Clock Mode** (not shown)
 - Auto/Manual/Time Zone
 - **Clock Format** (not shown)
 - 12H/24H
 - **Date Format**
 - Select **Date Format** to view and record settings.
 - **Offset (hour)**
 - **Offset (min.)**
 - **Daylight Savings Time**
 - ON/OFF
 - **Time Zone**
 - Select **Time Zone** to view and record settings.
 - **Set Clock Manually**
 - Select **Set Clock Manually** to view and record settings.

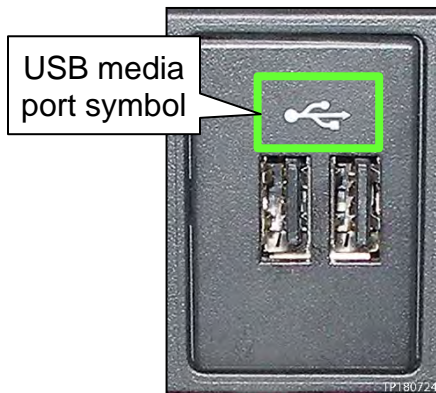
Figure 14

14. Insert the USB drive with the infotainment update-software into the vehicle's USB media port (Figure 14).

Do not insert the USB drive into a charging port. If used, the update-software and/or USB drive may become damaged. Only insert the USB drive in a USB media port.

HINT: Charging ports are marked in the vehicle with a “lightning bolt” symbol.

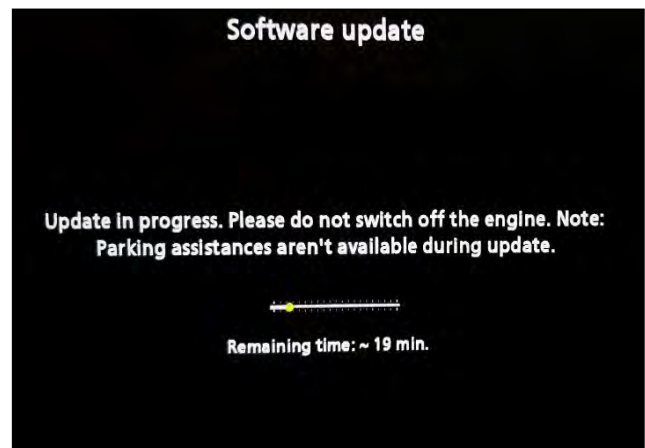
Figure 16

15. Wait for the update to complete.

- Follow the on-screen instructions while waiting.

HINT: The update lasts 15-25 minutes.

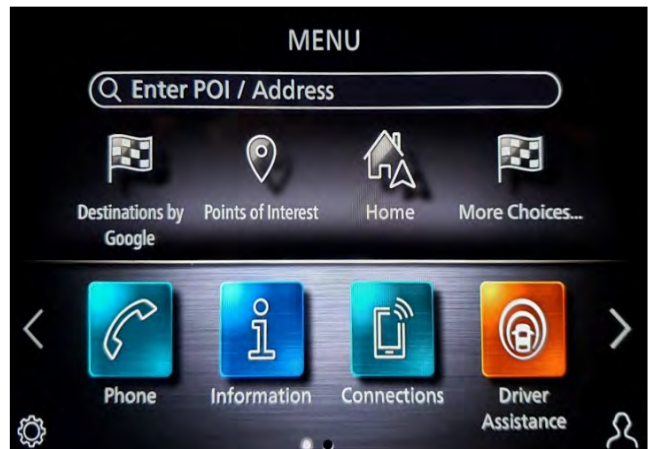
22. After the Infiniti logo appears, wait about 1 minute.
- The MENU (Home) screen in Figure 19 will be displayed.

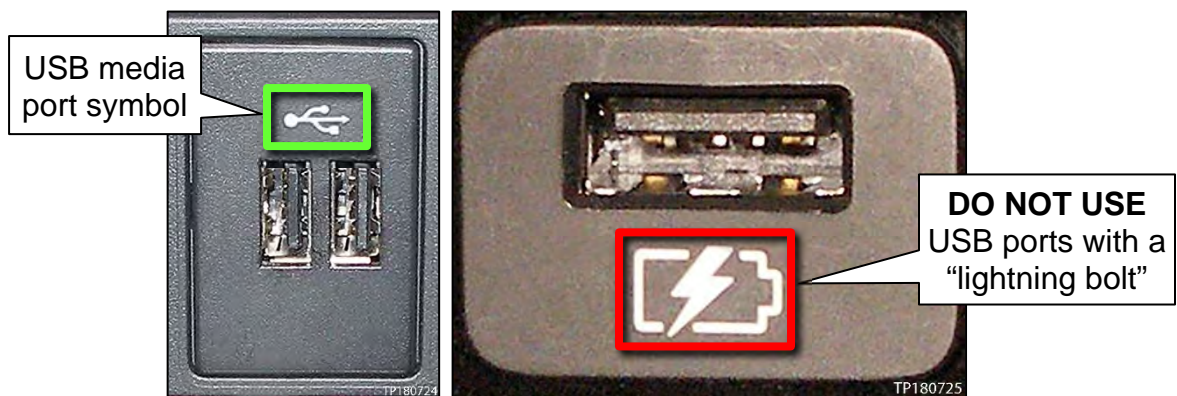
Figure 20

30. Insert the USB drive with the infotainment update-software into the vehicle's USB media port (Figure 20).

Do not insert the USB drive into a charging port. If used, the update-software and/or USB drive may become damaged. Only insert the USB drive in a USB media port.

HINT: Charging ports are marked in the vehicle with a “lightning bolt” symbol.

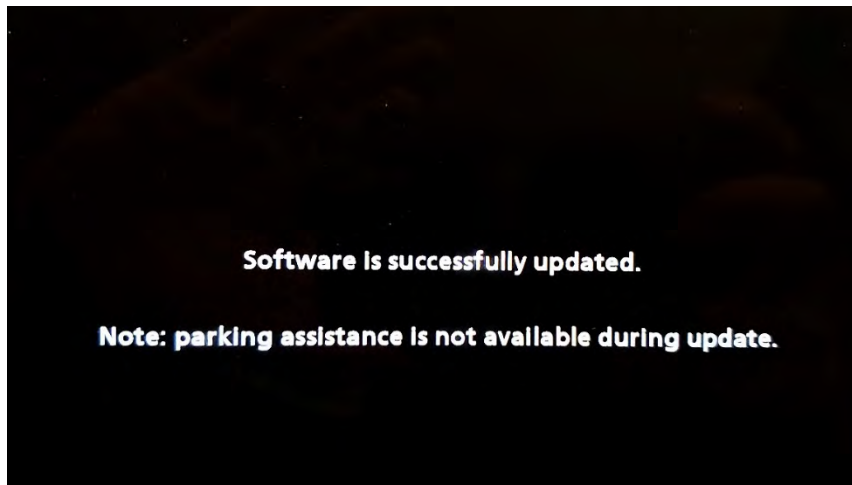
Figure 23

32. Once the update is complete (Figure 23), remove the USB drive; the system will reboot (restart).

HINT: The system will not reboot until the USB drive is removed.

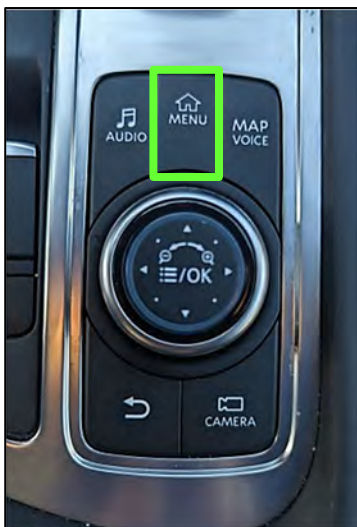
Figure 24

33. Press and hold the **MENU** button on the IT Commander (Figure 24) and turn the AV Control Unit volume knob (Figure 25) left-right-left at the same time.

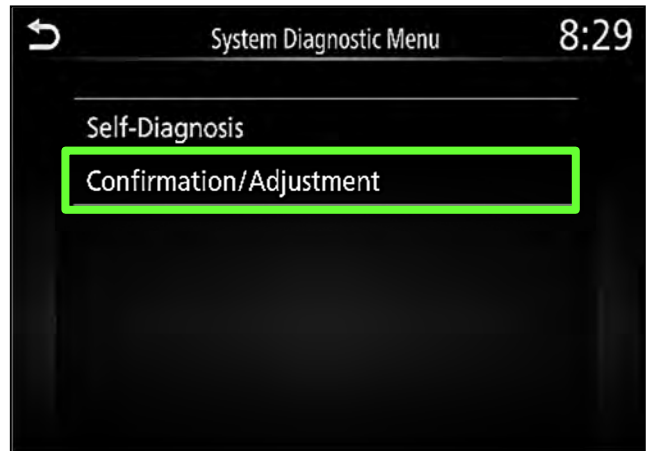
Figure 26

34. Select **Confirmation/Adjustment**.

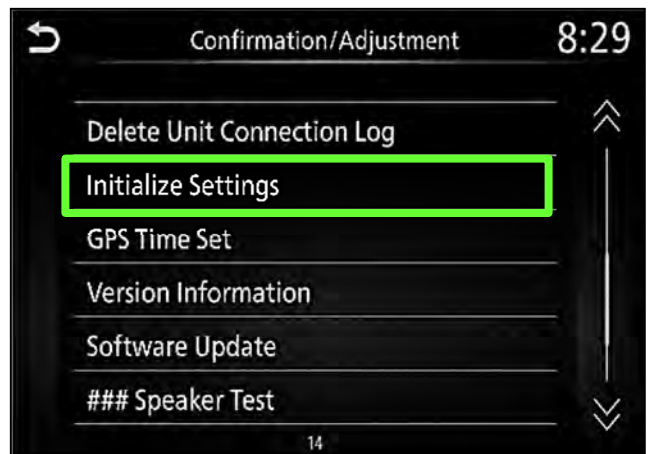
Figure 27

35. Select **Initialize Settings**.

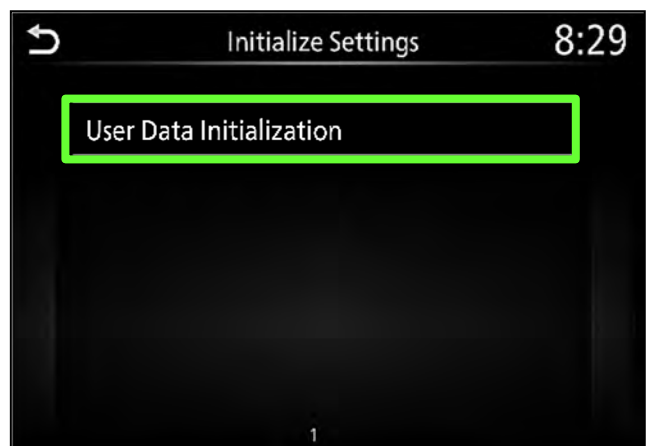
Figure 28

36. Select **User Data Initialization**.

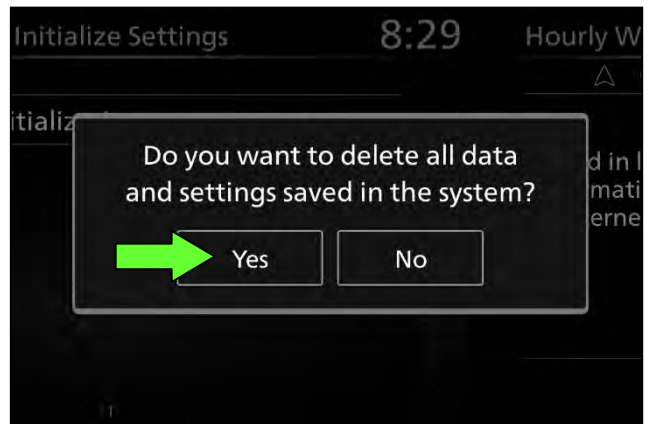
Figure 29

37. Select **Yes**.

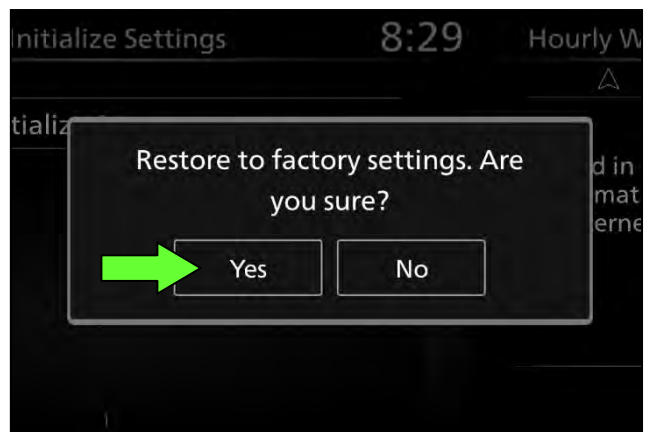
Figure 30

38. Select **Yes**.

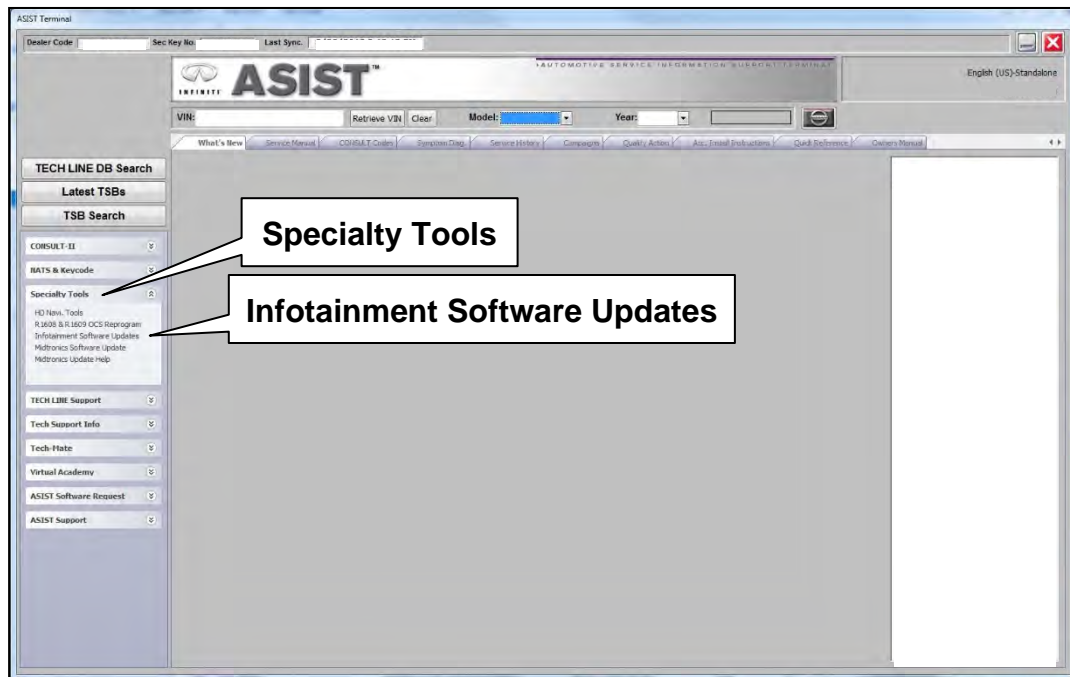
Figure 31

42. Select **Specialty Tools**, and then select **Infotainment Software Updates**.

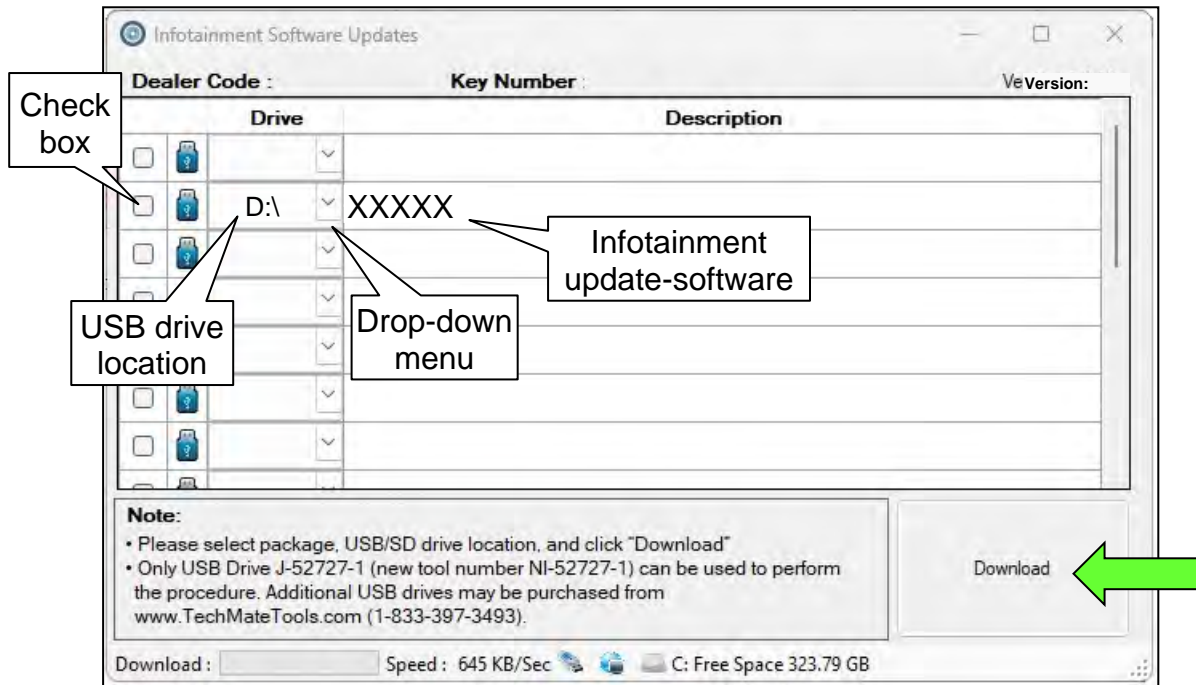
Figure 32

43. Select the check box next to the infotainment update-software (Figure 32).
 - Refer to the appropriate vehicle table to determine the correct infotainment update-software for your vehicle.
44. Use the drop-down menu and select the location of the USB drive that was inserted in step 40 on page 28.

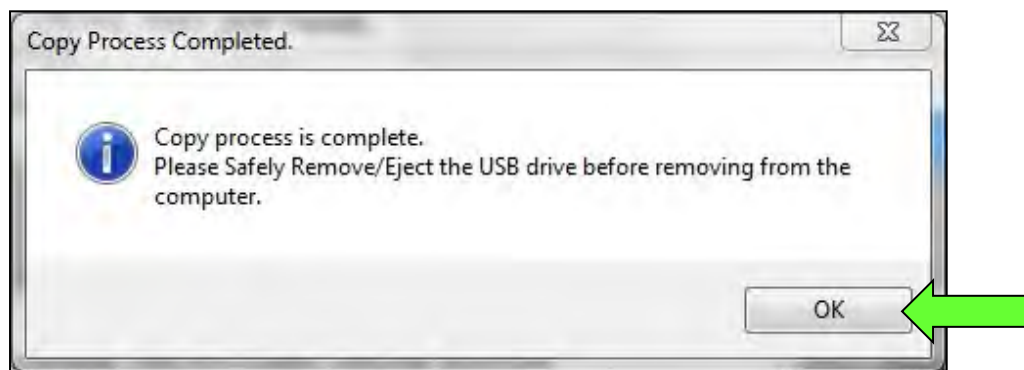
HINT: The update-software is estimated to take 10-15 minutes to download to the USB drive.
46. Select **OK** when the message in Figure 33 is displayed.

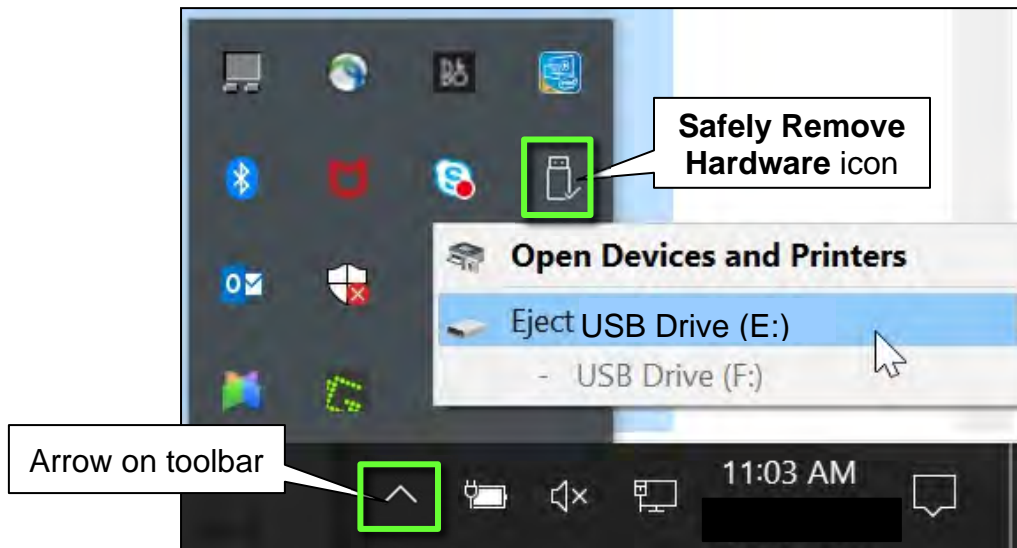
Figure 34

47. Once the transfer is complete, safely remove the USB drive from the CONSULT PC.
 - a. From the PC toolbar, select the **Safely Remove Hardware** icon.
 - o The icon is on the toolbar, or can be found after selecting the arrow.
 - b. Select the USB drive to be removed, and then remove the USB drive from the CONSULT PC.
