VW Elsa Newsletter

Edition 113: November 24, 2014

Offboard Diagnostic Information System Service (ODIS Service) – Installation Version 2.2.2 DVDs

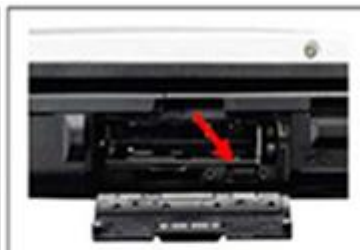
Image 1

VAS 6150 & VAS 6150A
(Front panel behind handle)

- Connect the tester to the on-line network using an Ethernet cable.
- Connect the VAS 5054A transmitter head to the VAS tester using the USB cable.
- Disable Bluetooth by physically turning the switch to the OFF position (Figures 1, 2 or 3).

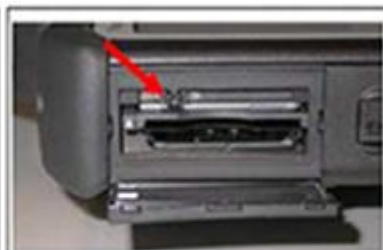
Image 2

VAS 6150B
(Middle right side behind WIRELESS door)
