CUSTOMER SATISFACTION NOTIFICATION
 NORTH AMERICA
Radio Software Update

FCA US LLC

Reference: ZD7

2018 – 2021 (RU) Chrysler Pacifica/Voyager
 2018 – 2021 (LX) Chrysler 300

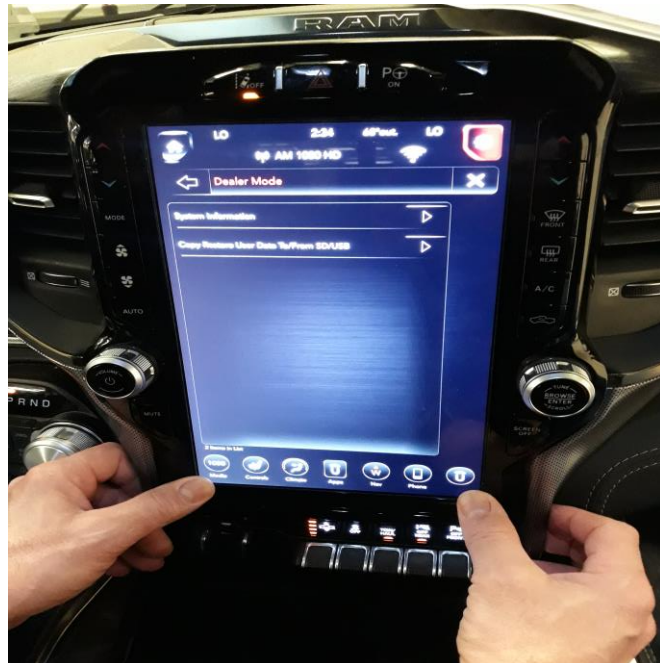
Figure 1 – Display Screen

1. Using the radio touch screen, simultaneously place both thumbs on the corners of the touch screen and hold for approximately 6 seconds or until the “Dealer Mode” screen is displayed (Figure 1).

2. Select “System Information”.
3. Select “Radio Part Information”.
4. Read “Application Version”.
5. Verify that the software version is at PR40.1 or above for 12” radio QR40.1 above for 8.4” radio.

- **Yes** – Software version is at **PR40.1 or above for 12” radio QR40.1 or above 8.4” radio**. This notification is complete. Claim the inspection LOP.
- **No** – Software version number is **lower than PR40.1**. QR 40.1 Update radio software. Proceed to **Section B. Download Software**

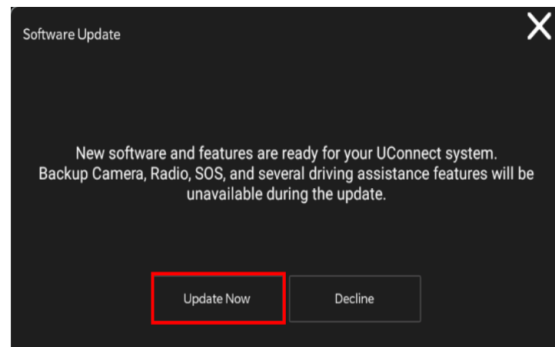
Figure 1

1. Start Engine
2. Insert the provided USB into the vehicles USB media port.
3. Display screen will display “Update Now” or “Decline” (Figure 1).
4. Select “Update Now” to update the radio software (Figure 1).
5. “Updating” screen will display (Figure 2).

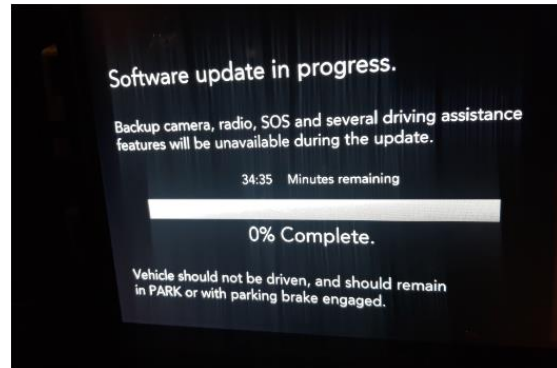
Figure 3

6. Software update in progress screen will display (Figure 3).

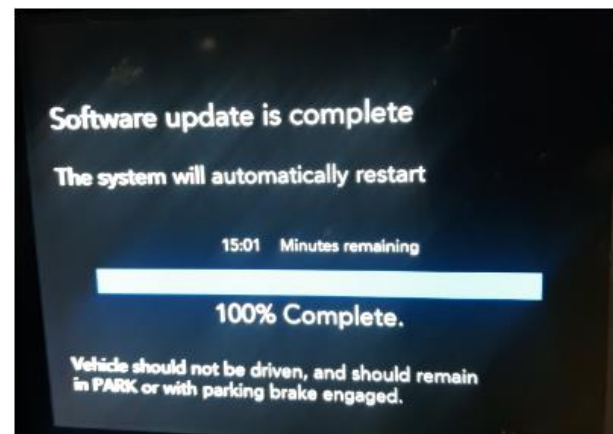
Figure 4

7. Upon successful completion of software update, the display will indicate "Software Update is complete" (Figure 4).
