GROUP	MODEL
ELE	2020-2024MY Multiple Models w/ AVN5W
NUMBER	DATE
303 (Rev 1, 09/28/2023)	August 2023

TECHNICAL SERVICE BULLETIN

SUBJECT: **AVN 5.0 WIDE NON-RESPONSIVE RADIO ICON (AM, FM, SXM)**

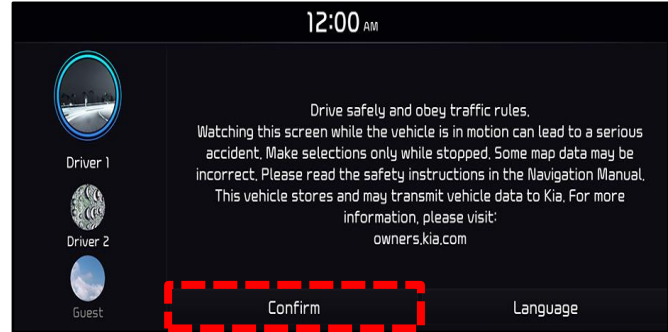
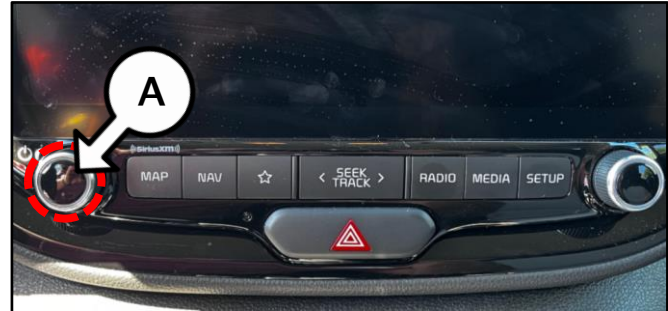
3. Press the 'Power' button (A) to turn the Radio/Media 'OFF'.

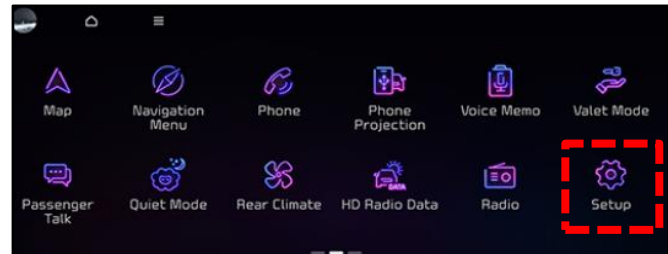
4. Select 'Setup'.

11. Once the update has completed, repeat steps 4-6 to confirm the Software Version has been correctly updated.

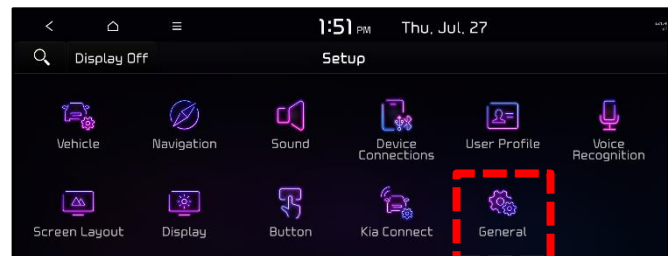
5. Select 'General'.

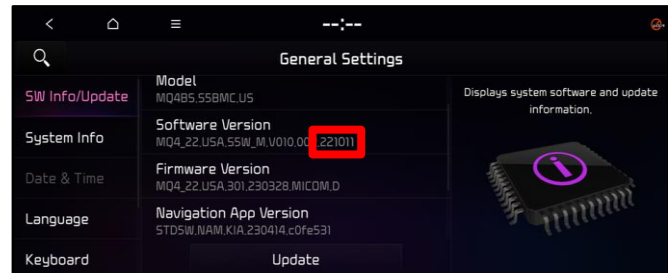
6. Inspect the last six (6) digits of the AVN Software Version displayed in 'General Settings'.

- If the current software version shown in 'General Settings' is included in the software version listed below, then proceed to step 7.
- If the current software version shown in 'General Settings' is not included in the software version listed below, **this TSB does not apply.**

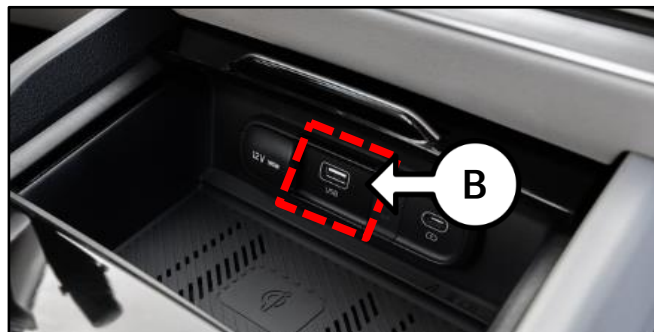
7. Insert the USB Flash Drive (refer to the table below) into the USB slot (B) located underneath the AVN unit.

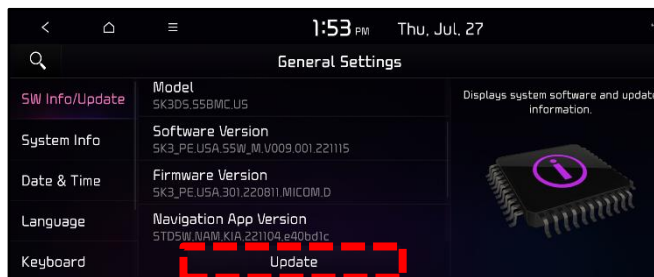
8. On the 'General Settings' screen, select 'SW Info/Update', then select 'Update'.

Note: If the USB Flash Drive is not recognized, the 'Update' button will not be activated, as shown. If this occurs, remove the USB Flash Drive and repeat steps 3-7.

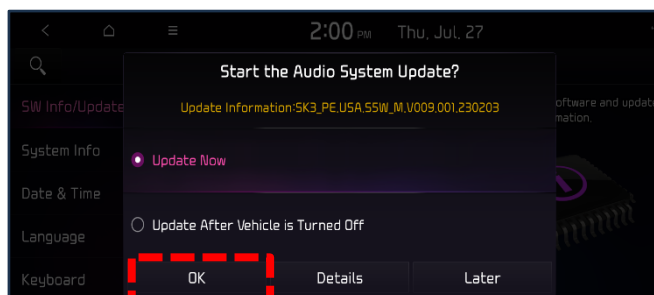
9. Select 'OK' on the pop-up screen.

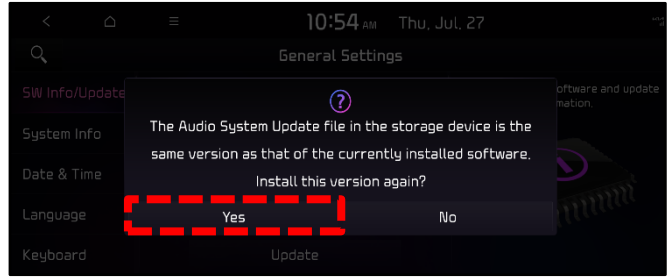
Note: After selecting 'OK', there may be some instances where the pop-up shown may be displayed. Select 'Yes' and proceed to step 10.

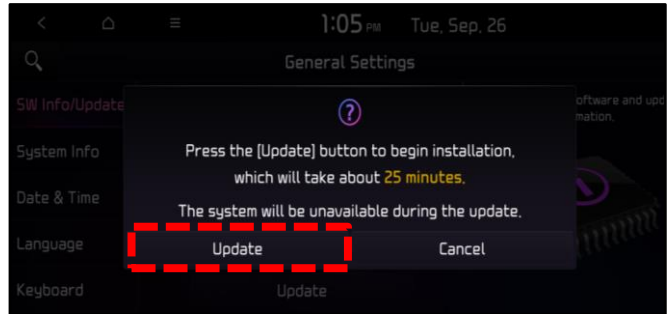
10. Select 'Update' on the pop-up screen.

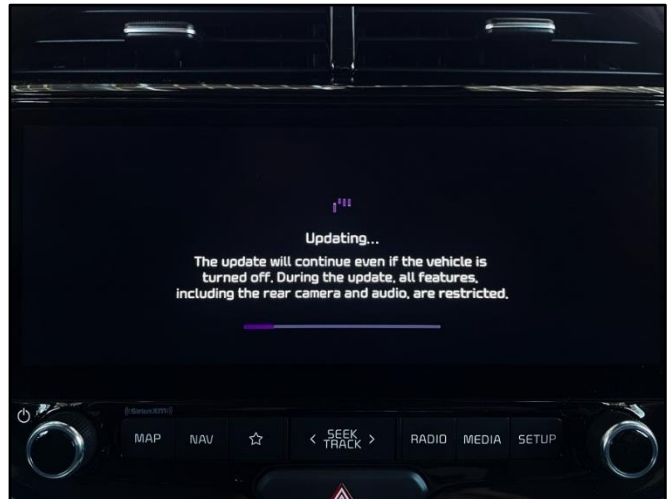
Note: There will be multiple occurrences where the Kia logo will appear or the display will be black during the update process. This is normal.

DO NOT turn the ignition switch 'OFF', start the engine, and/or remove the USB drive from the vehicle during the update process.
