# Hybrid Regenerative Brake Transition Feeling Improvement

YEAR(S)	MODEL(S)	ADDITIONAL INFORMATION
2020 - 2022	Highlander HV

## Introduction

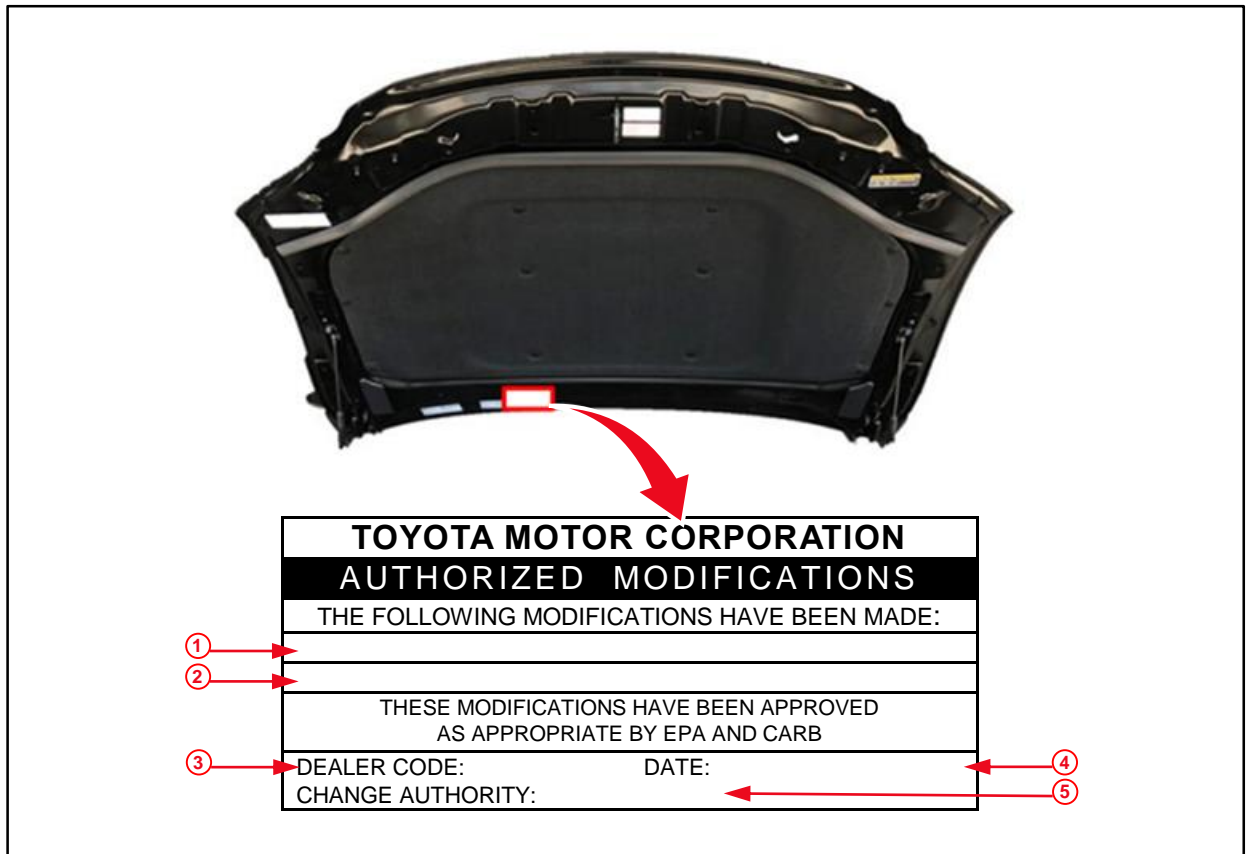
**Figure 1. Location of Authorized Modifications Label on 2020 – 2022 Highlander Hybrid**

<b>1</b>	Brake Actuator Assembly Part Number (e.g., 44050-#####)
<b>2</b>	New Calibration ID (e.g., Main – F1526-48L5000)
<b>3</b>	Dealer Code

<b>4</b>	Date Completed
<b>5</b>	This SB Number

3. Use Techstream to confirm if the brake actuator assembly control module calibration has been updated and check for the Authorized Modifications Label affixed to the vehicle in the location shown below.  
 Is the calibration ID listed in Techstream and on the label the latest brake actuator assembly ECU calibration?
  - **YES** — This bulletin does NOT apply. Continue diagnosis using the applicable Repair Manual.
  - **NO** — Continue to step 4.

5. Prepare and install the Authorized Modifications Label.
  - A. Using a permanent marker, enter the following information on the label:
    - Brake Actuator Assembly part number [Refer to the **Parts Information** section for the **NEW PART NUMBER**]
    - Calibration ID(s) [*Refer to the **Calibration Information** section for the **NEW CALIBRATION ID***]
    - Dealer Code
    - Repair Date
    - Change Authority [***This bulletin number***]
  - B. Install the Authorized Modifications Label onto the vehicle at the location shown in Figure 1. The Authorized Modifications Label is available through the MDC, P/N 00451-00001-LBL.
6. Clear ANY DTCs and test-drive the vehicle to confirm the condition is no longer present.
