Service Action

Code: 97HB

Subject ID.4 Software Update

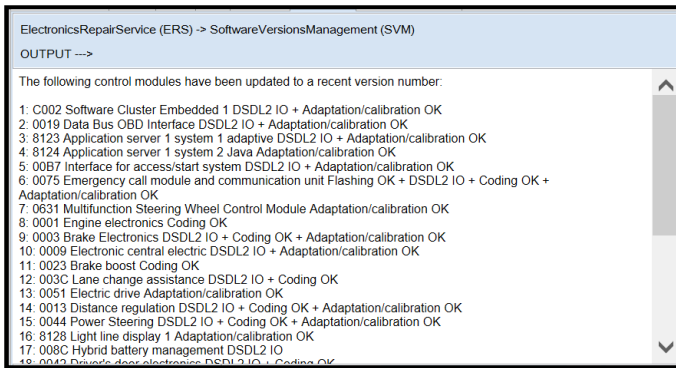
SVM code
S313

- Select “Accept” <arrow> and follow the on screen prompts.
- Pay attention to the status report of the control module updates.
- Any module stating NOT OK will have to be updated again.
- Selecting “Complete/Next” will begin another attempt to update the control module.
- Do not end the diagnostic session.
