# TECHNICAL INSTRUCTIONS

22TC01

## DATA COMMUNICATION MODULE (DCM) REPROGRAMMING

2021 MODEL YEAR C-HR, RAV4 PRIME, TUNDRA

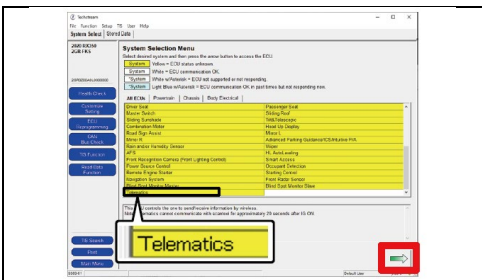
- b) Select the "System Select" tab at the top left of the screen, select "Telematics" and click the right-arrow.

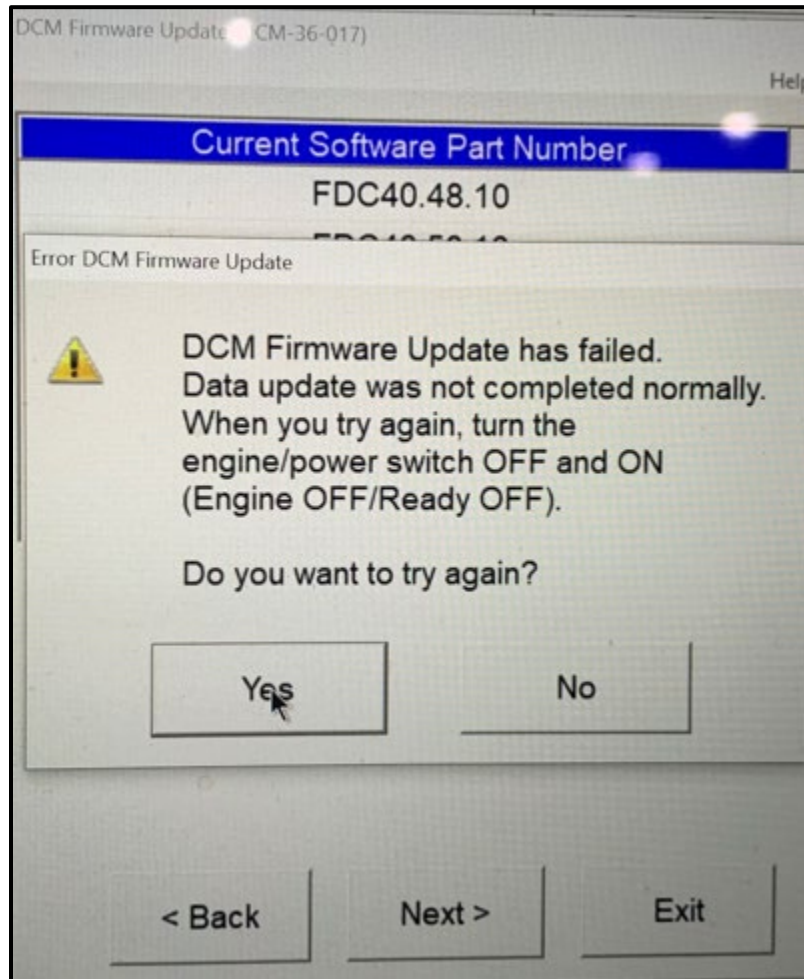
If the error message below is displayed after attempting to start the firmware update, refer to the Appendix B, RESTORING A WAIVED TELEMATICS ACCOUNT, starting on page 15. Otherwise proceed to the next step.

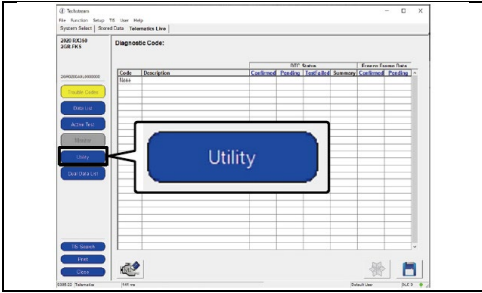
- b) Click “Utility”.

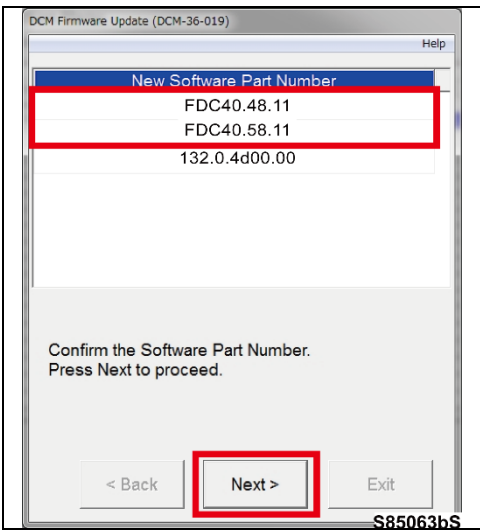
f) Confirm that the displayed software part number (Calibration ID) has been changed to the new one, then click “Next”.

New Software Part Number
<b>FDC40.48.11</b>
<b>FDC40.58.11</b>

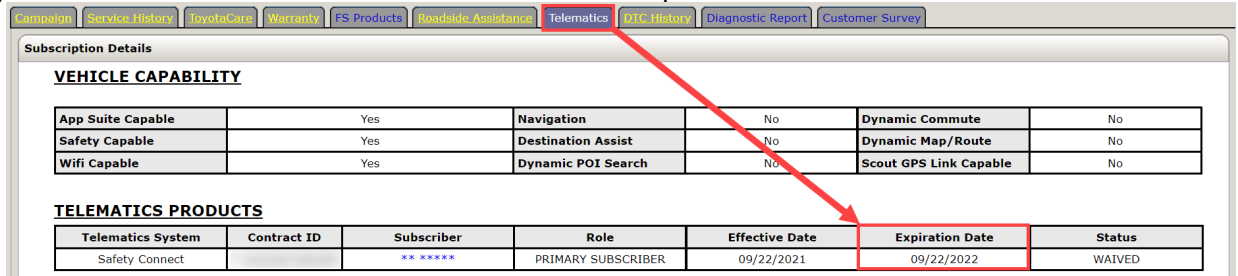
- Navigate to <https://one.tis.toyota.com/serviceLane/>.
- Enter the VIN in Vehicle One-View and click Search.
- Scroll down to the Telematics tab and check the expiration date of TELEMATICS PRODUCTS.
