PRODUCT SAFETY RECALL

SUBJECT: Unintended Ignition Key Rotation

MODELS: 2003-2010 Cadillac CTS
2011 Cadillac CTS (VIN D and Built Prior to December 13, 2010)
2004-2006 Cadillac SRX

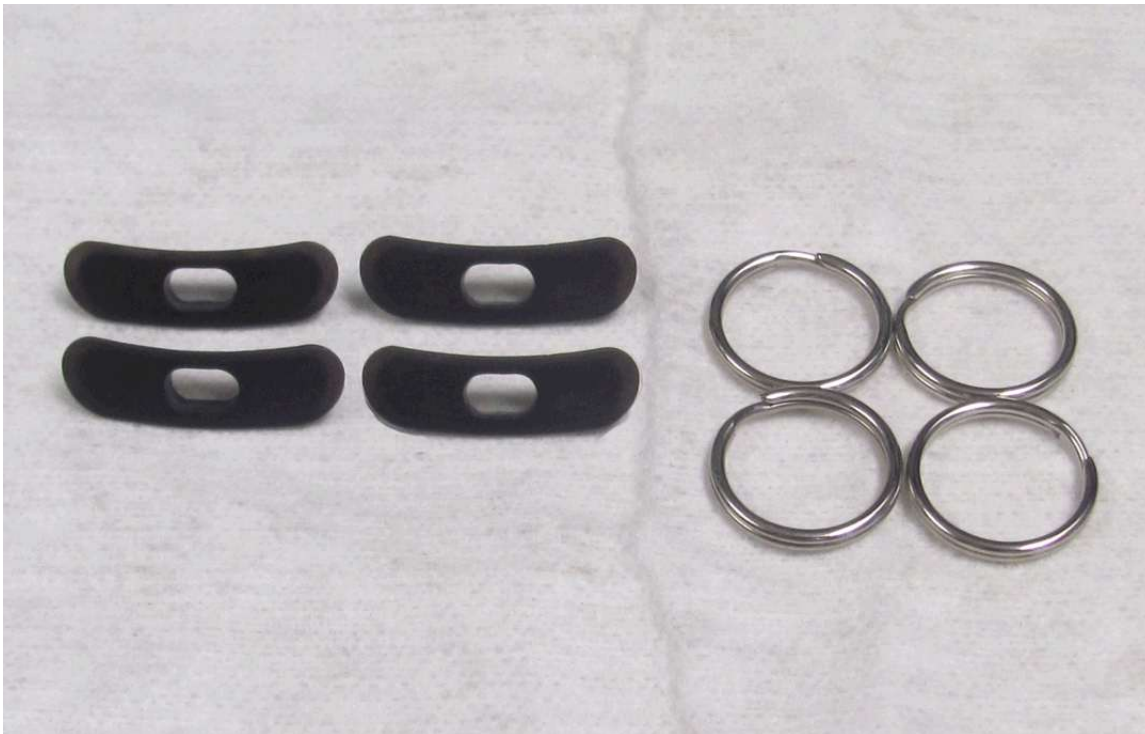
3970365

Note: Locate the four key inserts and four 16 mm rings. Two key inserts are required to modify one key. Two 16mm key rings are required for each key repair.

Note: If the key slot is too small or large for the insert, use the two-piece key cover repair. If the head of the insert does not cover the entire slot, the key insert repair cannot be used.

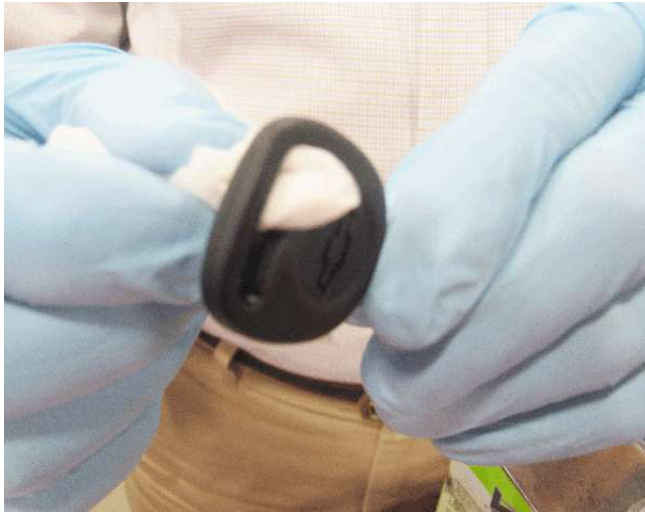
3970395

1. Test fit the customer-provided key. Insert a key insert into the front slot of the key and insert a second key insert into the back slot of the key. Ensure the key insert fits flush into the slot of both sides of the key.
2. Remove the inserts from the front and back key slots.

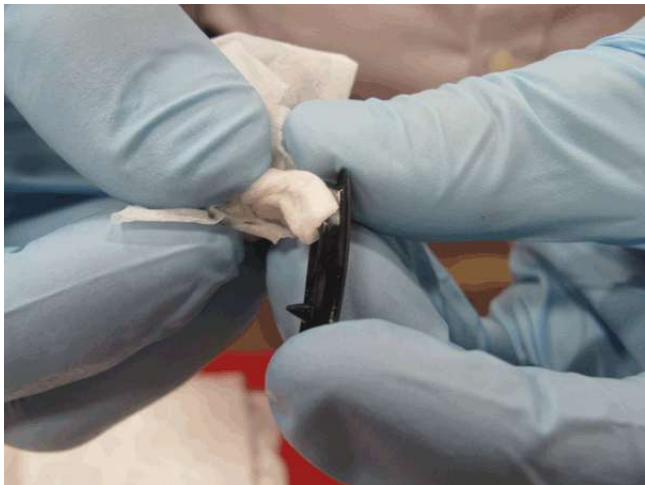
3970397

3. Clean the head and slot of the keys using a shop towel and isopropyl alcohol.

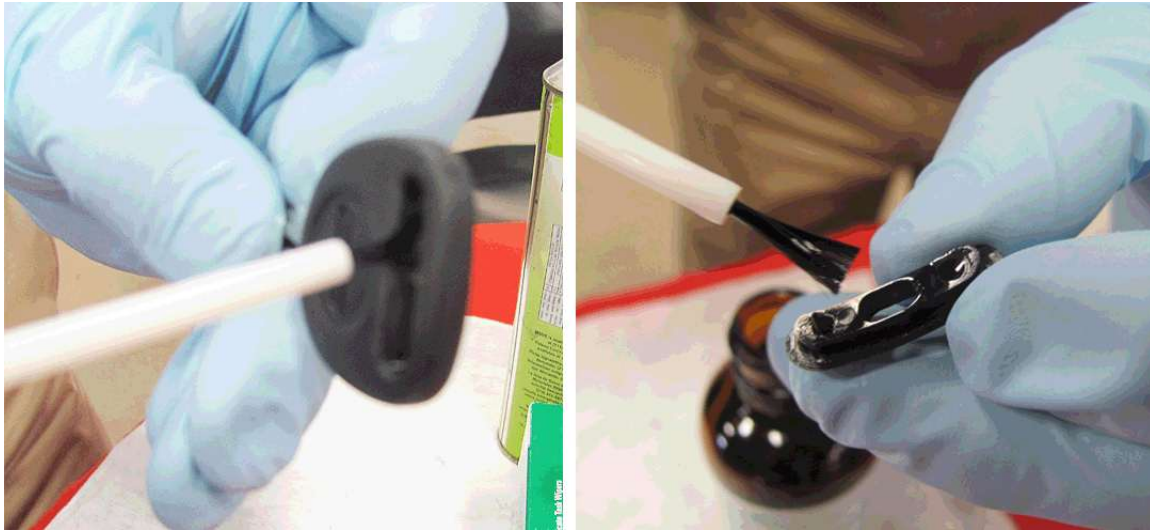
3970399

5. Apply the primer to the front and back key slot of the two keys.
6. Apply the primer to the four inserts.

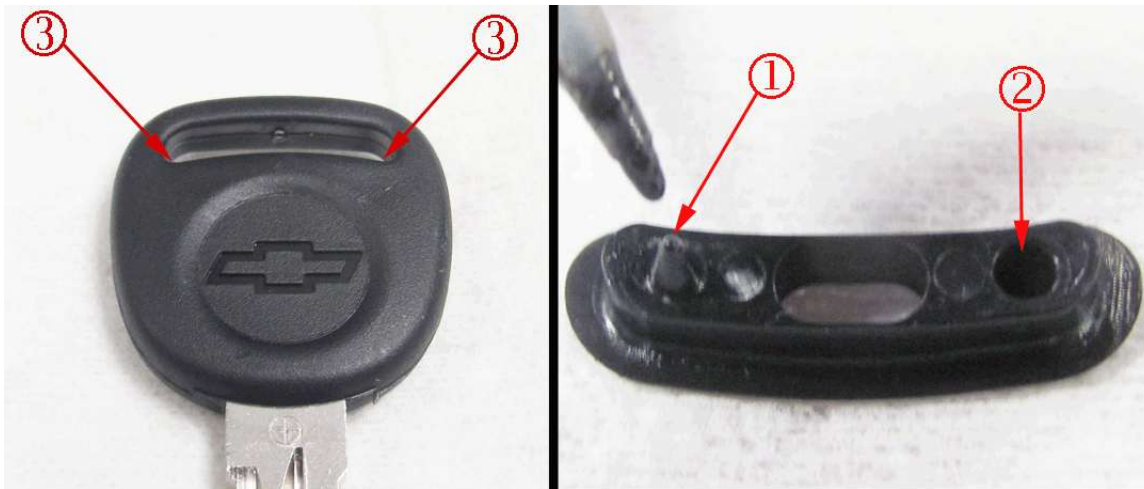
3970372

7. Apply adhesive to the corners (3) of the key slots.
8. Apply adhesive to the post (1) and hole (2) of each insert.

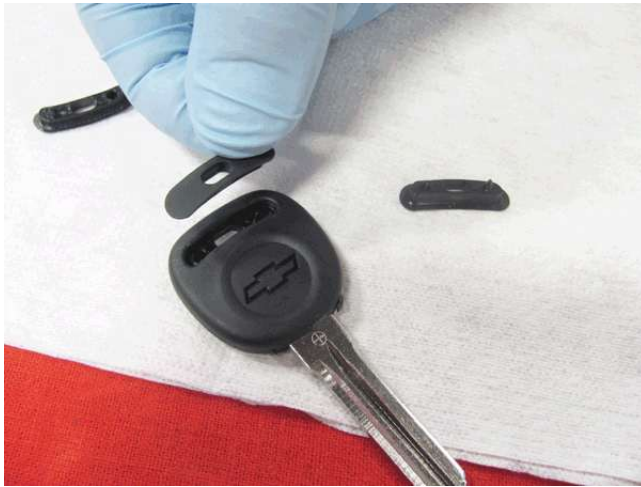
3970401

9. Insert a front and back insert to the key slot of each key.
10. Clean the body of the keys with a shop towel.
11. Clean the hole of each key with a shop towel and screwdriver.

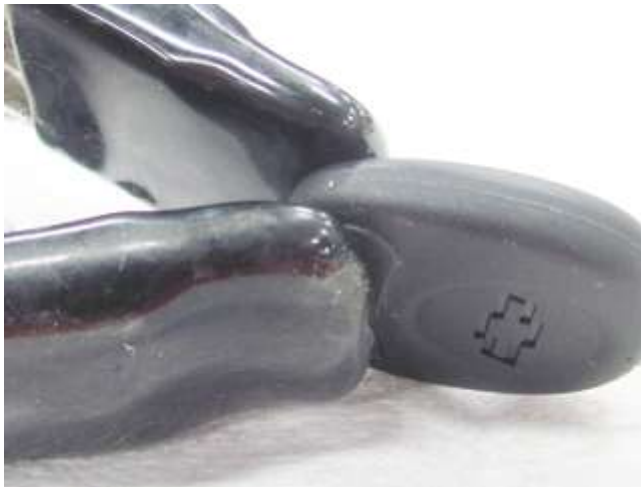
3970376

12. Clamp the two key insert to the key slot using a spring clamp with rubber ends.
13. Remove the clamp from the key assembly after allowing the adhesive to dry for 5 minutes.

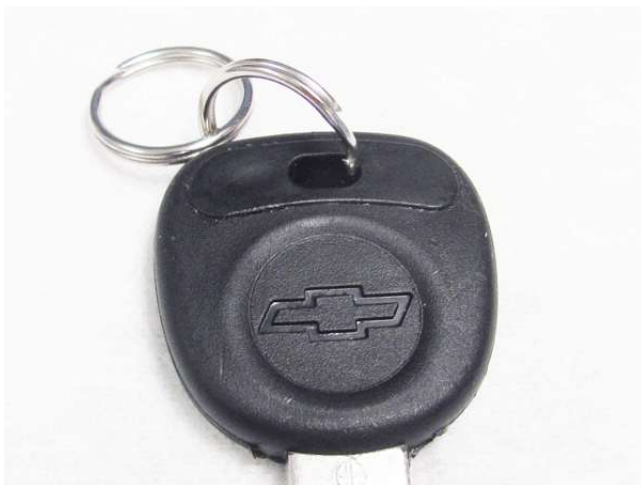
3970400

14. Install two 16 mm key rings to the key assembly. Attach the first 16 mm ring to the key hole. Attach the second 16 mm ring to the first 16 mm ring. Refer to photograph.
15. Make a copy to the owner manual supplement on the last page of this bulletin and insert it into the vehicle's owner manual.

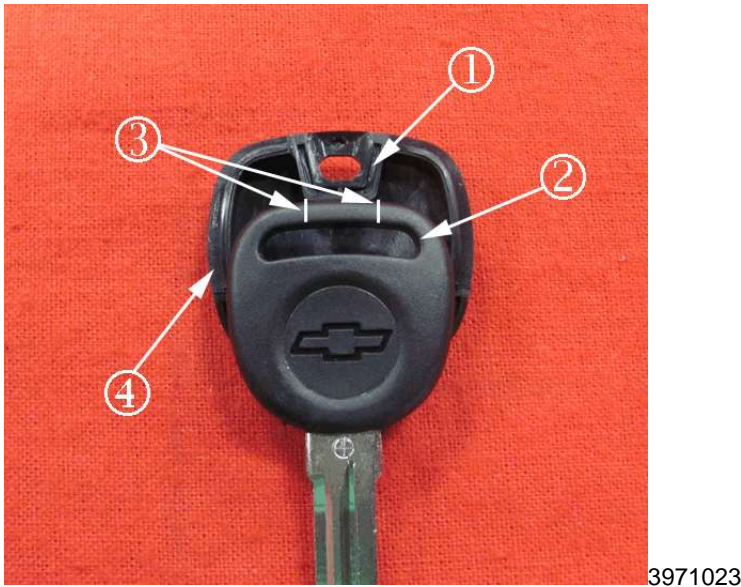
1. Test fit the customer-provided key into the back key cover.
 - 1.1 Ensure the body of the key fits into the back key cover. The body of the key may require some filing to fit into the cover. Use a file to remove the material from the body of the key.
 - 1.2 Align the back cover boss (1) with the slot (2) of the customer-provided key.
 - 1.3 Using a pen or knife mark the top portion of the slot (3) that must be cut in order for the customer-provided key to fit inside of the back cover.

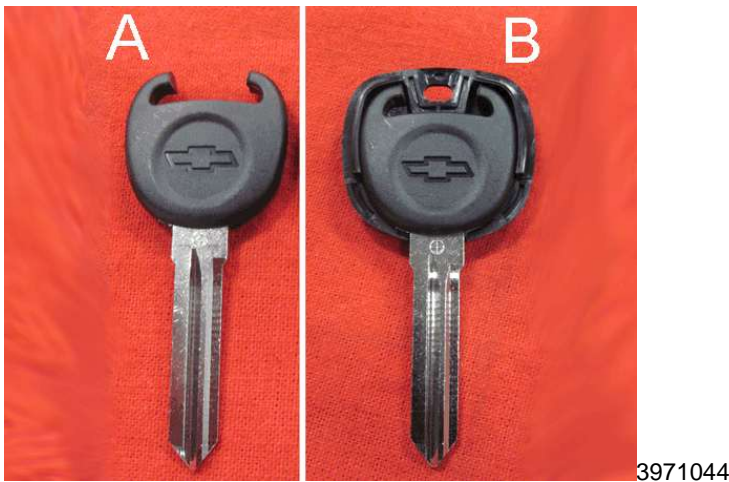
- 1.4 Using a knife or box cutter, cut out a notch (A) in the slot of the key.
 - 1.5 The back cover boss must fit inside of the notched area of the key (B).
 - 1.6 Remove the key from the back cover.

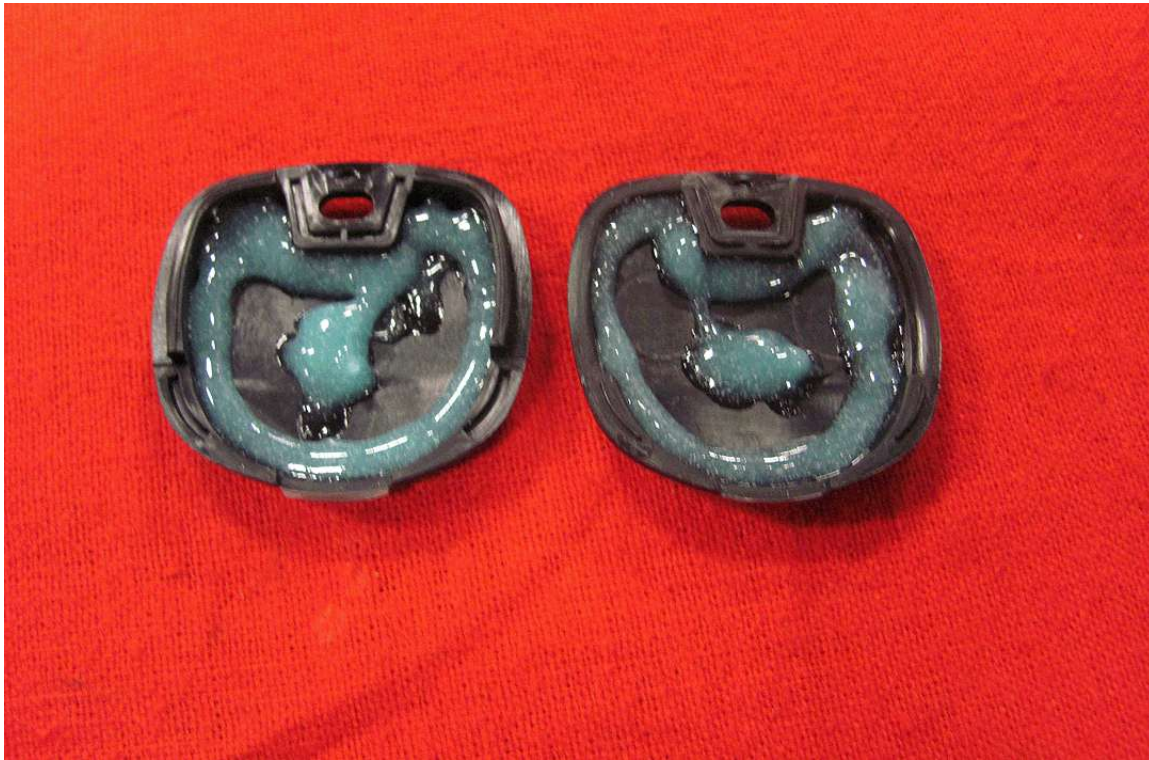
3971030

5. Dispense a small amount of adhesive to ensure the mixed adhesive is blue or green (not white or brown) in color. Then apply a bead of adhesive to the inside of the front and back key cover. Ensure a bead of adhesive is applied to the whole perimeter of the cover.

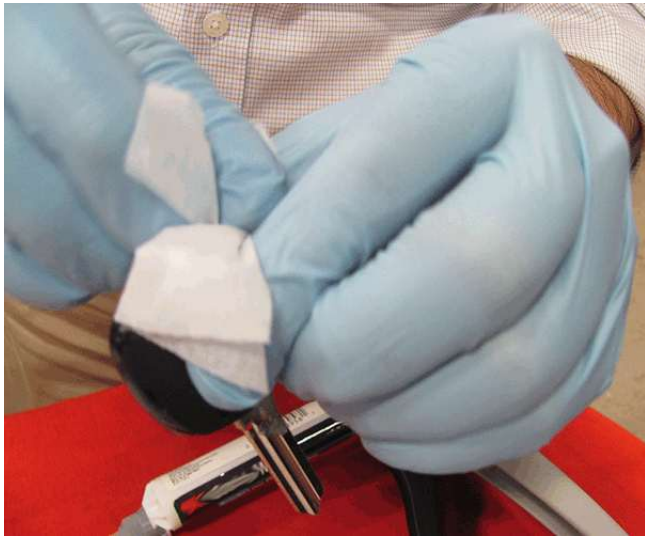
3971005

7. Remove excess adhesive from the body of the key using a shop towel and isopropyl alcohol.
8. Remove excess adhesive from the hole of the front and back key cover using a shop towel and small screwdriver.
