SERVICE BULLETIN

APPLICABILITY: 2015-20MY Legacy & Outback
 2015-20MY Forester
 2015-20MY WRX & WRX STI
 2019-20MY Ascent

NUMBER: 07-207-22R

SUBJECT: Subaru Battery Drain Product Liability Litigation

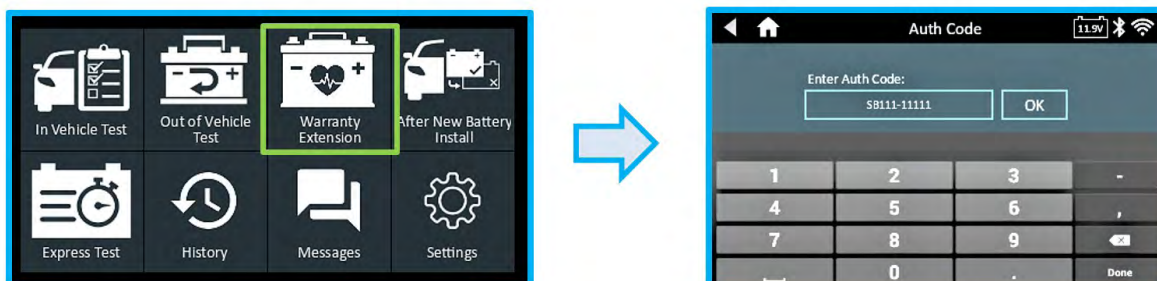
DSS-5000 TESTING:

The DSS-5000 can be used for initial testing or testing when charging is not required. The Authorization Code will be needed prior to testing. This code will be requested after the testing equipment is properly connected and the Warranty Extension icon is pressed. If the test requires charging, the DSS-5000 cannot meet the testing requirements as it does not have charging capabilities.

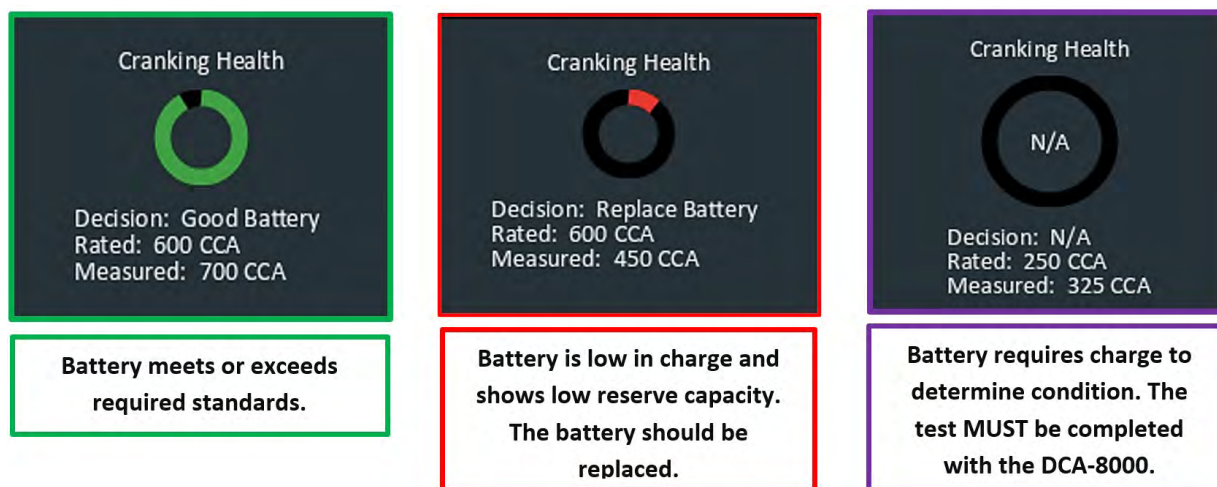
Continue with the normal test procedures. The possible test results given from the DSS-5000 are “Good Battery”, “Replace Battery”, or the battery requires a further charge.

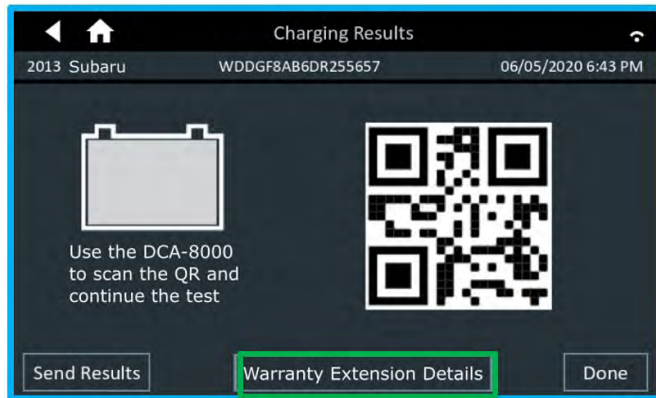
If the DSS-5000 determine charging will be needed for further diagnostic measures, the DCA-8000 will be needed to continue. When test results determine further charging is needed, a transfer QR code will be displayed on the screen. This code can be used to transfer vehicle information and charging requirements to the DCA-8000.

The following information is encrypted into the QR Code:

- Battery Information
- Vehicle Information
- Authorization Code
- Test Timestamp
- Warranty Extension Code (if applicable)
- Test Index

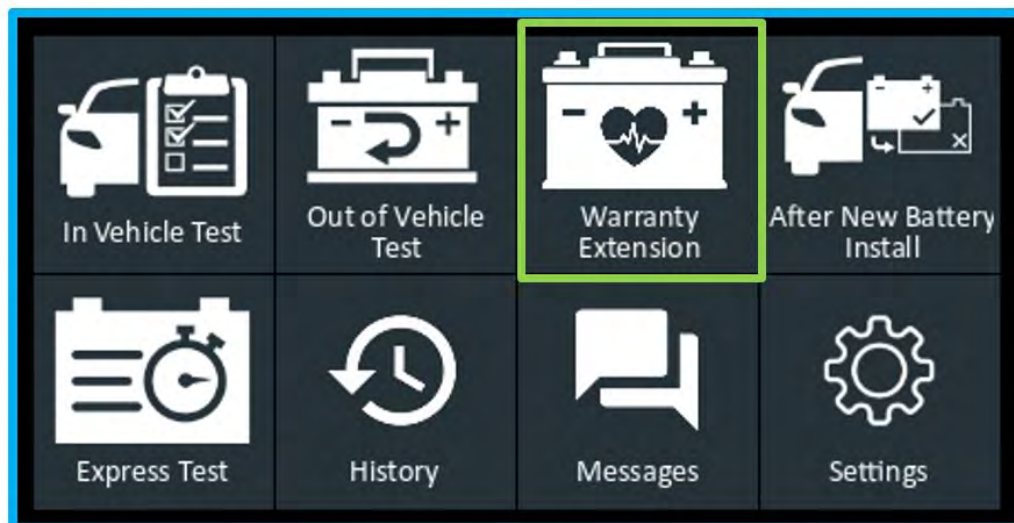
1. Carefully connect the testing equipment to the vehicle and press the Warranty Extension icon to continue.

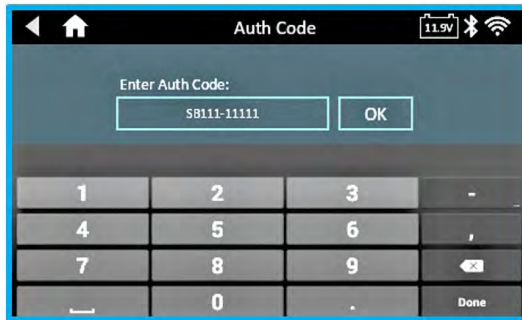
DCA-8000

- The Authorization Code or the QR scan code (if testing is started with the DSS-5000) is required at this point. Enter the required information.

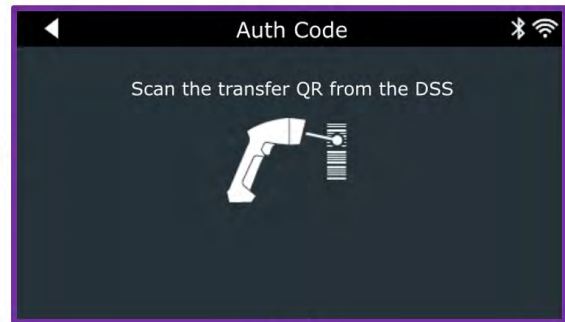
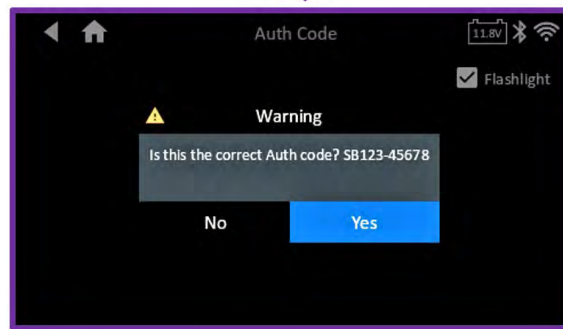
DSS-5000 to DCA-8000

NOTE: In a case when the QR Code is entered from the DSS-5000, a Warning screen will display to confirm the Authorization Code for the vehicle being tested. Click “Yes” if the code is correct.

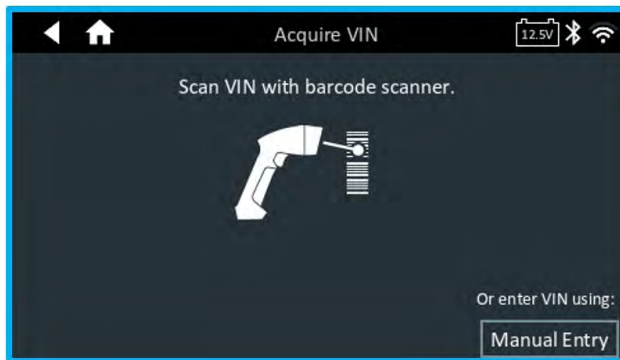
- Verify the VIN using the scan tool.

NOTE: In a case where the scanner option is unavailable the VIN can be entered by using the manual entry function.

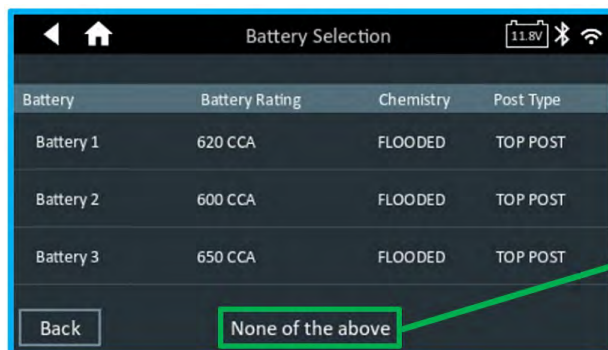
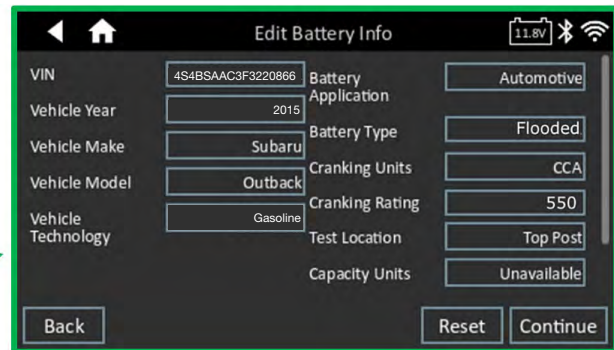
- Select the battery type being tested. If the “None of the above” button is selected, the Edit Battery Info menu will be displayed requiring manual entry into the required fields.

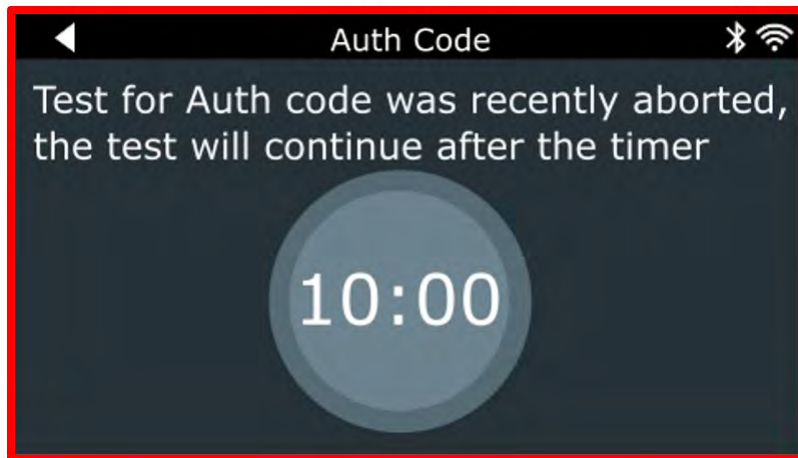
Once the battery information is confirmed and accurately entered, select “Continue” to proceed with the battery testing.

CAUTION: In the event of a test or charge being aborted for any reason, a ten-minute time window is displayed. After ten minutes have elapsed, the test must be restarted from the beginning.

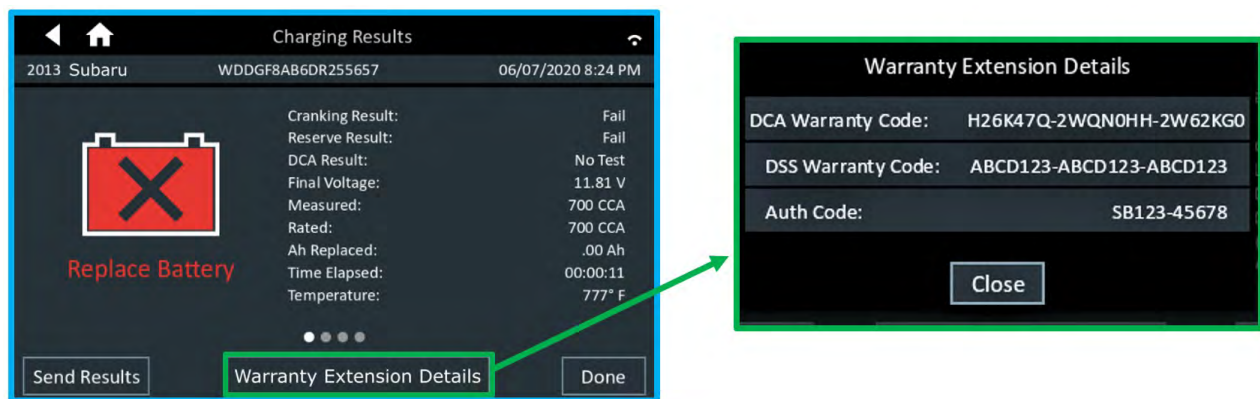
5. The DCA-8000 will display the testing results when complete. A 21-digit Warranty Extension Code will be generated. A Warranty Extension Details clickable icon will be displayed on the screen. When pressed, both the Authorization Code and the Warranty Extension Code are displayed in detail. These codes are to be retained and attached to the repair order and will be required for claim submission.
