Subject: N232412720 – Service Update

ECM Communications to Emissions Test Tools

Models: 2024 Chevrolet Silverado 2500 HD/3500 HD

2024 GMC Sierra 2500 HD/3500 HD

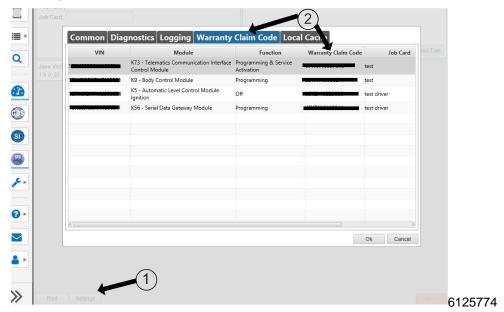
Warranty Claim Code Information Retrieval

If the Warranty Claim Code was not recorded on the Job Card, the code can be retrieved in the SPS2 system as follows:

- 1. Open TLC on the computer used to program the vehicle.
- 2. Select and start SPS2.
- 3. Select Settings (1).
- 4. Select the Warranty Claim Code tab (2).

The VIN, Warranty Claim Code and Date/Time will be listed on a roster of recent programming events. If the code is retrievable, dealers should resubmit the transaction making sure to include the code in the SPS Warranty Claim Code field.

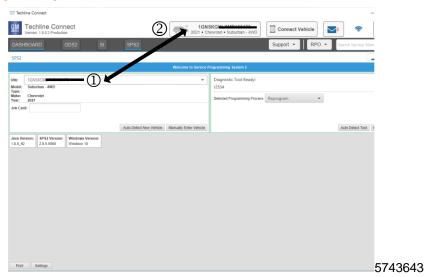
Caution: Be sure the VIN selected in the drop down menu (1) is the same as the vehicle connected (2) before beginning programming.

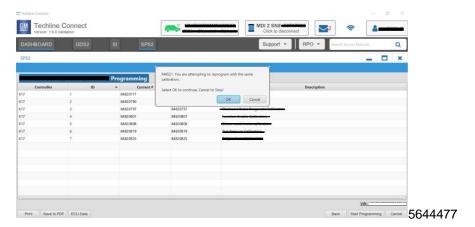
Important: If the vehicle VIN DOES NOT match, the message below will be shown.

Important: Techline Connect screens shown above.

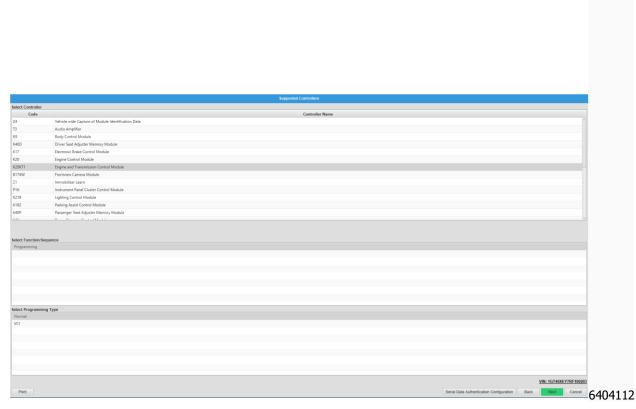
Reprogram the ECM and TCM Control Modules using a sequential programming event in SPS2.

- 2. Select K20K71 Engine and Transmission Control Module as shown on the Selected Controllers screen and proceed with programming. Follow all instructional pop-ups in SPS2.
 - 2.1 After reprogramming, perform the following steps in GDS2.
 - 2.2 Select: Module Diagnostics.
 - 2.3 Select: Engine Control Module.
 - 2.4 Select: Configuration/Reset Functions.

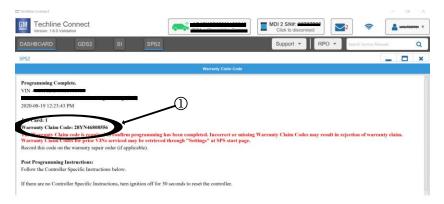
5644478

Note: The screenshot above is an example of module programming and may not be indicative of the specific module that is being programmed. Module selection and VIN information have been blacked out.
