# Service Update

## N232408731 Park Assist Not Enabled

**Release Date:** December 2023

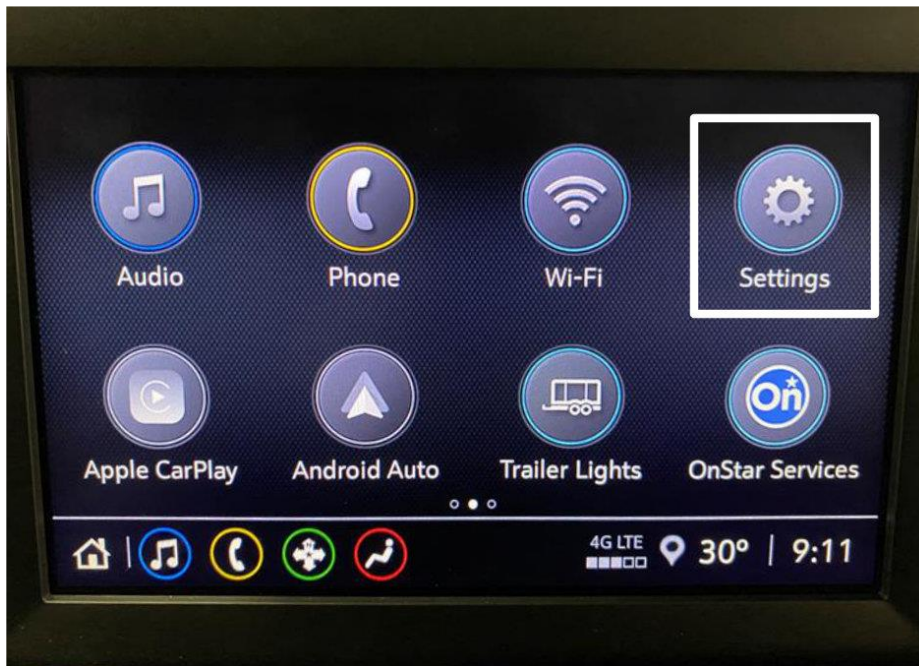
6493764

3. Touch the “Settings” icon on the Home Page of the infotainment display.

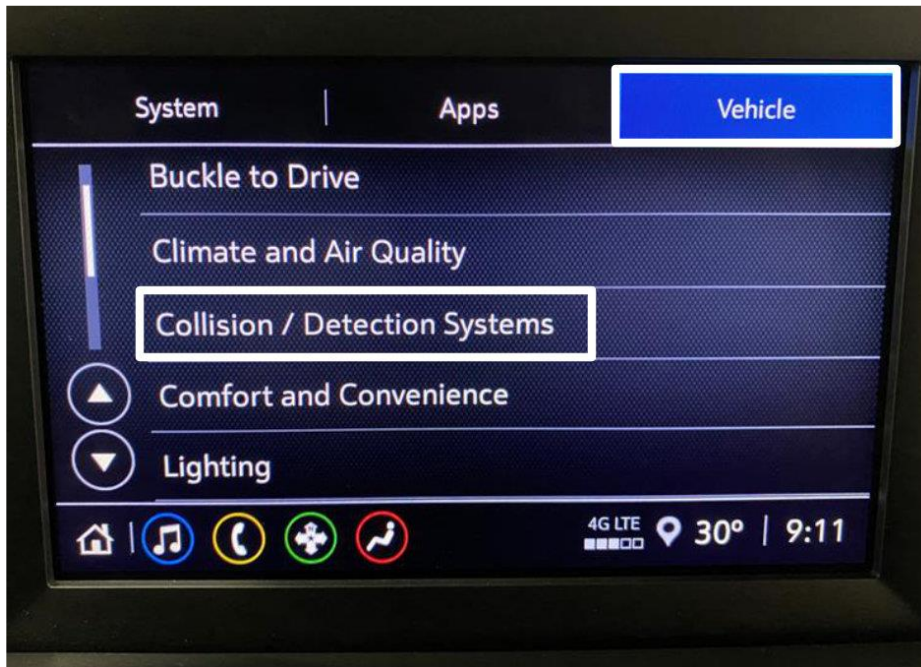
6493765

4. Touch Vehicle to display a list of available options. Select "Collision/Detection Systems."

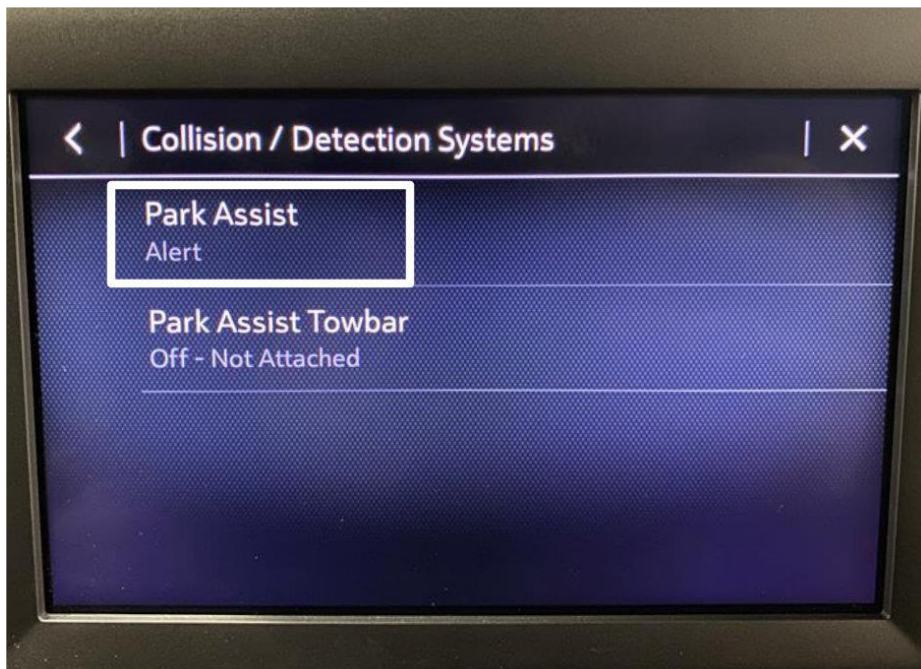
6493766

5. Touch to select "Park Assist" in the menu.

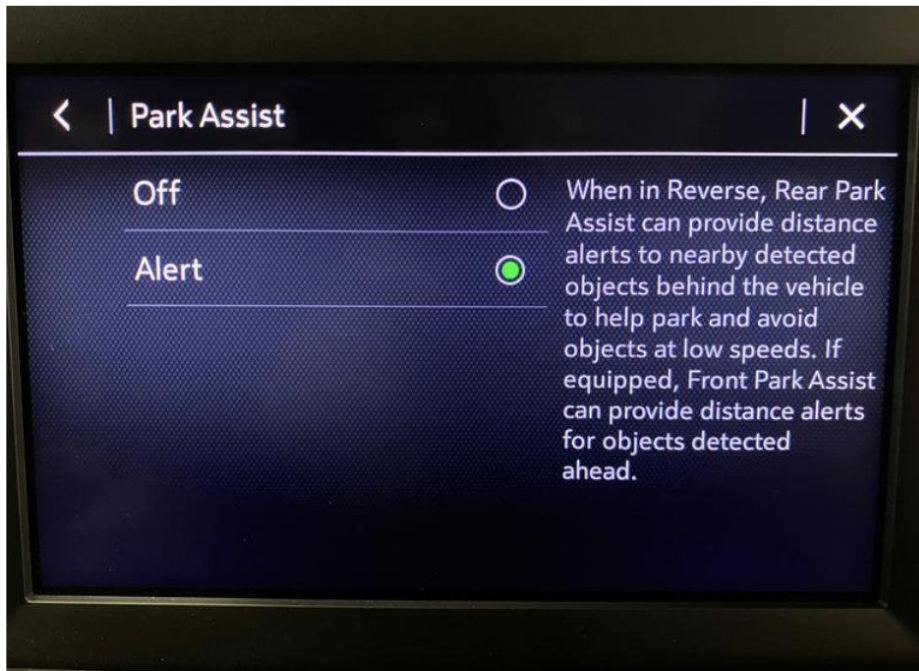
6493767

6. Touch to select either “Off” or “Alert” based on what the customer wants. After the selection has been made, close out of the menu.
