# Service Bulletin

Bulletin No.: 22-NA-150

**Subject: Malfunction Indicator Lamp (MIL) Illuminated, Service Emission System and/or DEF Level Low Message on Driver Information Center (DIC), DEF Level Sensor Reading Incorrectly, DEF Level Sensor Being Erratic, DEF Level Sensor Stuck**

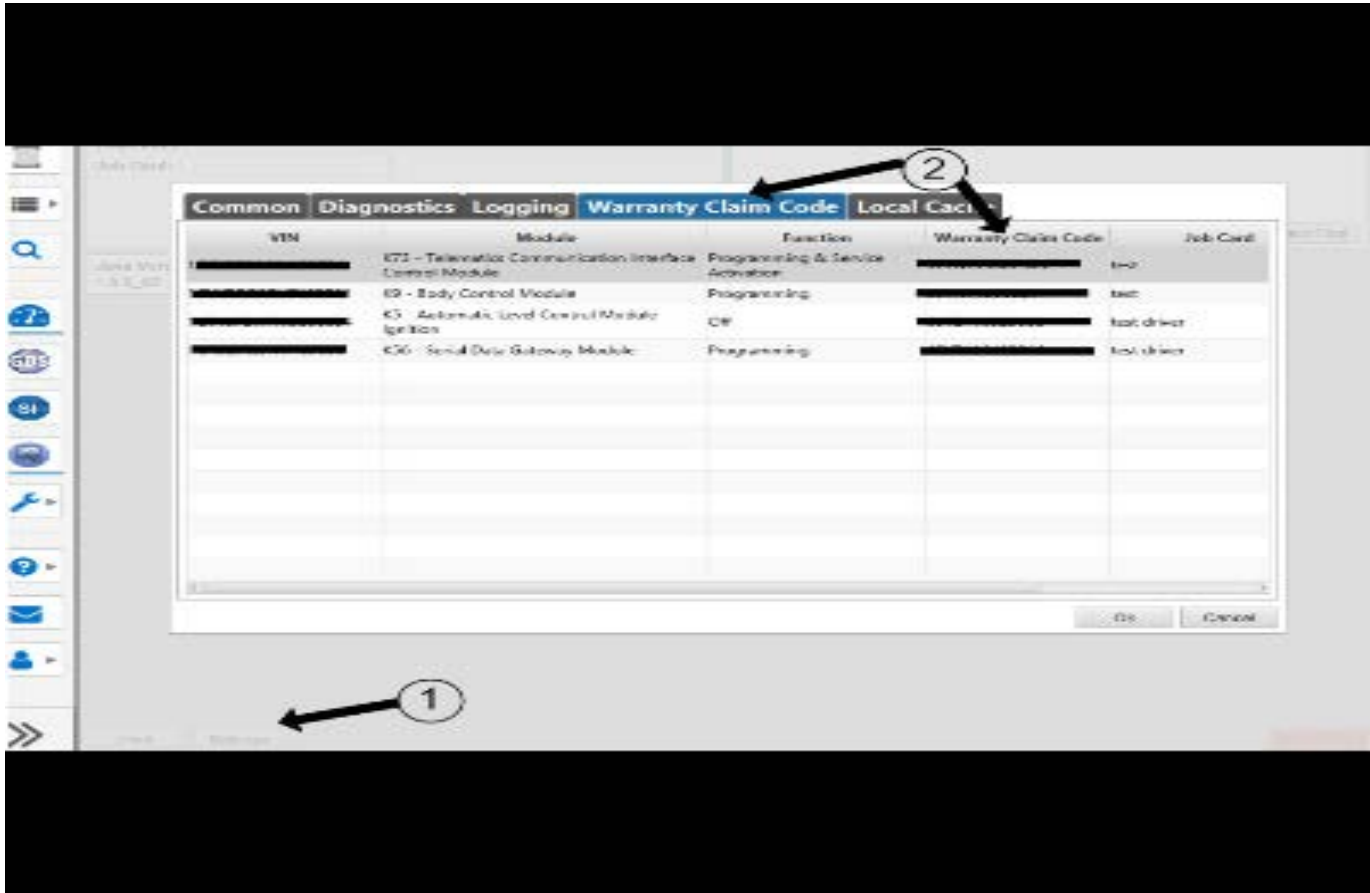
If the Warranty Claim Code was not recorded on the Job Card, the code can be retrieved in the SPS2 system as follows:

1. Open TLC on the computer used to program the vehicle.
2. Select and start SPS2.
3. Select Settings (1).
4. Select the Warranty Claim Code tab (2).

The VIN, Warranty Claim Code and Date/Time will be listed on a roster of recent programming events. If the code is retrievable, dealers should resubmit the transaction making sure to include the code in the SPS Warranty Claim Code field.
