Service Action

Code: 91FN

Subject	Software Update for High Voltage Battery Control Module - Version 3.2.1																									
Document History	<table border="1"> <thead> <tr> <th style="background-color: #c00000; color: white;">Date</th> <th style="background-color: #c00000; color: white;">Summary</th> </tr> </thead> <tbody> <tr> <td>01/19/2024</td> <td>Original publication</td> </tr> </tbody> </table>	Date	Summary	01/19/2024	Original publication																					
Date	Summary																									
01/19/2024	Original publication																									
Affected Vehicles	<table border="1"> <thead> <tr> <th style="background-color: #c00000; color: white;">Country</th> <th style="background-color: #c00000; color: white;">Beginning Model Year</th> <th style="background-color: #c00000; color: white;">Ending Model Year</th> <th style="background-color: #c00000; color: white;">Vehicle</th> <th style="background-color: #c00000; color: white;">Vehicle Count</th> </tr> </thead> <tbody> <tr> <td>USA</td> <td>2022</td> <td>2023</td> <td>Q4 E-TRON SPORTBACK</td> <td>914</td> </tr> <tr> <td>USA</td> <td>2022</td> <td>2023</td> <td>Q4 E-TRON SUV</td> <td>4,321</td> </tr> <tr> <td>C

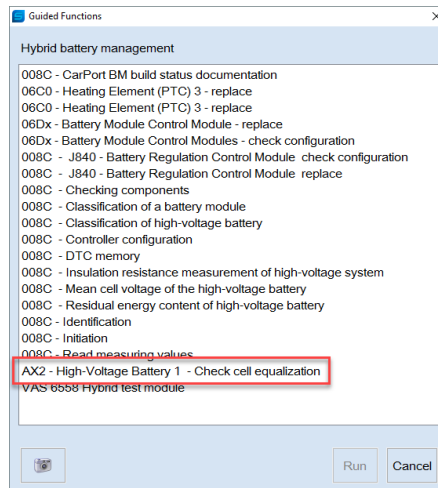
Step 1 - Perform “Check Cell Equalization” Test Plan

- Use operating mode, **DIAGNOSIS**.
- Select the Guided Functions test plan list for address 008C.
- Perform test plan, “AX2 – High-Voltage Battery 1 – Check cell equalization” and follow the on-screen prompts.
- If the test plan results indicate the HV battery is OK:
 - Proceed to Step 2
- If the test plan results indicate a cell module requires replacement:
 - **The cell module(s) must be replaced before performing any additional software updates.**
 - Proceed to Section C.
 - After the cell module(s) have been replaced, proceed to Step 2 of the SVM instructions to begin the software update process.

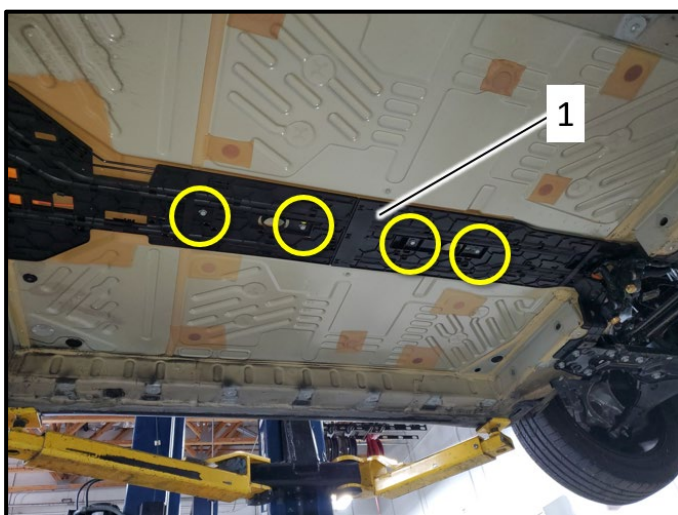
Remove high-voltage battery:

- See ELSA Repair Manual: *Repair Manual > Motor > Electric Drive Motor 0EH, 0EJ > 93 Electric drive > High-Voltage Battery Unit > High-Voltage Battery 1 AX2, Removing and Installing, 82 kWh*
- Note the following when removing the high-voltage battery:
 - Mark the position of the scissor lift table on the floor to aid in re-positioning the table during reinstallation.
 - Pay close attention to all wiring harnesses when lowering the battery.
 - Pay close attention to coolant hoses when lowering the battery.

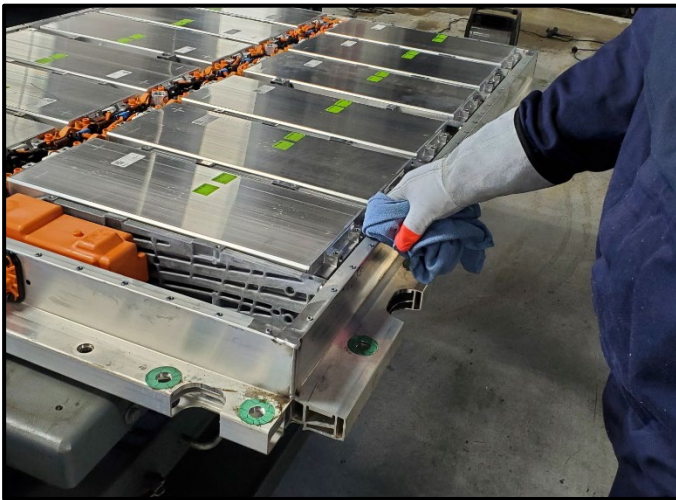
Perform insulation measurement:

- Perform insulation measurement according to ELSA Repair Manual: *Repair Manual > Motor > Electric Drive Motor 0EH, 0EJ > 93 Electric drive > High-Voltage Battery Unit > Voltage and Insulation Measurement, 82 kWh*
- Perform the measurement in conjunction with ODIS test plan, "VAS 6558 Hybrid test module."

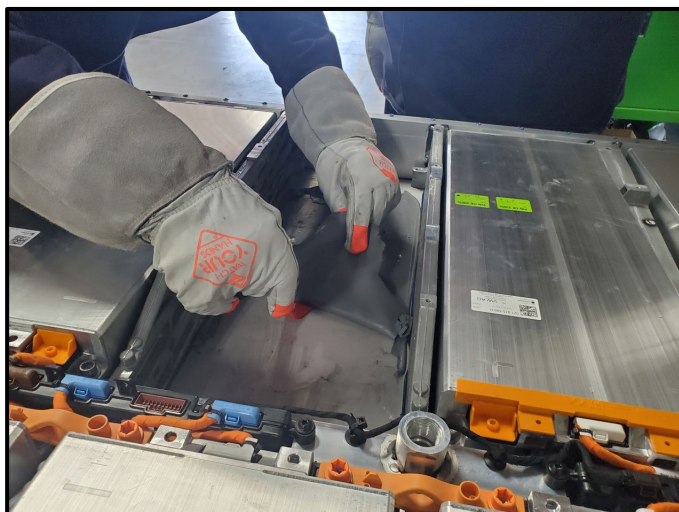
Remove the cell module:

- See ELSA Repair manual: *Repair Manual > Motor > Electric Drive Motor 0EH, 0EJ > 93 Electric drive > High-Voltage Battery Components > Battery Module, Removing*
- Ensure the shock protection is installed on ALL open high-voltage connections.

Pay close attention to the wiring harnesses, so they are not damaged or pinched during removal.

The cell module can be freed from the adhesive bond from either end of the cell module.

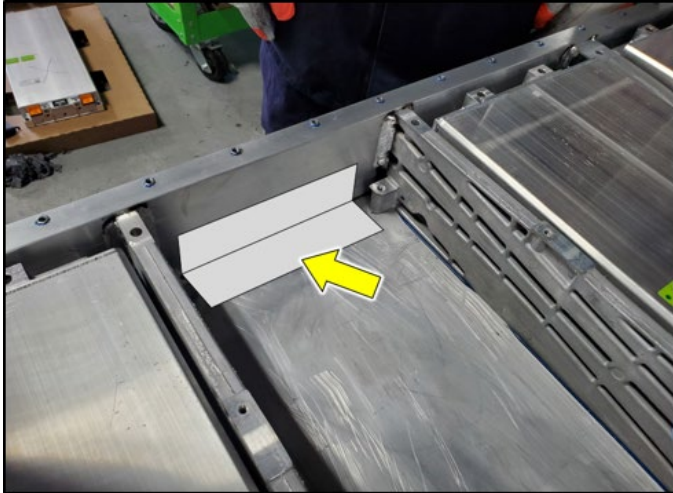
Installing new cell module(s):

- Reference ELSA Repair manual: *Repair Manual > Motor > Electric Drive Motor 0EH, 0EJ > 93 Electric drive > High-Voltage Battery Components > Battery Module, installing*
- Note the following when installing the new cell module(s):
- Peel off the protective backing and apply the separating foil <arrow> as needed along the outer frame edges, in the area where the cell module is mounted.

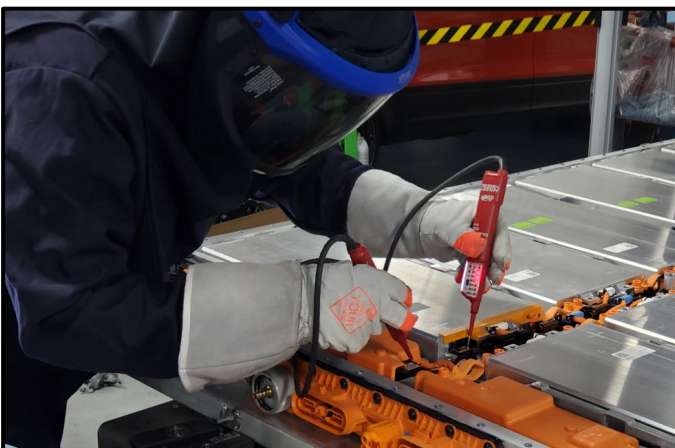
- Torque bolts <3> for the high-voltage connection <4> to 8 Nm.

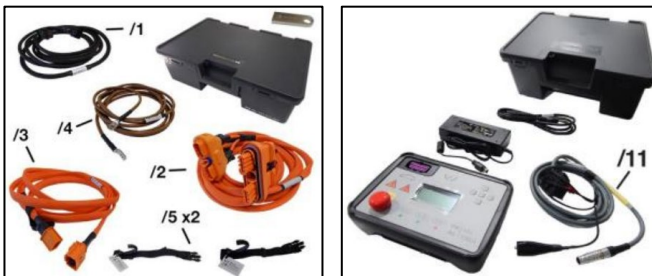
Reconnect high-voltage circuit:

- Reconnection is the reverse order of disconnecting.
- Reference ELSA Repair Manual: *Repair Manual > Motor > Electric Drive Motor 0EH, 0EJ > 93 Electric drive > High-Voltage Battery Unit > Circuit, Disconnecting, 82 kWh*

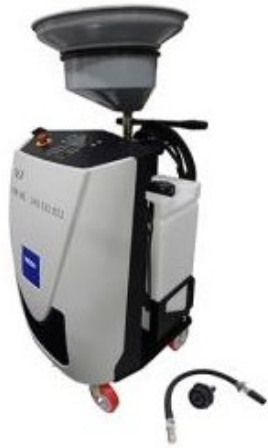
Fill cooling system

- Top off coolant.
- See ELSA Repair Manual: *Repair manual > Motor > Electric Drive Motor 0EH, 0EJ > 19 Cooling System > Cooling System/Coolant > Cooling System, Filling*
- Perform these steps in conjunction with Guided Function test plan, “0001 – Filling cooling circuit.”
