Service Action

Code: 97HB

Subject ID.4 Software Update

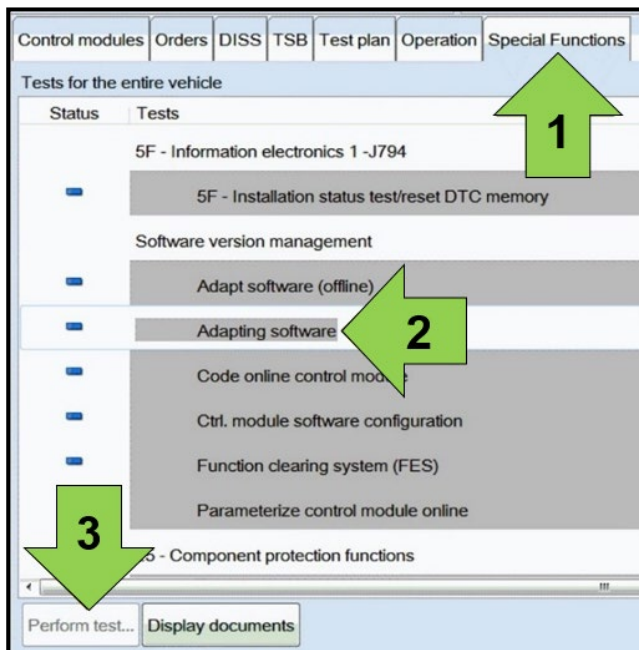
- Once the GFF scan is complete, select “Special functions” <arrow 1>, then “Adapting software” <arrow 2>, then select “Perform test” <arrow 3>.

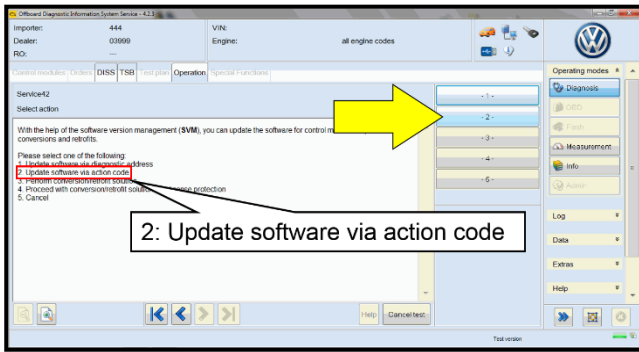
- Select the correct option to “Update software via action code”.

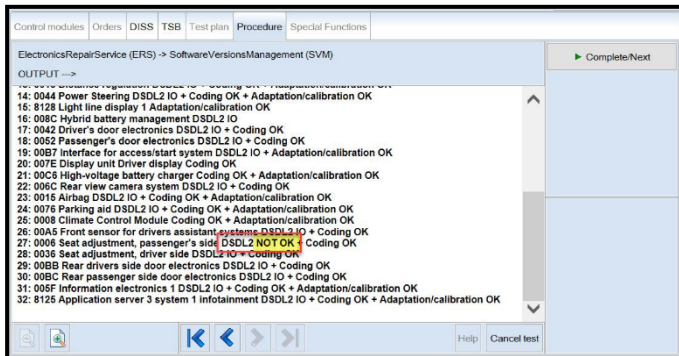
- Pay attention to the status report of the control module updates.
- Any module stating NOT OK will have to be updated again.
- Selecting “Complete/Next” will begin another attempt to update the control module.
- It may take more than one attempt to update every control module.

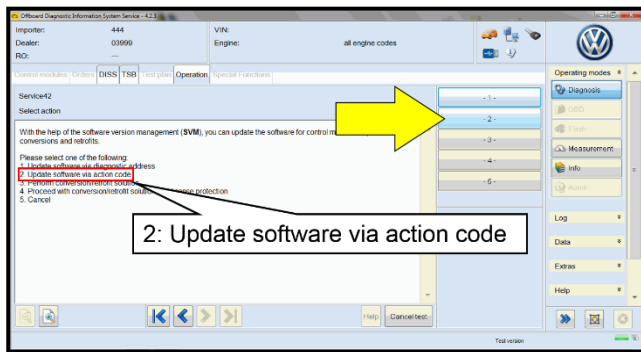
- Select the correct option to “Update software via action code”.

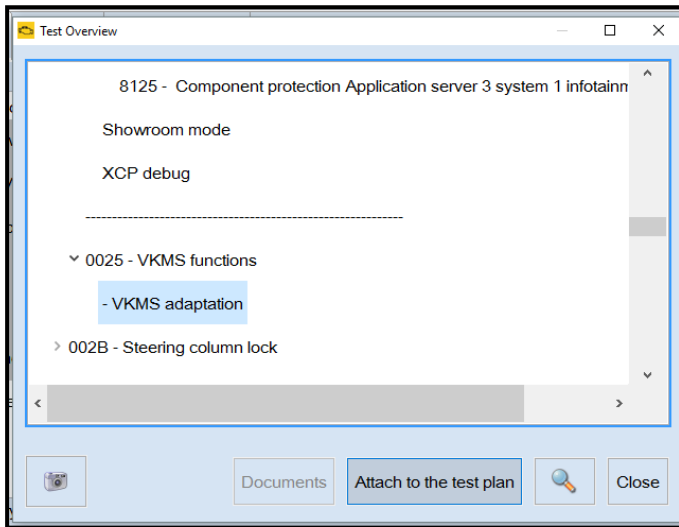
- Perform 0025 Immobilizer “VKMS Adaptation” test plan.

After selecting “Self Test,” use the search function and enter “VKMS” to aid in finding the test plan.

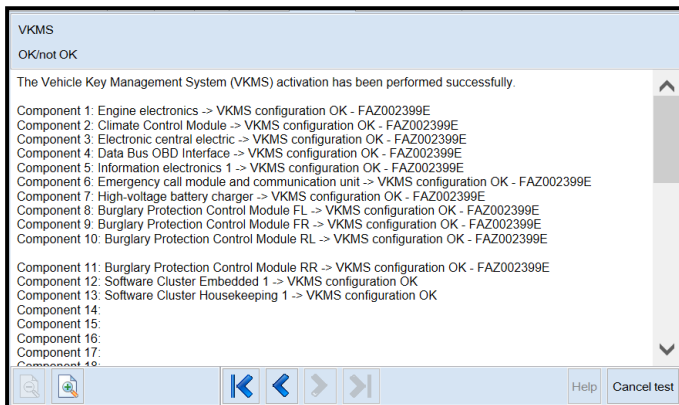
- Ensure each component shows the VKMS configuration is OK.
- If any component does not complete the VKMS adaptation, repeat the test plan.

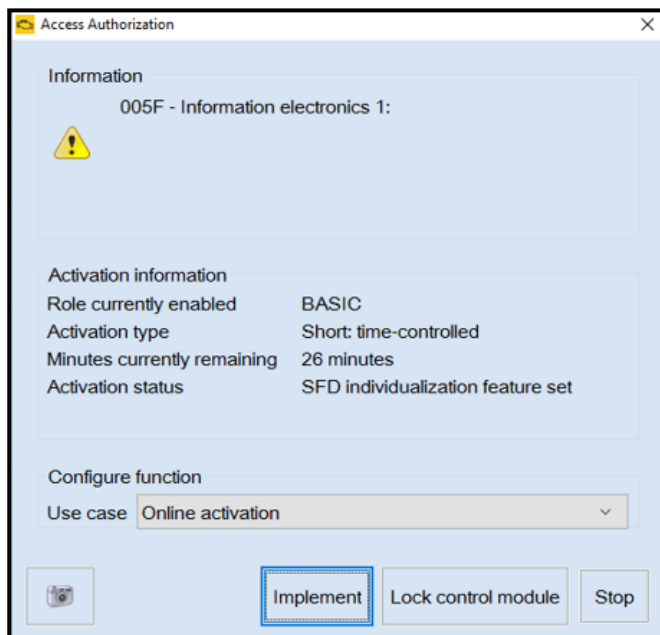
- From the OBD menu, go to: OBD > DA 005F > *Access authorization*.
- Select “Implement” and then enter ODIS login/password if prompted (to unlock SFD).
- Select “stop” to close the window.

- Using Operating mode “OBD”, check 005F adaptation channels \$0548 and \$0549 for the current service interval settings (OBD > DA 005F > *Adaptations*).
- If the values are the same as the previously recorded values, no change is necessary.
- If the values have changed, enter the correct values as needed.

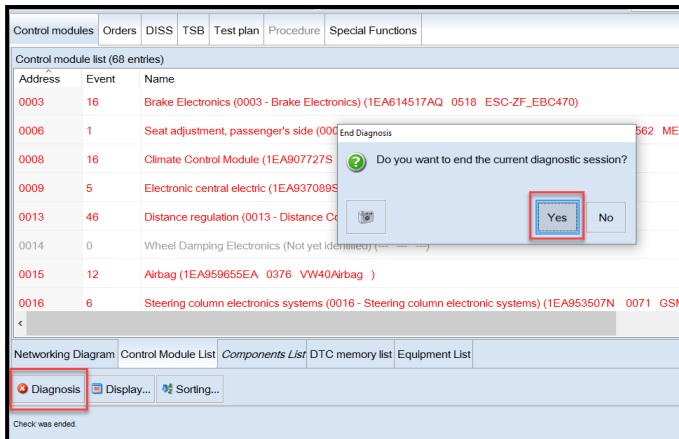
- Exit Diagnosis and select “Yes” to end the diagnostic session.

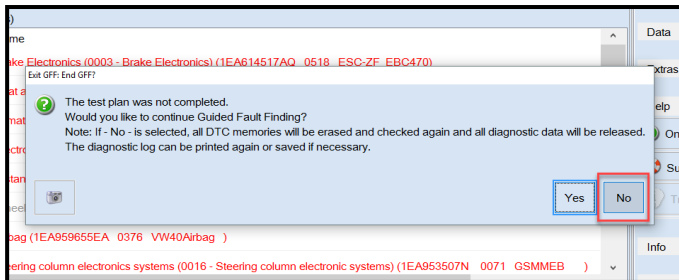
- When prompted to continue Guided Fault Finding, select “NO”.
- GFF will be exited and faults will be erased.

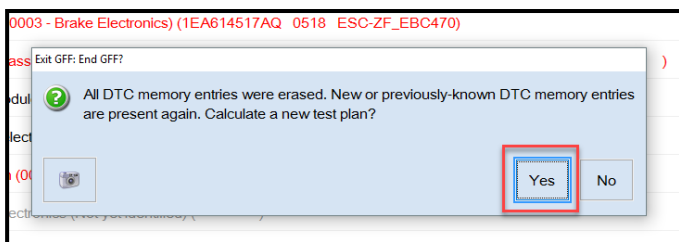
- Static faults created by the flash process will remain.
- When prompted, select “YES” to populate new test plans.

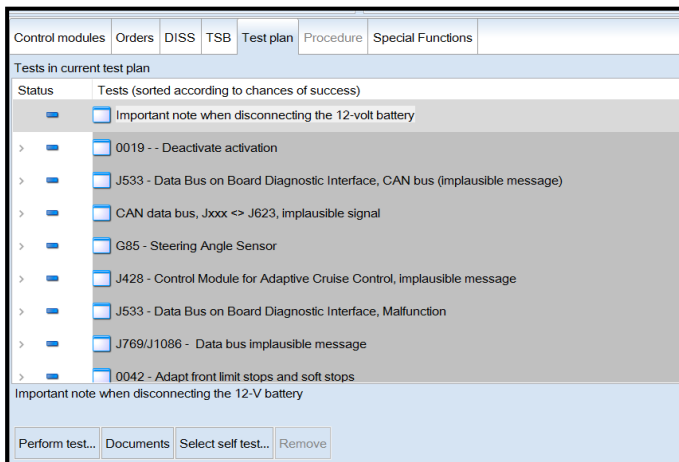
- Work through all test plans for faults created by the flash process.
- Reference any applicable TSBs that address “ghost” faults.
- Pay close attention to all steps outlined in the test plans and follow them exactly as described.
- Exit GFF and send diagnostic protocol online.
