# Service Bulletin

Bulletin No.: 24-NA-016

**Subject: Malfunction Indicator Lamp Illuminated in the Driver Information Center and DTC C053E**

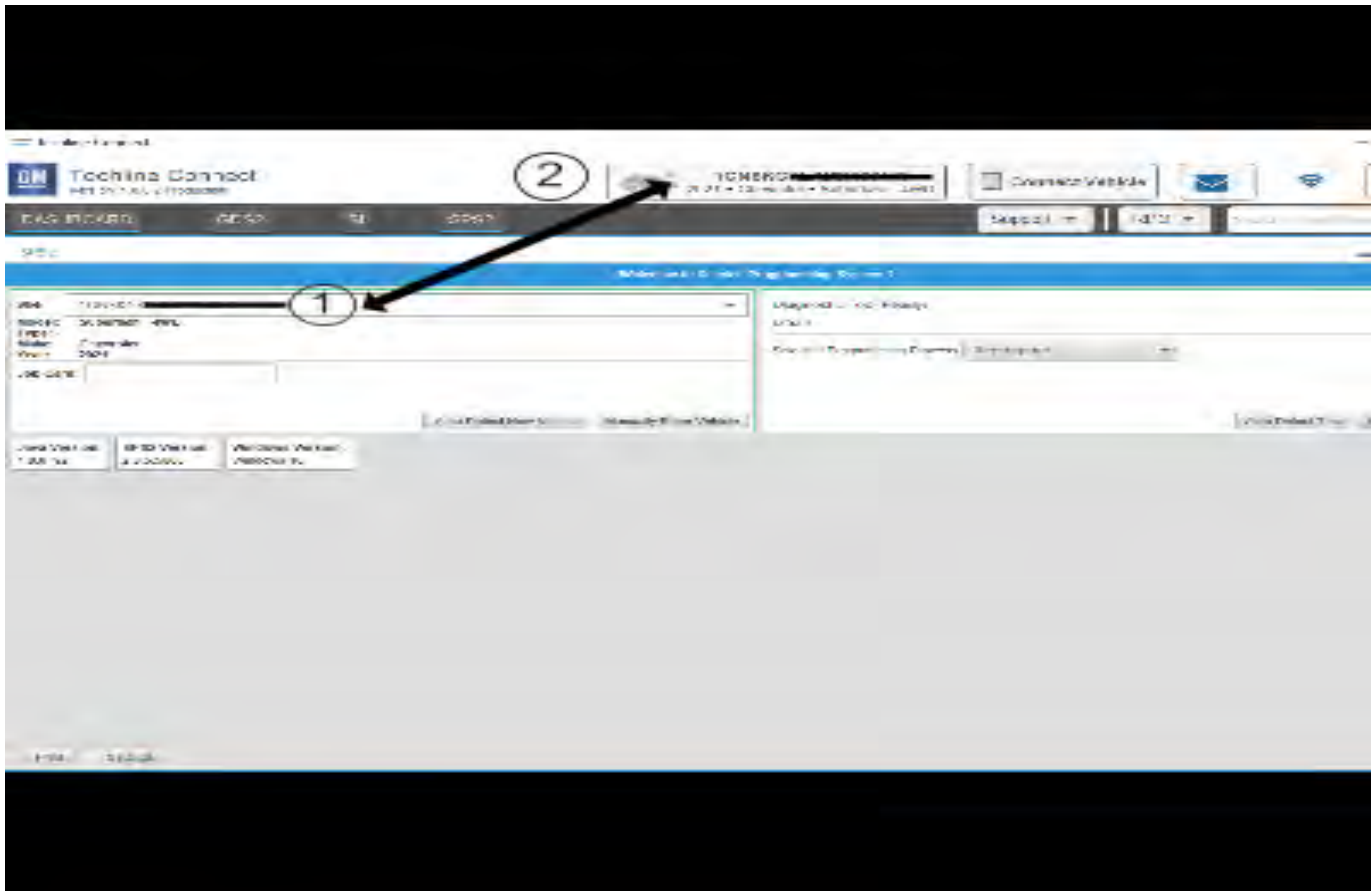
**Caution:** Be sure the VIN selected in the drop down menu (1) is the same as the vehicle connected (2) before beginning programming.

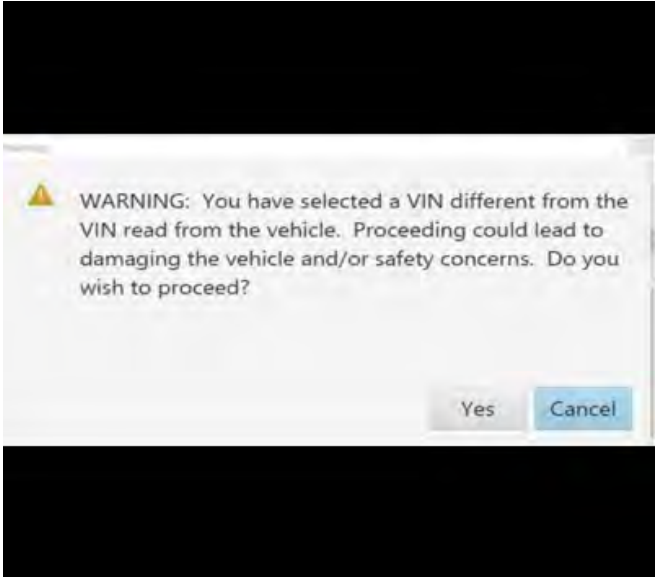
5877000

**Important:** If the vehicle VIN DOES NOT match, the message below will be shown

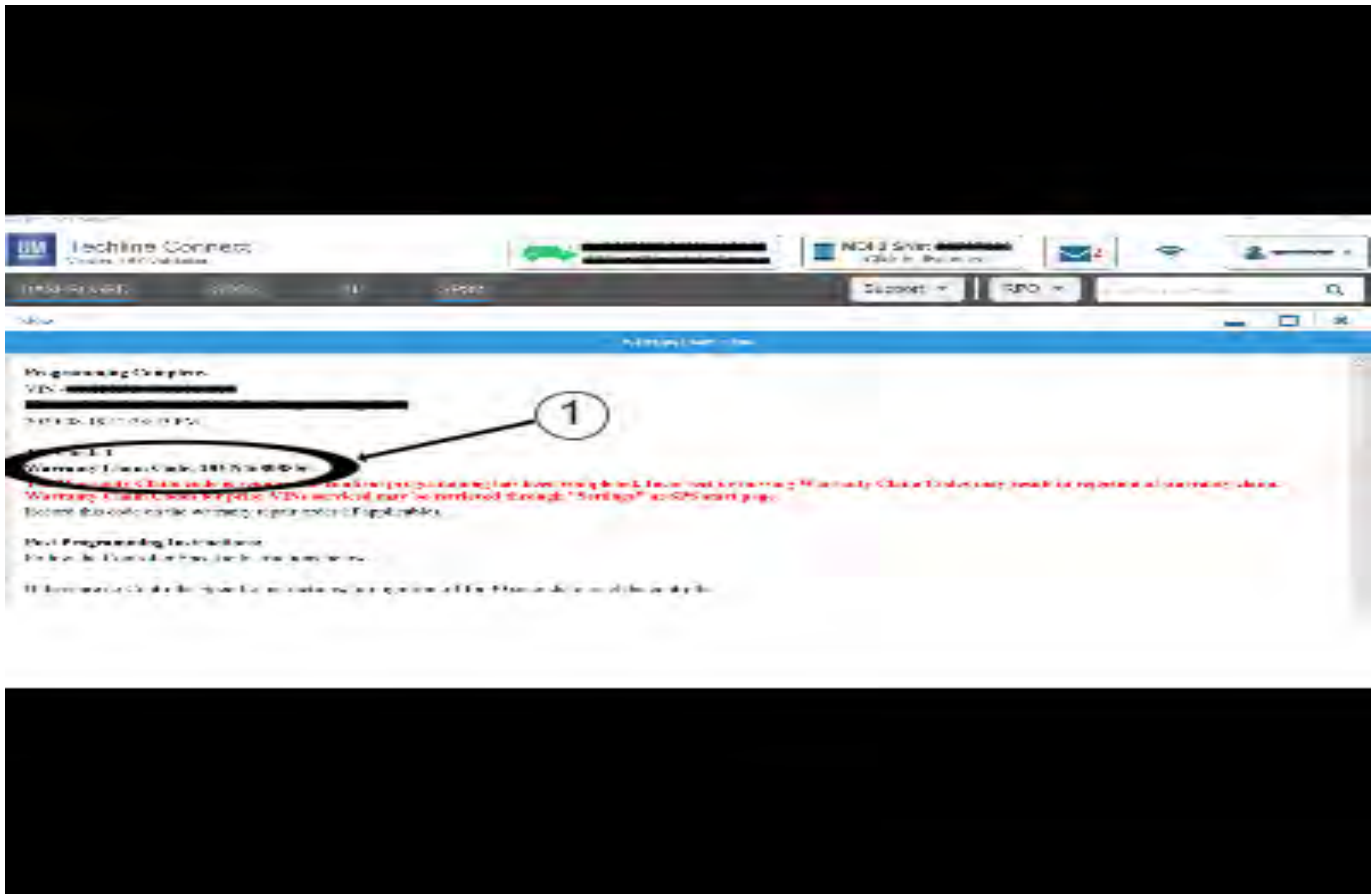
5644478

**Note:** The screenshot above is an example of module programming and may not be indicative of the specific module that is being programmed. Module selection and VIN information have been blacked out.

**Important:** To avoid warranty transaction rejections, you **MUST** record the warranty claim code provided on the Warranty Claim Code (WCC) screen shown above on the job card. Refer to callout 1 above for the location of the WCC on the screen.
