**TECHNICAL INSTRUCTIONS**  
**FOR**  
**23TC08**  
**SKID CONTROL ECU REPROGRAM**  
**CERTAIN**  
**2021 - 2023 MODEL YEAR VENZA HYBRID**

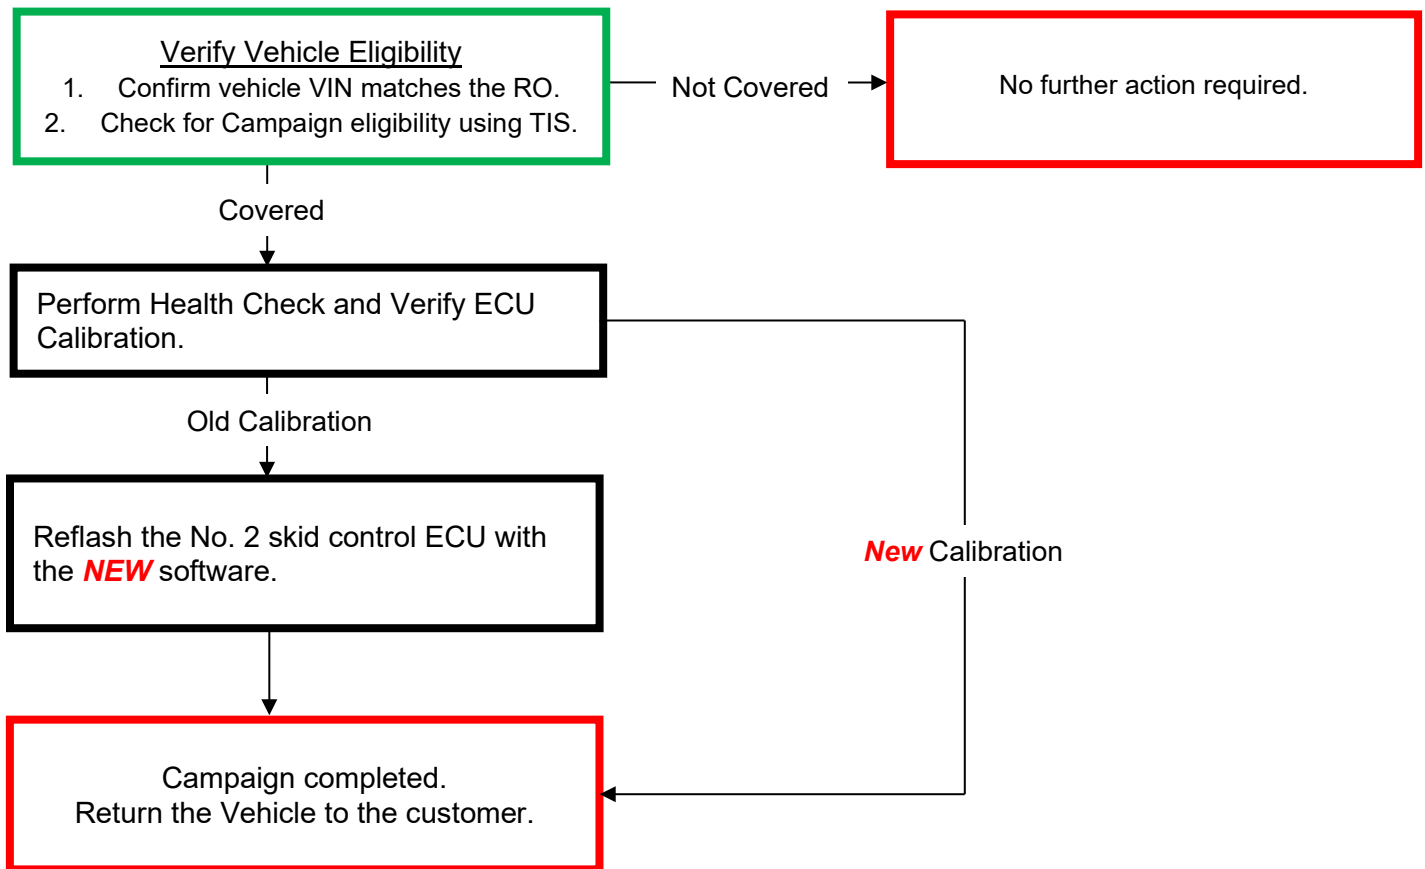
## I. OPERATION FLOW CHART

The flow chart is for reference only. **DO NOT** use it in place of the full technical instructions. Follow **ALL** steps as outlined in the full technical instructions to confirm the campaign is completed correctly.

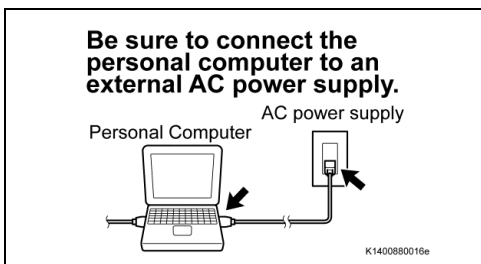
### 1. STABILIZE THE POWER TO THE PERSONAL COMPUTER SIDE

- Be sure to connect the personal computer to an external AC power supply.

The ECU could be damaged if the battery voltage of the personal computer drops while reprogramming.

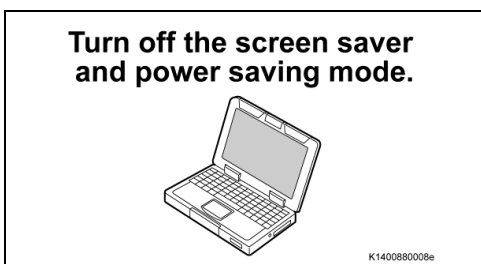
- Turn off the screen saver and power saving mode of the personal computer so that the power to the hard disk is kept supplied.

If the screen saver or power saving mode launches while reprogramming, the communication may be disconnected, resulting in damage to the ECU.

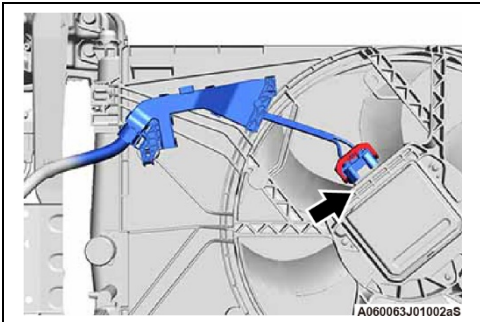
### 2. STOP THE OPERATION OF THE COOLING FAN

- a) Disconnect the connector from the cooling fan on the radiator fan shroud.
- b) Cover the disconnected connector with a tape, etc. to prevent foreign material or water, etc. from adhering.

**If the cooling fan runs during the Calibration update procedure, the battery voltage will be inconsistent and could cause damage to the control module(s).**

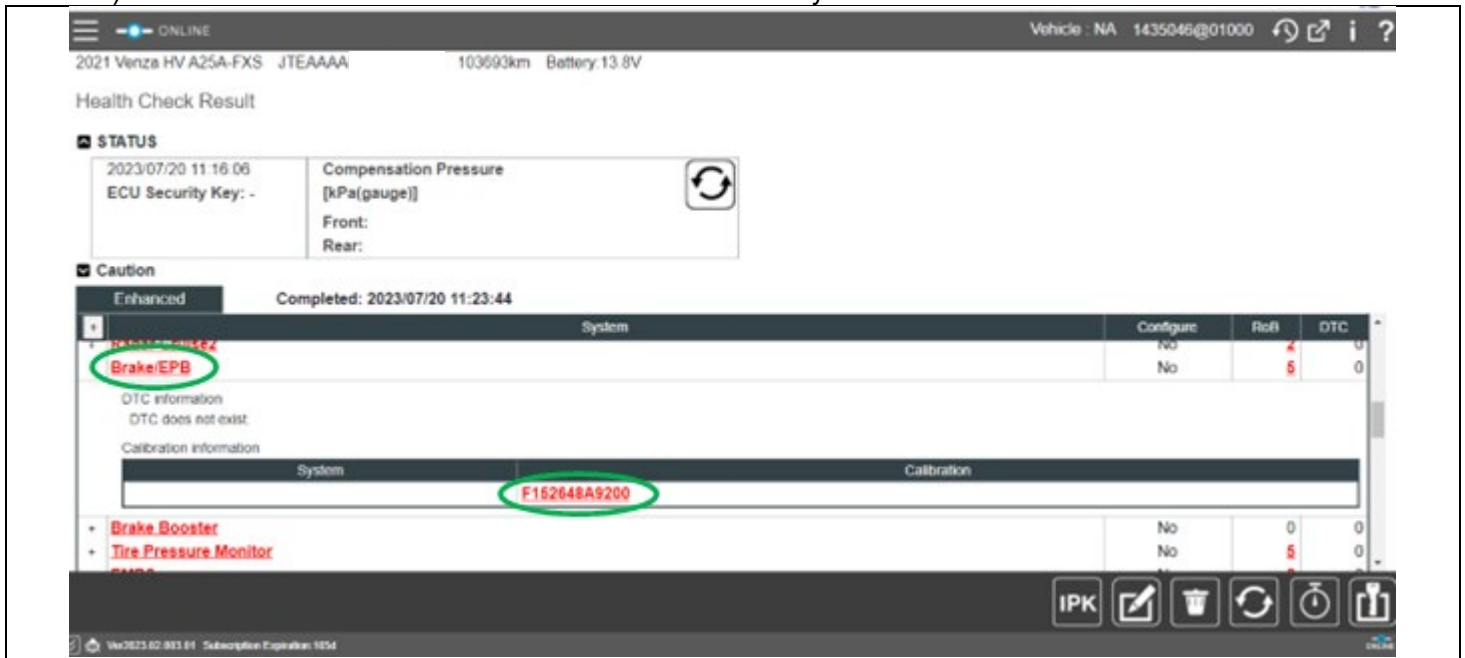
- a) Confirm the current calibration ID in the Brake/EPB System.

The calibration IDs to re-flash in this campaign are shown in the table below.

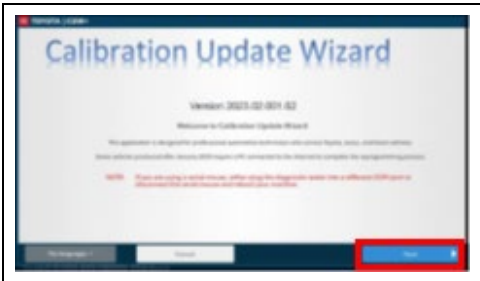
c) Click "Next" to start the calibration update process.

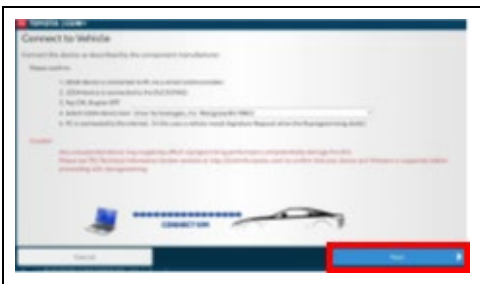
d) Confirm the following:  
 - The PC is connected to VIM.  
 - VIM is connected to the DLC3 connector.  
 - Ignition is ON and the engine is OFF.  
 - Select the correct device tool.  
 e) Then, click "Next".

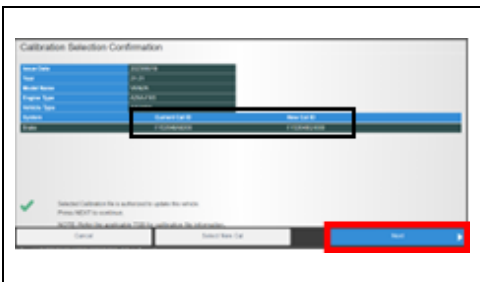
f) Verify correct current and **NEW** calibration information, then click "Next".

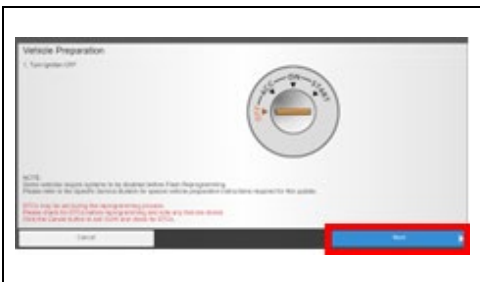
g) Turn the ignition OFF, then click "Next".

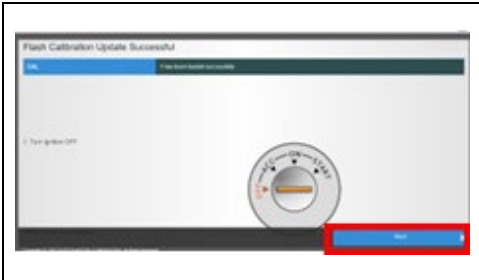
q) Turn the ignition **OFF** for a minimum of 10 seconds, then click "Next".

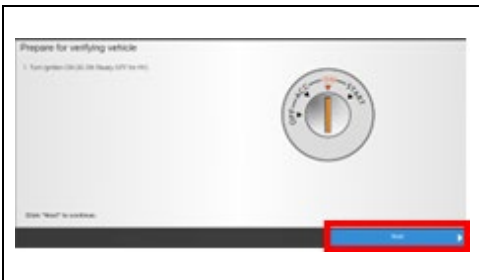
r) Turn the ignition to the **ON** position, then click "Next".
