March 2024
SF673 A-B

Subject: Common Telematics Platform (CTP) Installation and Initialization

Models Affected: Specific model years 2018-2023 Freightliner Cascadia; and Western Star 49X vehicles, manufactured March 16, 2017, through February 2, 2022.

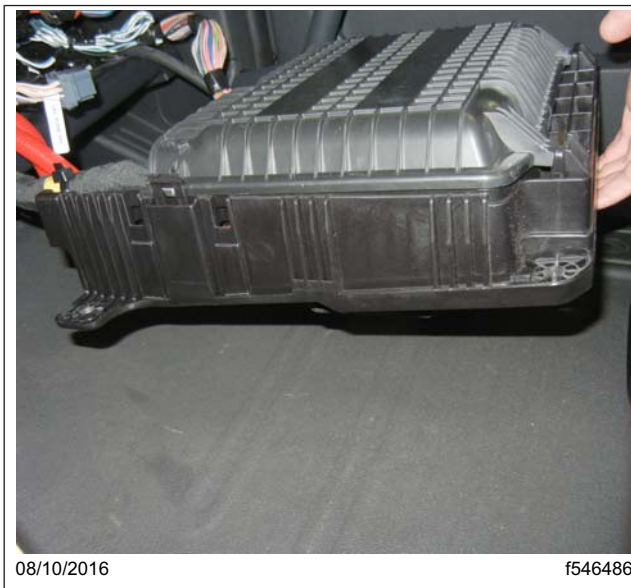
Fig. 1, Lowering the VPDM to the Cab Floor

IMPORTANT: The VPDM is positioned on the mounting tabs to assist with retaining the VPDM in position while mounting fasteners are removed. Care should be taken so the VPDM does not fall to the floor after all four mounting fasteners have been removed.

4. Remove the four VPDM mounting fasteners, then gently lower the VPDM on to the cab floor. See [Fig. 1](#).

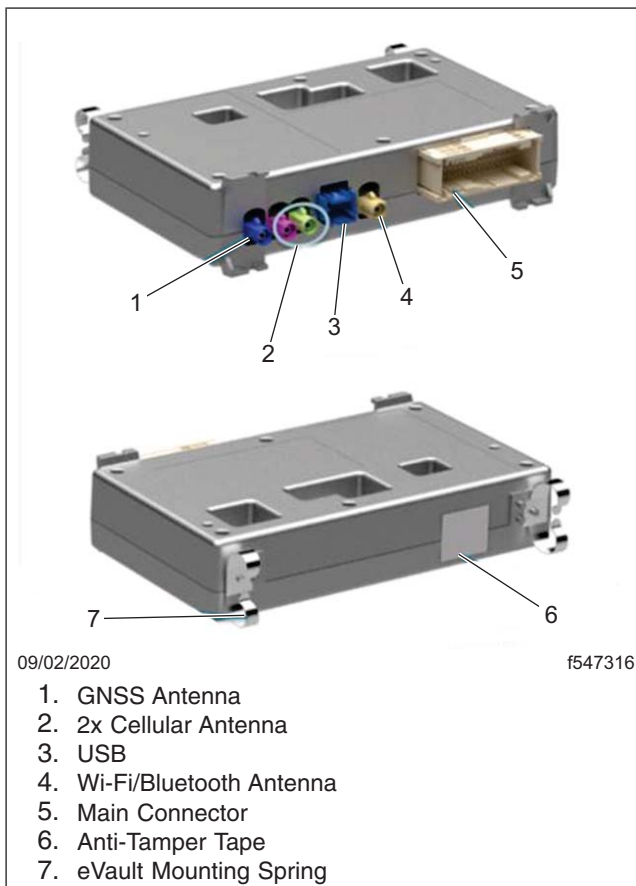
Fig. 2, CTP2 Connection Locations

11. Connect the CTP antennas to the matching color connector on the CTP. See [Fig. 2](#).
- Only for vehicles in SF673 A:*
- 11.1 Install the new 4G antenna. See [Fig. 3](#).

- 11.4 Before installation, clean the antenna mounting area using isopropyl alcohol.
- 11.5 Make sure the mounting surface is completely dry before using the included adhesive foam tape.
- 11.6 Route and secure the 4G antenna cable as needed.
- 11.7 Connect the 4G antenna cable to the CTP2, as shown in [Fig. 2](#). Each antenna connector must match the color on the CTP2.

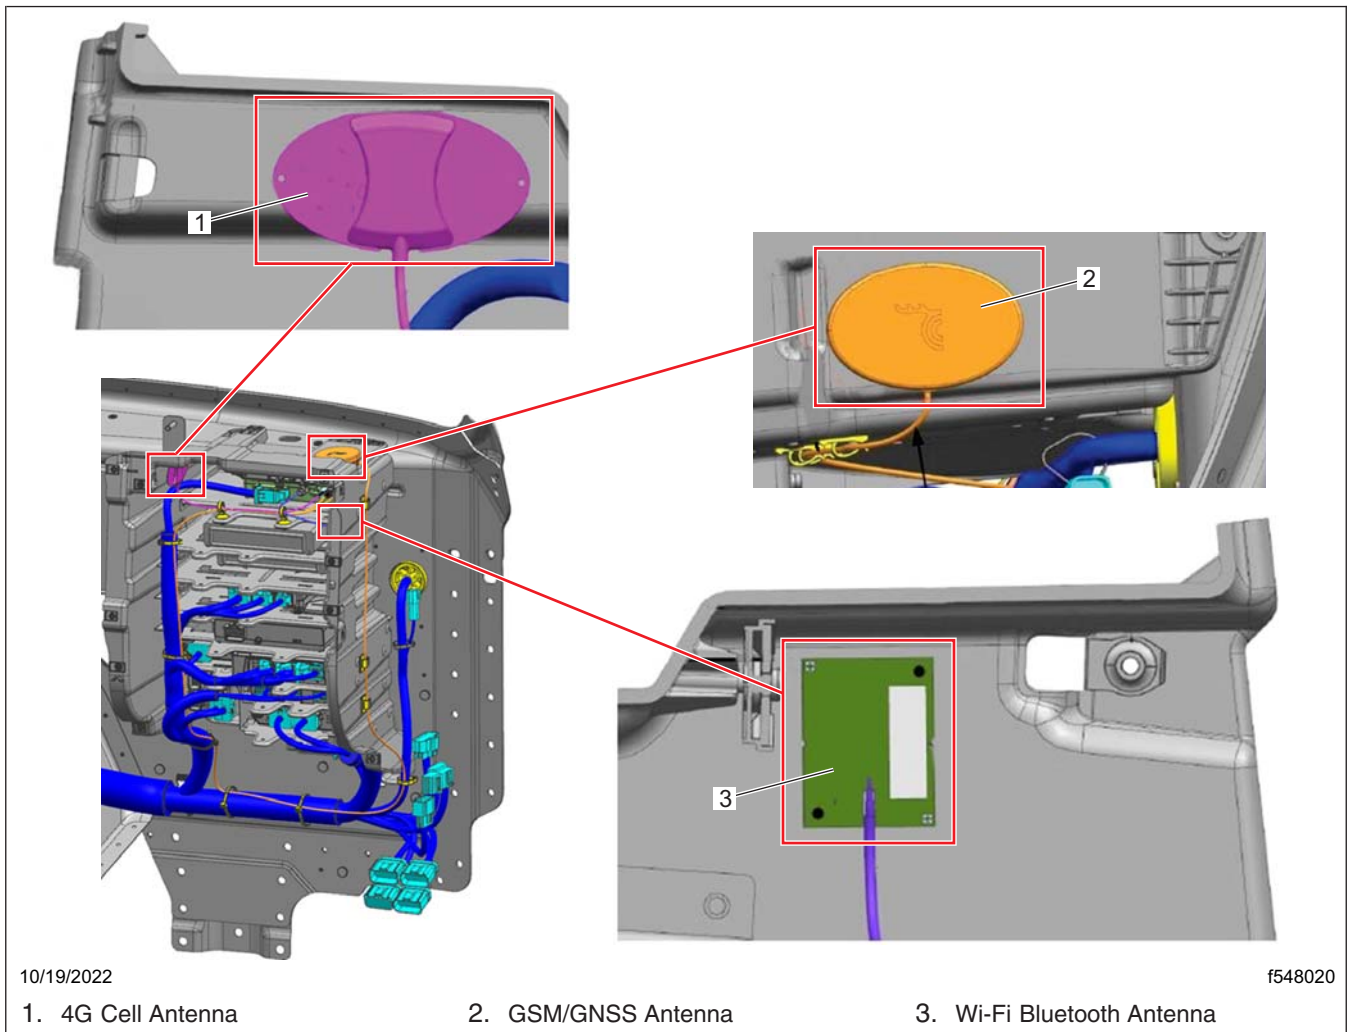
Fig. 4, Antenna Mounting

- 11.2 Route the 4G antenna cable, as shown in [Fig. 4](#).
 - 11.3 Mounting location of the 4G antenna is identified in [Fig. 4](#).

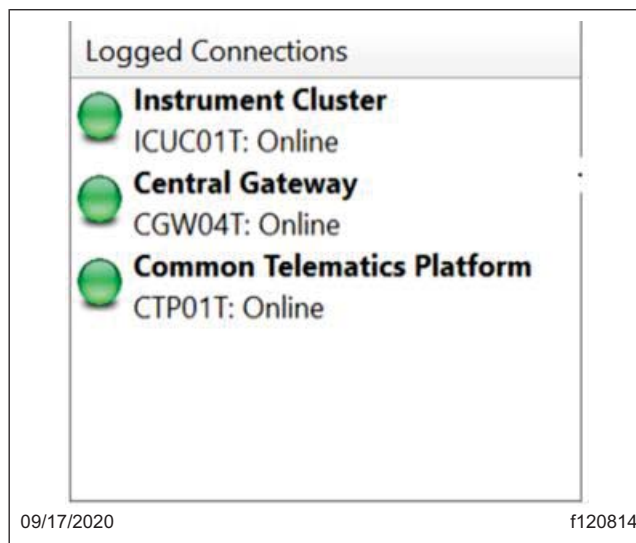
Fig. 5, DiagnosticLink Logged Connections Panel

22. Wait until all three controllers are fully connected and the connection indicators turn green. See [Fig. 5](#).

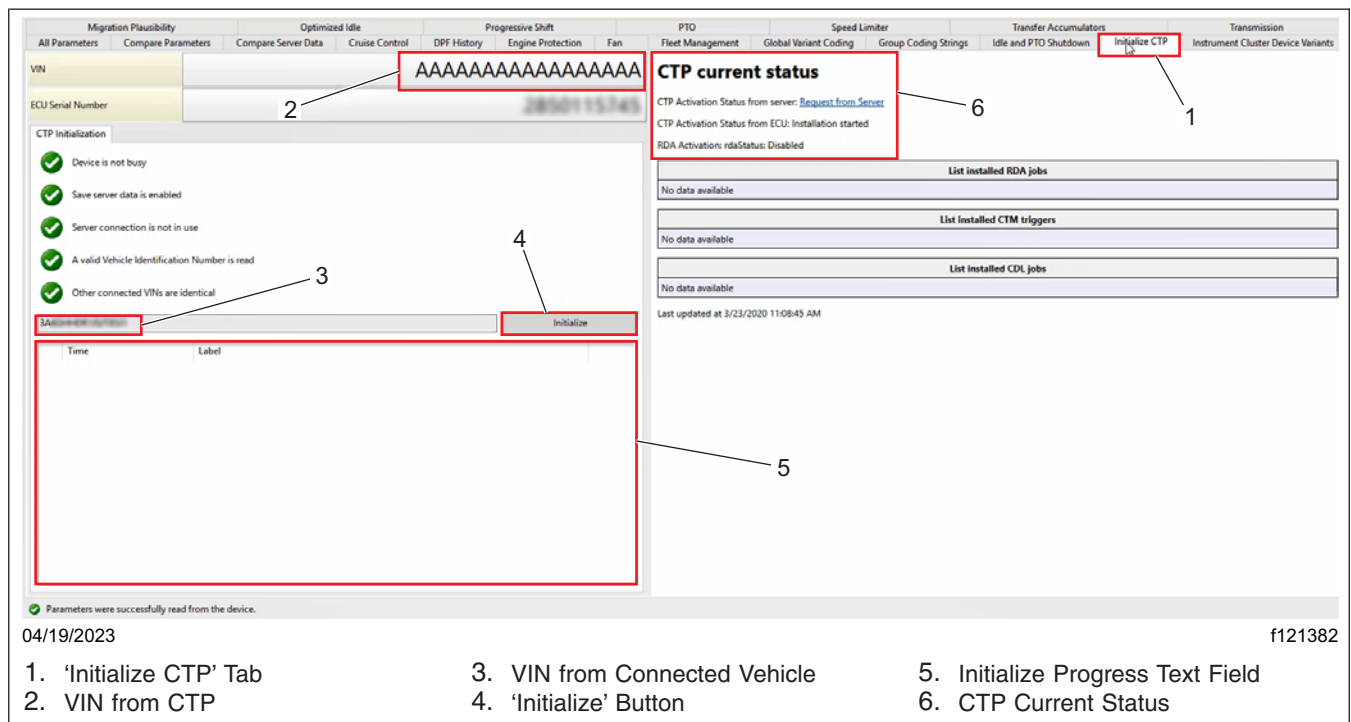
Fig. 6, CTP Initialization

24. Select the 'Initialize CTP' tab. Verify the vehicle identification number (VIN) from the new CTP2 displays default 'AAAAAAAAAAAAAAAA', or the VIN from the connected vehicle. See **Fig. 6**.

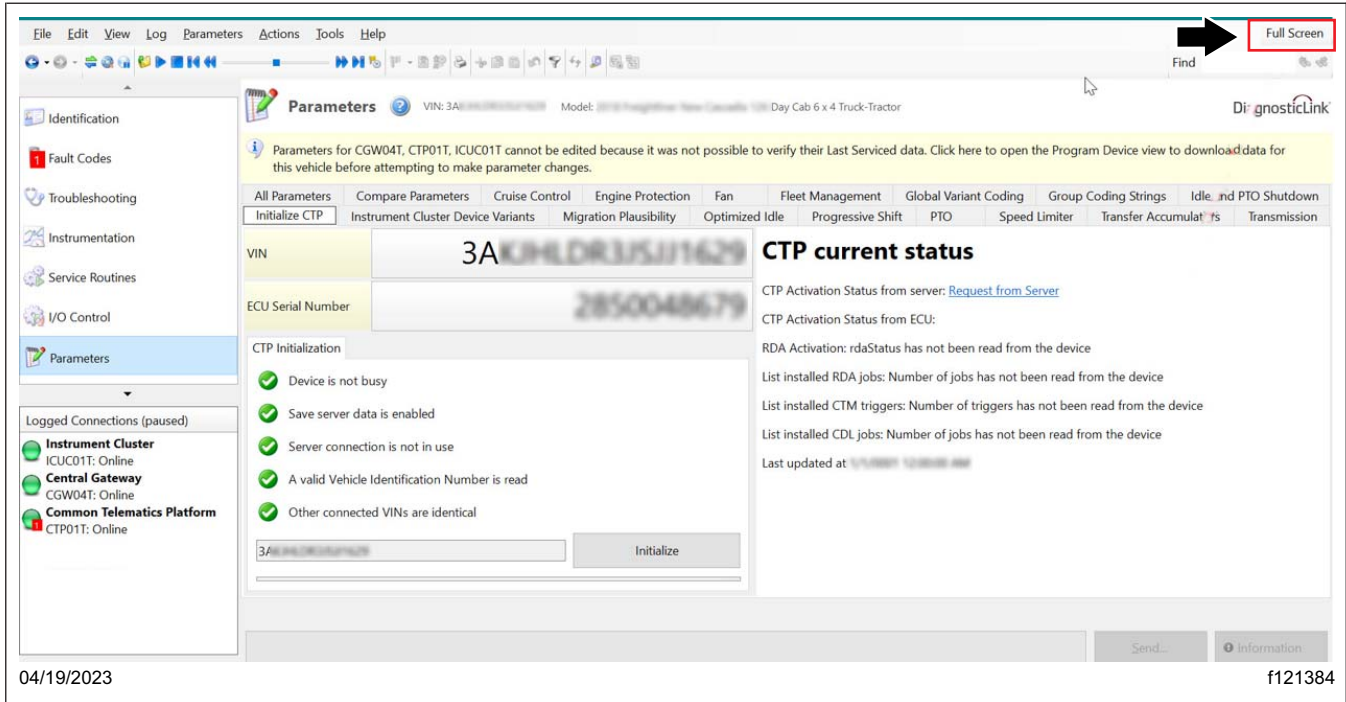
Fig. 7, Switching to Full Screen Display

30. With the 'Initialize CTP' tab still selected, select the 'Full Screen' button on the upper-right corner of the window. See Fig. 7.

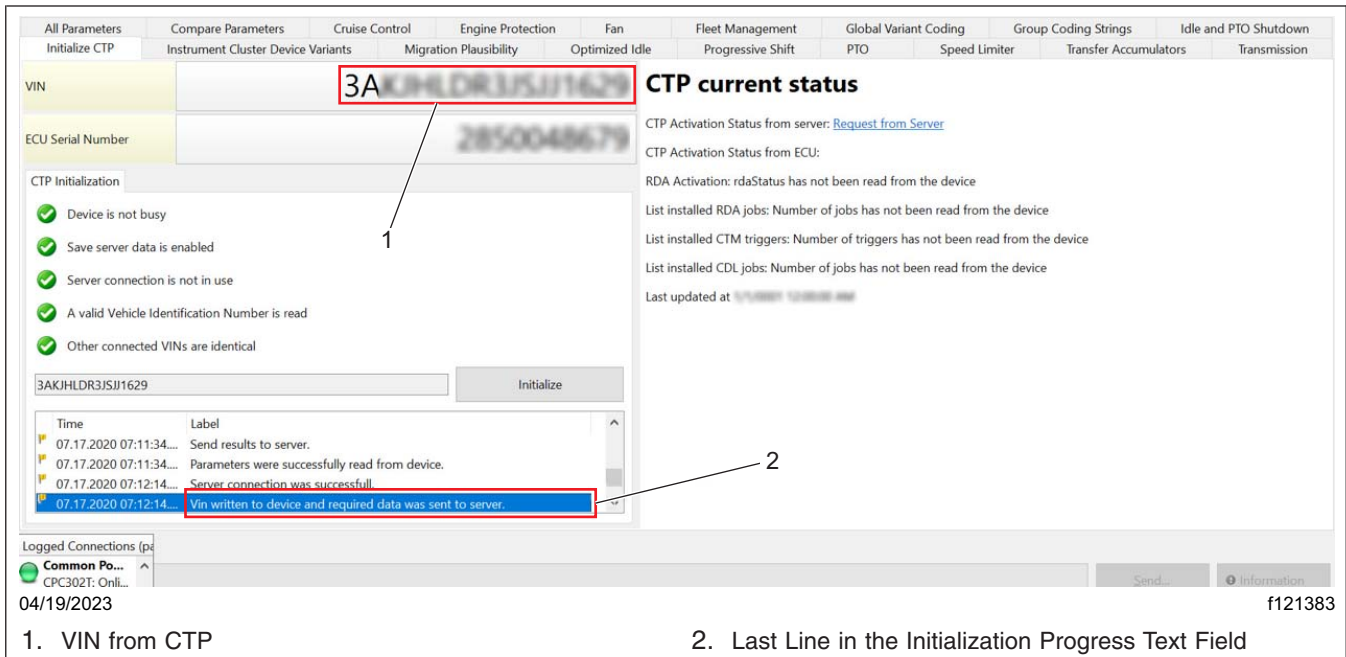
Fig. 8, Screenshot of DiagnosticLink

31. For validation that the CTP2 was properly initialized and for the dealership records, take a screenshot of the DiagnosticLink window while making sure the VIN and the last line in the initialization progress text field, as shown in Fig. 8, are visible. Keep the image as part of the work order.

1. VIN from CTP

2. Last Line in the Initialization Progress Text Field
