**Various Error Messages Regarding Driver Assistance Systems in the Instrument Cluster (03/23)**

Model Line: **Cayenne (9YA/9YB)**

Model Year: **As of 2019 up to 2020**

Concerns: **Control unit for driver assistance systems**

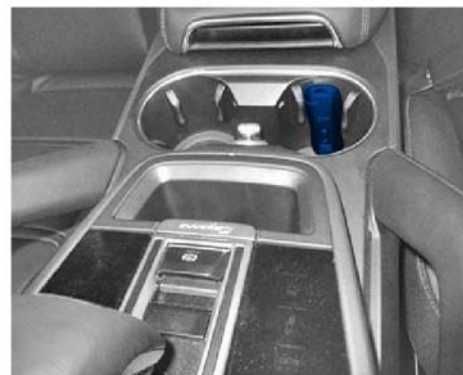
*Emergency start tray*

3 **Position** the driver key in the rear area of the left cupholder in the center console between the holding struts (emergency start tray) in order to ensure a permanent radio link between the vehicle and driver key ⇒ *Emergency start tray*.
