Technical Service Bulletin

SUBJECT:		No:	TSB-22-54-001REV
DISPLAY MESSAGE ERRORS OCCUR IN HEADS UP DISPLAY DUE TO COMMUNICATION ERROR BETWEEN ADAS-ECU AND FRONT RADAR-REVISED		DATE:	April 2024
		MODEL:	2022 Outlander
CIRCULATE TO:	<input type="checkbox"/> GENERAL MANAGER	<input checked="" type="checkbox"/> PARTS MANAGER	<input type="checkbox"/> TECHNICIAN
<input checked="" type="checkbox"/> SERVICE ADVISOR	<input checked="" type="checkbox"/> SERVICE MANAGER	<input checked="" type="checkbox"/> WARRANTY PROCESSOR	<input checked="" type="checkbox"/> SALES MANAGER

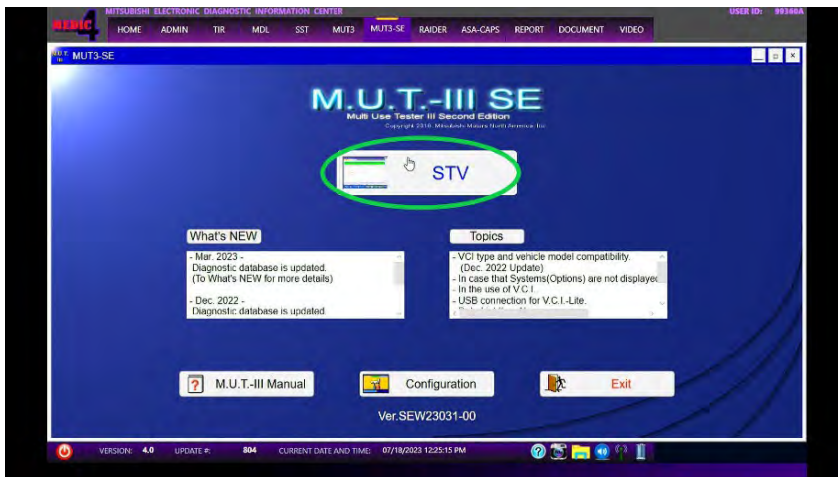
- a. Press the MUT-III SE STV button.

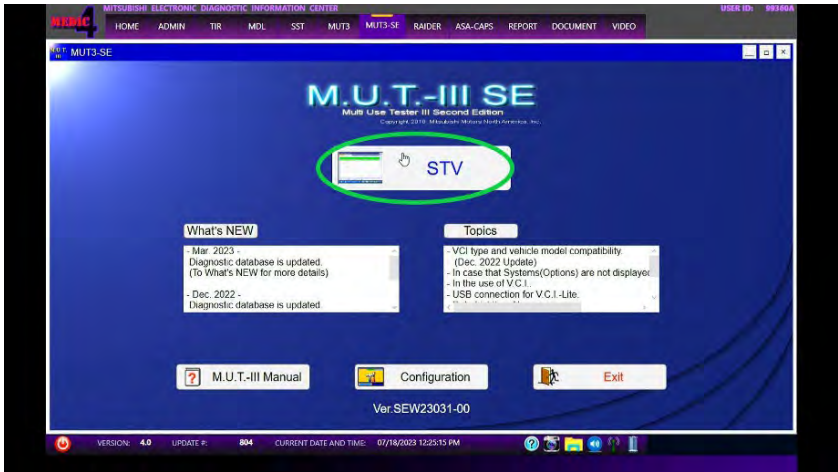
2. Turn the ignition switch to the "ON" position.
3. Turn on flashers to prevent vehicle from shutting/powering down.
4. Press the MUT-III SE STV button.

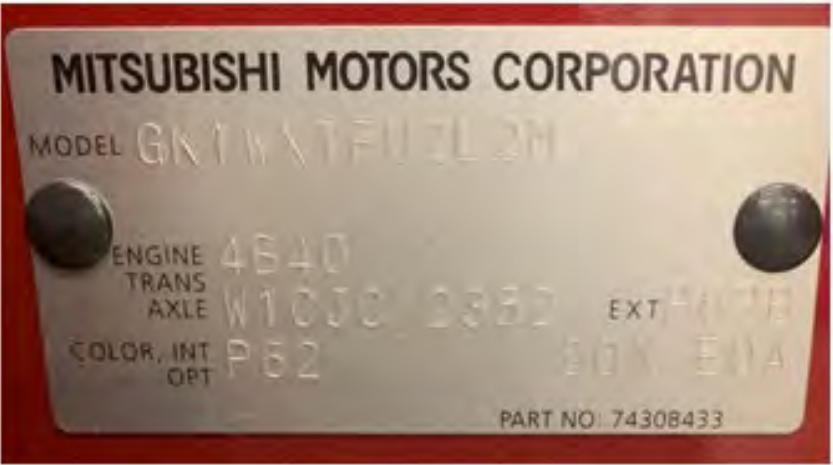
5. Press the model information display button (car icon) and verify all vehicle information. Look at the label on the passenger side B pillar to identify the appropriate class. (See B pillar label below; class is labeled as "model"). Select the correct class from the Loading Option Setup drop-down list.

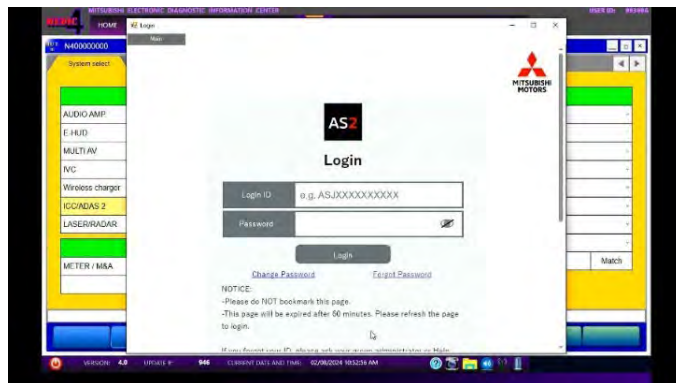
c. Log into AS2.

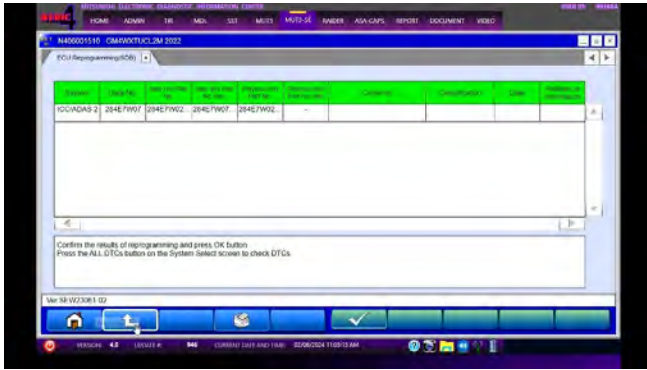
- g. Verify that the software version has been updated to the new data number.

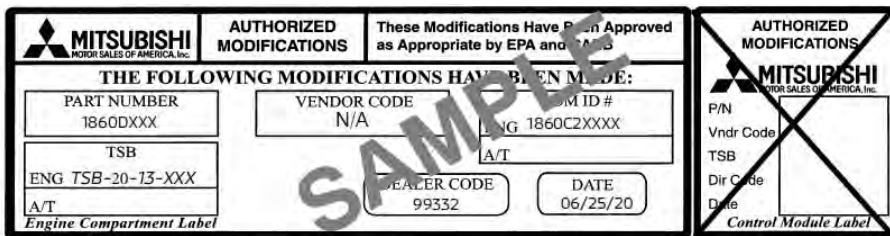
- Using a ball-point pen, enter the appropriate ECU part number, Software Part Number (ROMID#), this Technical Service Bulletin number, your dealer code, and the current date on the Engine Compartment/Control Module Label (p/n MSSF024G00). The Vendor Code is not applicable. The label is available from your facing PDC.
