Technical Service Bulletin

DISCHARGED AUXILIARY BATTERY		No: TSB-24-54-002	
		DATE: April 2024	
		MODEL: 2023-24 Outlander Plug-in Hybrid	
CIRCULATE TO:	<input type="checkbox"/> GENERAL MANAGER	<input checked="" type="checkbox"/> PARTS MANAGER	<input checked="" type="checkbox"/> TECHNICIAN
<input checked="" type="checkbox"/> SERVICE ADVISOR	<input checked="" type="checkbox"/> SERVICE MANAGER	<input checked="" type="checkbox"/> WARRANTY PROCESSOR	<input checked="" type="checkbox"/> SALES MANAGER

PURPOSE

This reprogramming of the ECU is to change the auxiliary battery charge stopping conditions under low State of Charge (SOC) conditions of the drive battery when the vehicle turns off. Additionally, the configuration update of the IPDM E/R and BCM increases the charging amount while reducing the discharge amount from the auxiliary battery while the vehicle turns off.

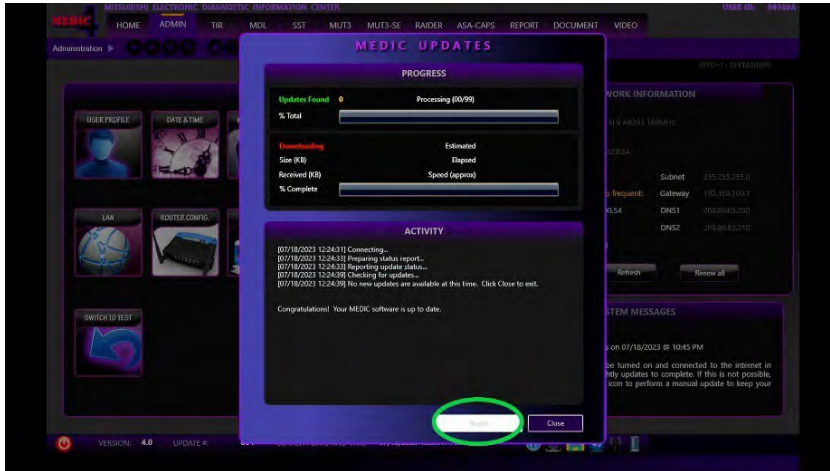
4. If the MEDIC update screen advises updates are available, click the "Begin" button. After all updates are complete, **GO TO THE REPROGRAMMING PROCEDURE.**

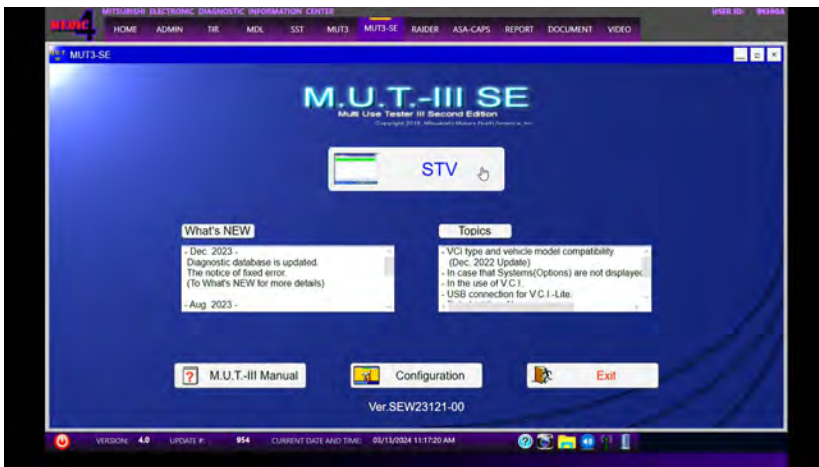
- a. Press the MUT-III SE STV button.

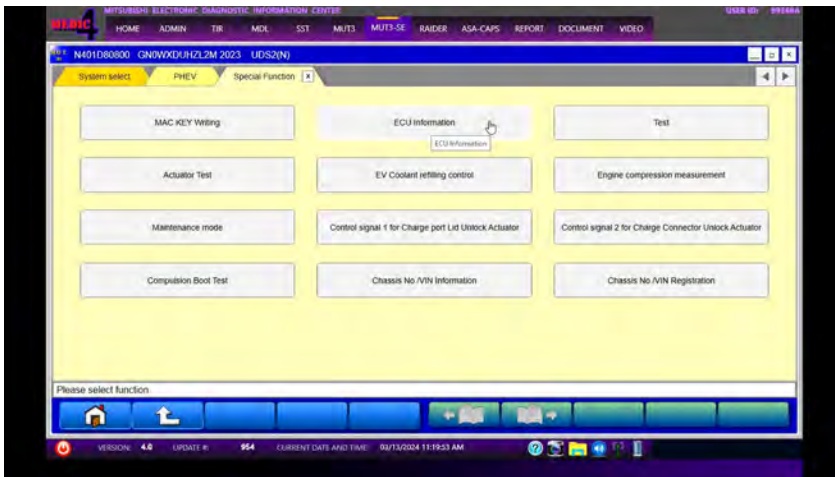
e. Press the ECU Information button.

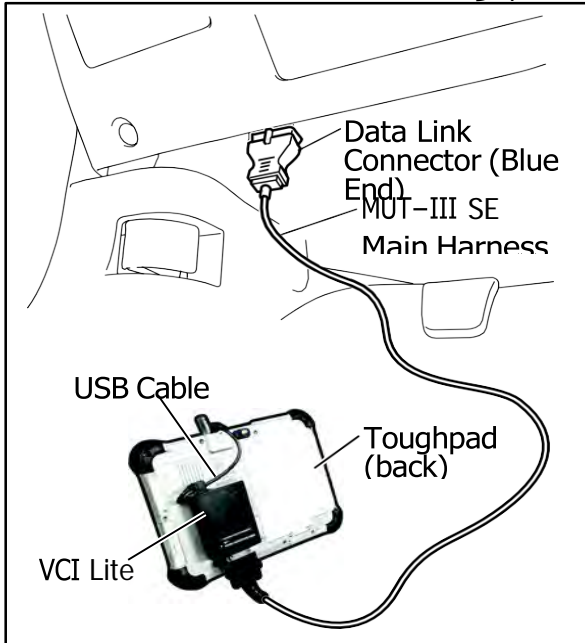
1. Connect the equipment as follows:

NOTE: VCI Lite and MEDIC 4.0 Toughpad shown for illustration purposes only.

- Turn the MEDIC PC/tablet on. If the battery indicator in the lower right hand corner of the screen does not show a full charge, it is recommended that either the battery be charged prior to beginning or be used with the A/C power adaptor connected.
- Connect the USB cable to the VCI/VCI Lite. When the laptop/tablet displays the MUT-III SE main screen, connect the USB cable to the device.
- Connect the MUT-III SE main harness with the blue DLC connection to the VCI/VCI Lite. Connect the blue connection of the MUT-III SE main harness to the vehicle's data link connector.
- For VCI only: Turn the VCI power switch ON. Verify that the indicator lamp in the upper right corner of the screen is green.

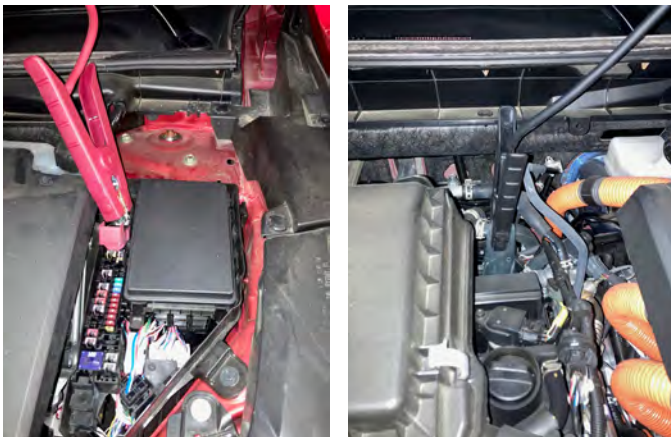
NOTE: Due to limited space it may be easiest to connect battery charger cable onto ground point.

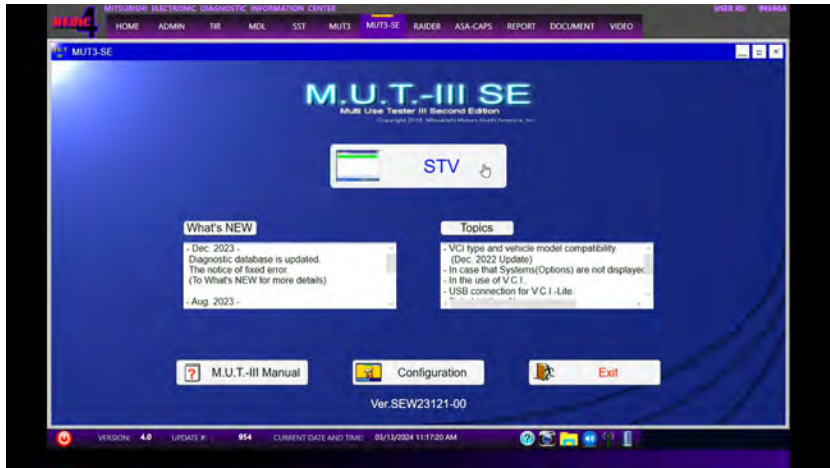
2. Turn the ignition switch to the "ON" position.
3. Turn on flashers to prevent vehicle from shutting/powering down.
4. Press the MUT-III SE STV button.

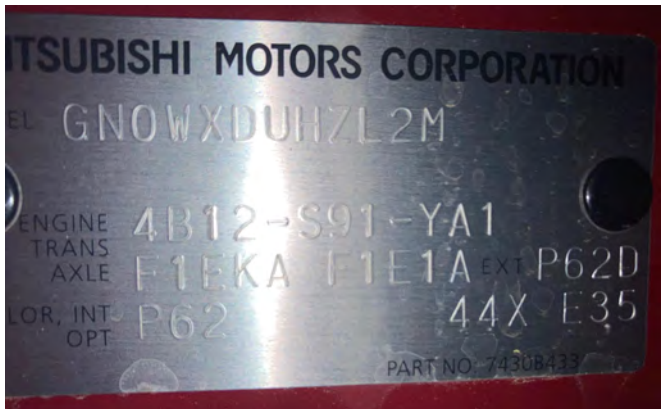
5. Press the Chassis No/VIN read out (car icon) and verify all vehicle information. Look at the label on the passenger side B pillar to identify the appropriate class. (See B pillar label below; class is labeled as "model").

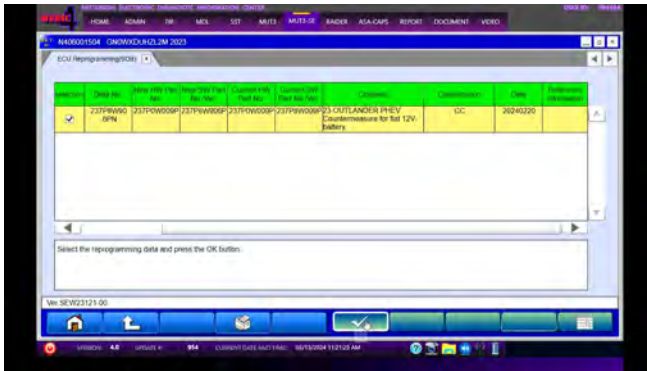
12. Check the reprogramming data and press the OK button.

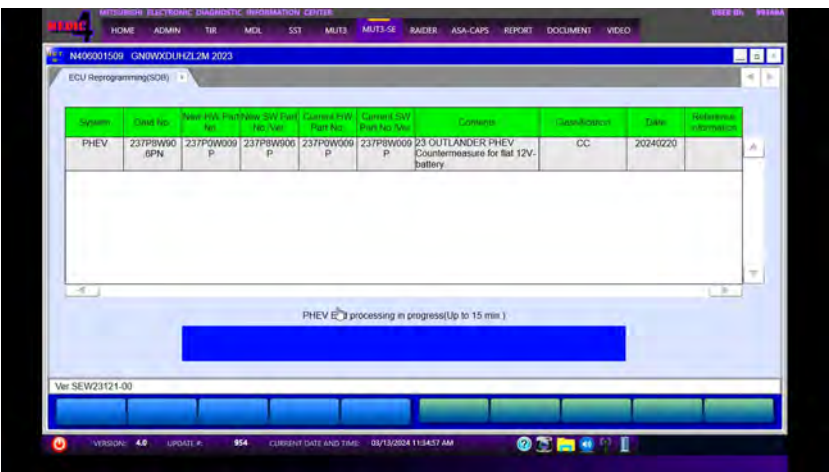
14. PHEV End processing will begin and a process status bar will appear.

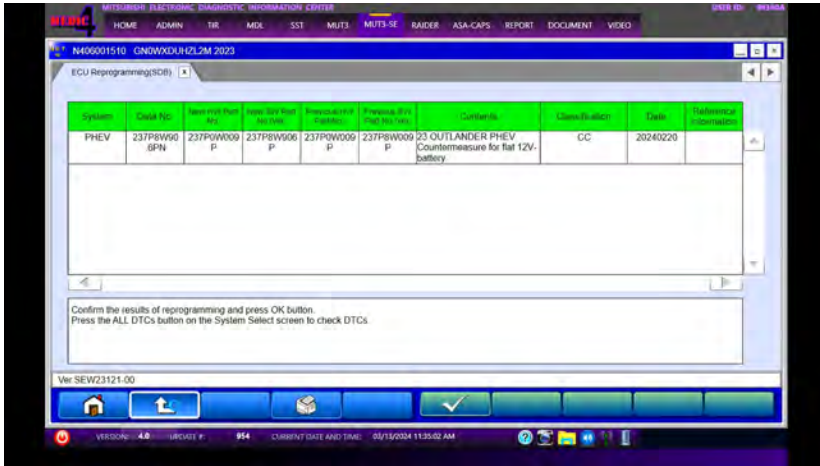
15. Refer to the Reprogramming Chart to confirm the results.

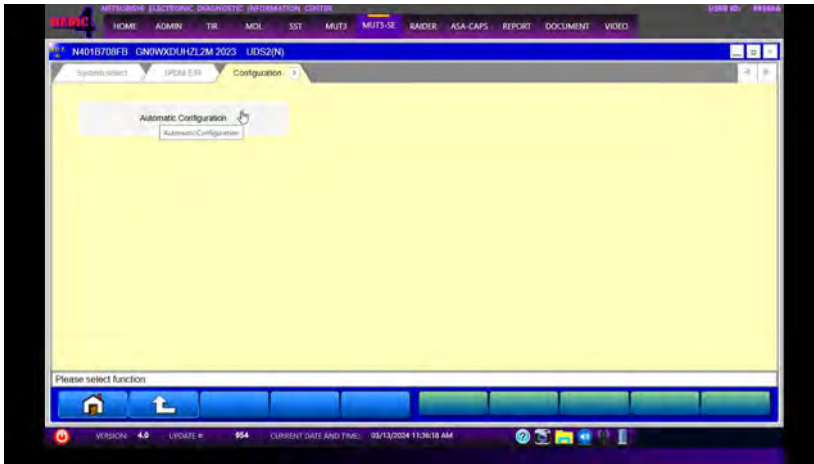
18. Press the Automatic Configuration button.

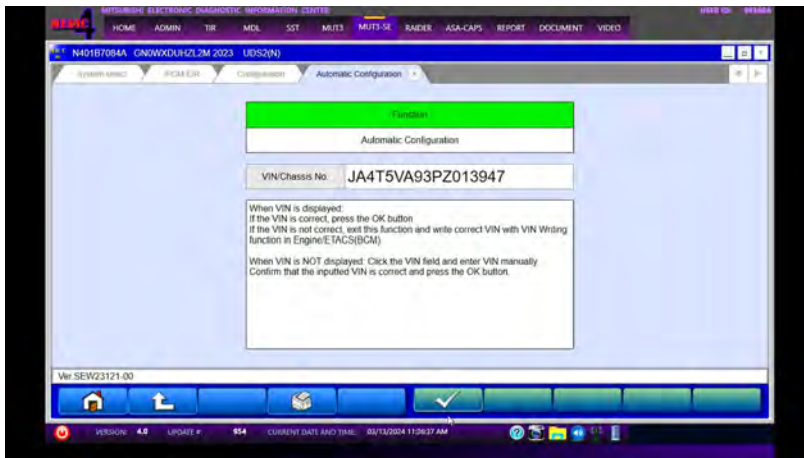
19. Verify the VIN/Chassis Number and press the OK button.

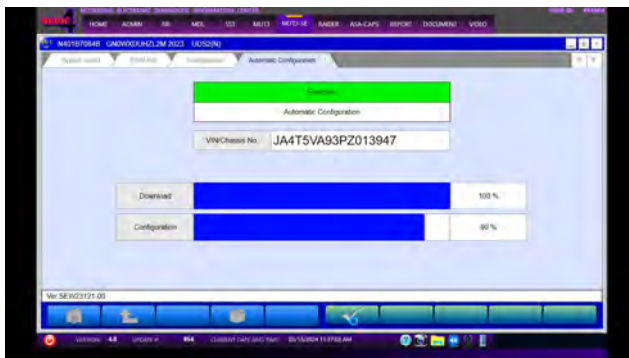
20. Automatic Configuration begins and a status bar will be displayed. Upon completion press the OK button.

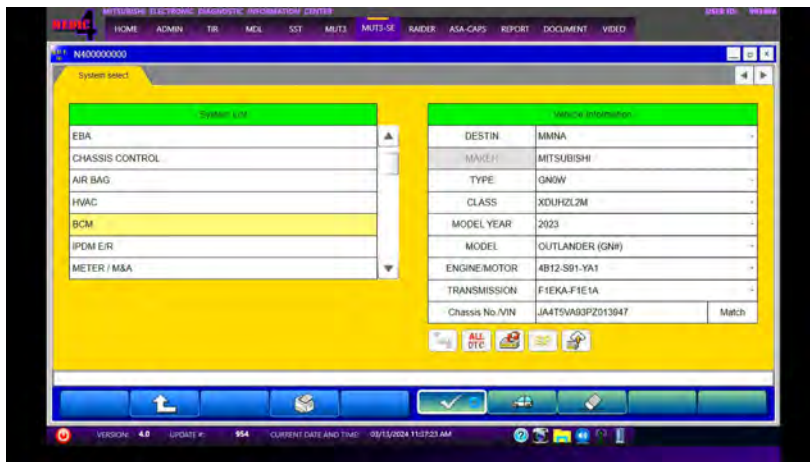
21. Return to the System List under the System Select tab, choose BCM and press the OK button.

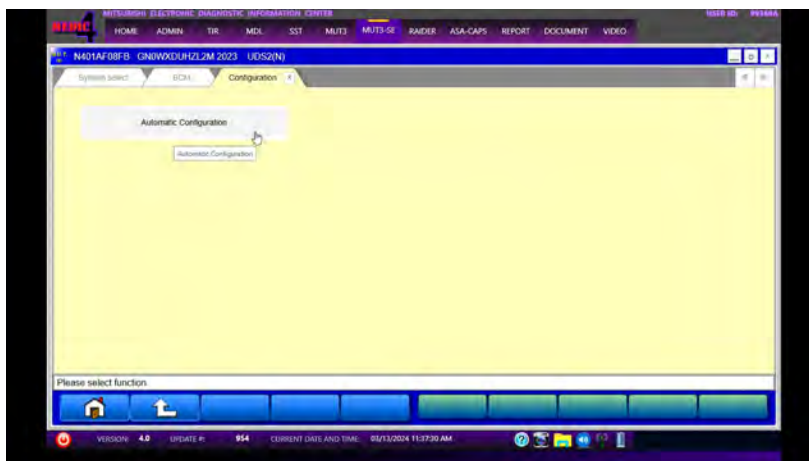
23. Press the Automatic Configuration button.

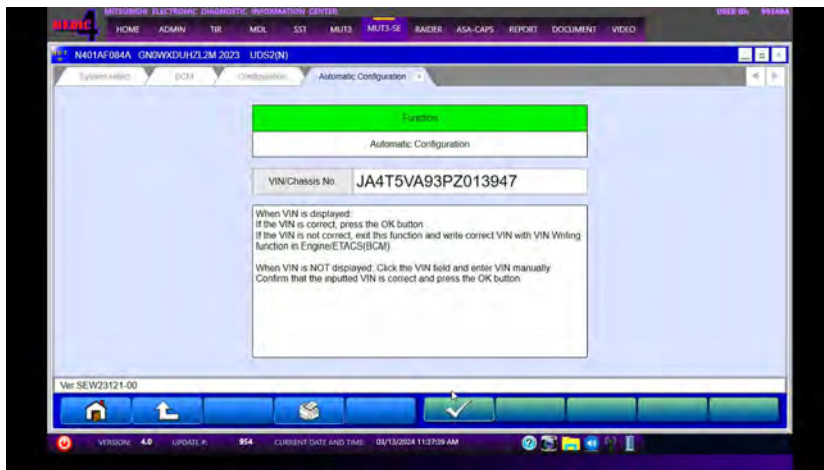
24. Verify the VIN/Chassis Number and press the OK button.

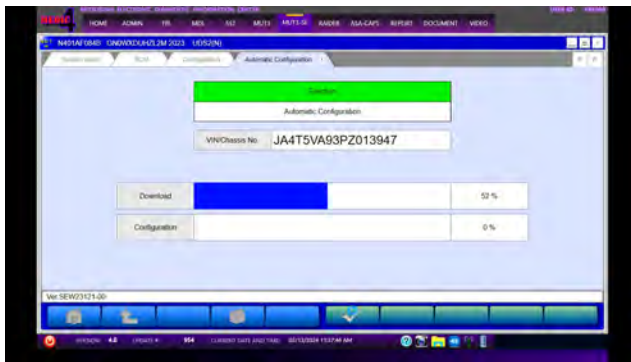
25. Automatic Configuration begins and a status bar will be displayed. Upon completion press the OK button.

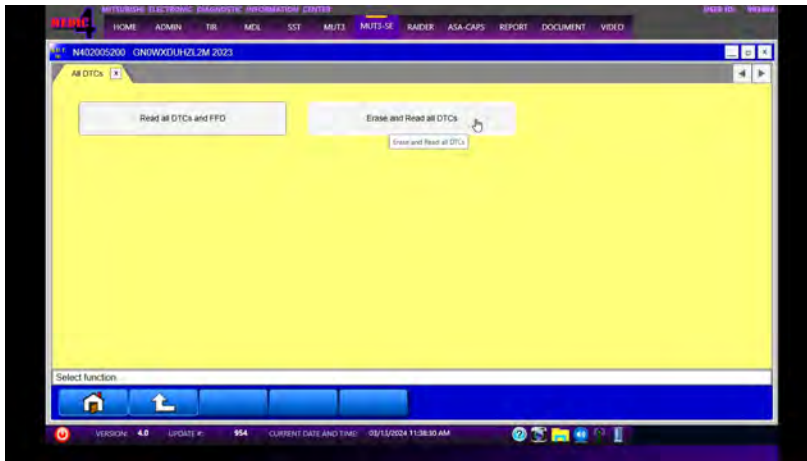
27. Press the Erase and Read all DTCs button.

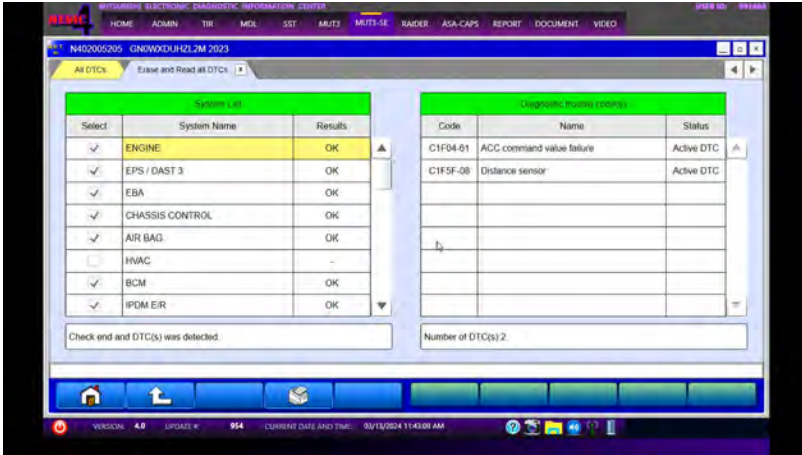
29. Review results and resolve any Active DTCs.

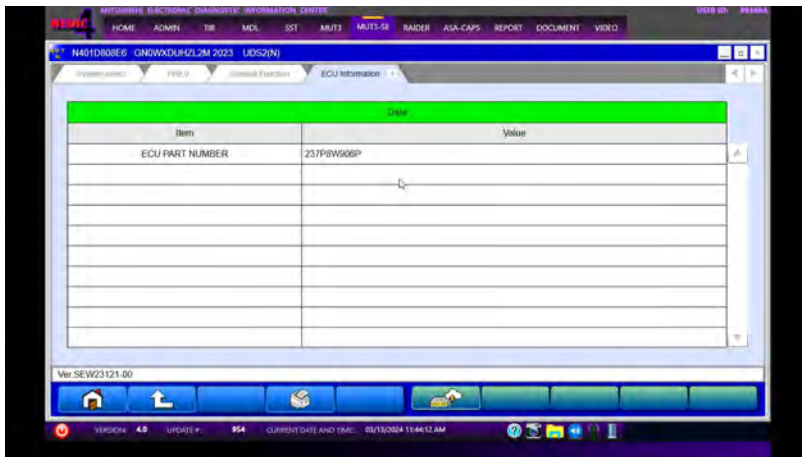
30. Refer to the Reprogramming Chart to confirm ECU information.

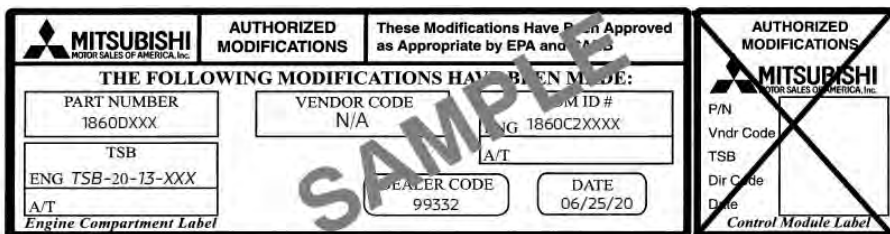
31. Using a ball-point pen, enter the appropriate ECU part number, Software Part Number (ROM ID#), this Technical Service Bulletin number, your dealer code, and the current date on the Engine Compartment/Control Module Label (p/n MSSF024G00). The Vendor Code is not applicable. The label is available from your facing PDC.
