# Technical Service Bulletin

SUBJECT:			No: <b>TSB-11-13-008REVII</b>
<b>ECM REPROGRAMMING FOR DTC P0016 or P0017: CRANKSHAFT/CAMSHAFT POSITION</b>			DATE: <b>November, 2011</b>
			MODEL: <b>See below</b>
CIRCULATE TO:	<input type="checkbox"/> GENERAL MANAGER	<input type="checkbox"/> PARTS MANAGER	<input checked="" type="checkbox"/> TECHNICIAN
<input checked="" type="checkbox"/> SERVICE ADVISOR	<input checked="" type="checkbox"/> SERVICE MANAGER	<input checked="" type="checkbox"/> WARRANTY PROCESSOR	<input type="checkbox"/> SALES MANAGER

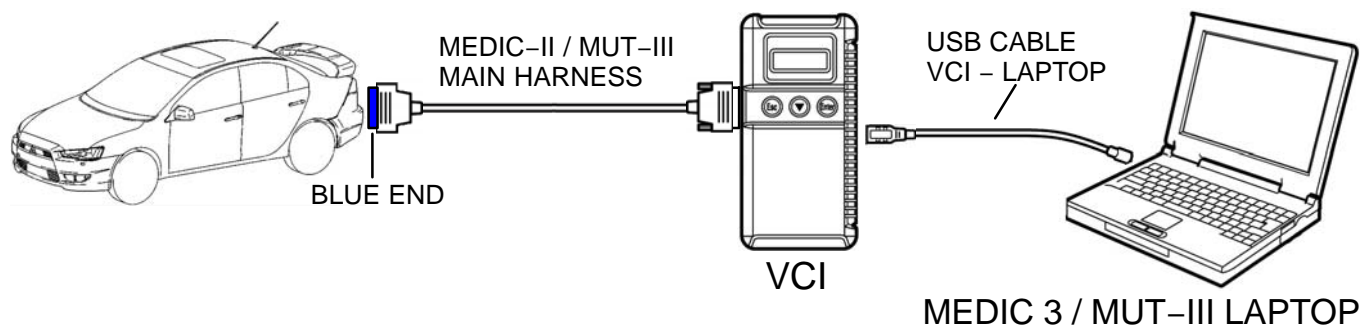
Connect the equipment as follows:

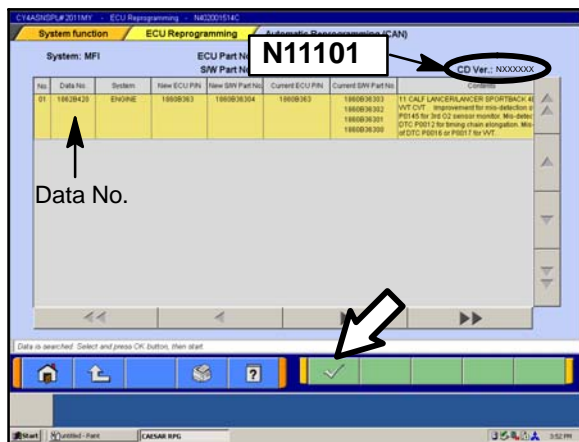
- l. The Automatic Reprogramming(CAN) database screen will display.

Confirm the database number at the top right of the table is **N11101** or higher.

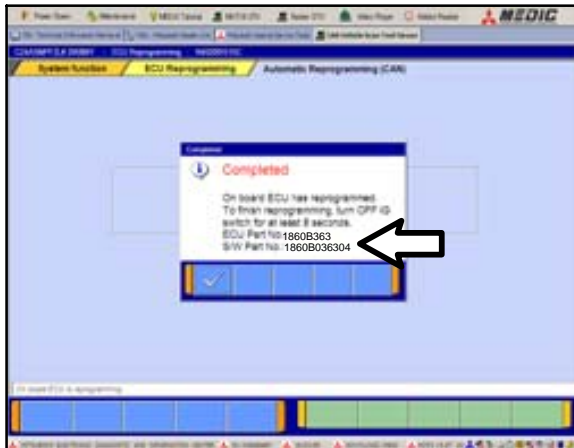
- o. This message will display when ECM reprogramming is successfully completed. Confirm the “New S/W P/N” displayed matches the table at the beginning of this TSB.
  - p. You will be prompted to turn the ignition switch to the OFF position, wait at least 8 seconds, then turn it back on.
  - q. Click the check mark and you will be returned to the “ECU Reprogramming” page.
2. Click the Home icon at the lower left corner of the page to return to the MUT-III main page.
