ITB10-065a

**VOLUNTARY SERVICE CAMPAIGN
2007 – 2008 FX WITH ICC
SPEEDOMETER AND ODOMETER PROGRAMMING ERROR**

CAMPAIGN ID#: P0332

APPLIED VEHICLES: 2007 – 2008 FX (S50) with Intelligent Cruise Control (ICC)

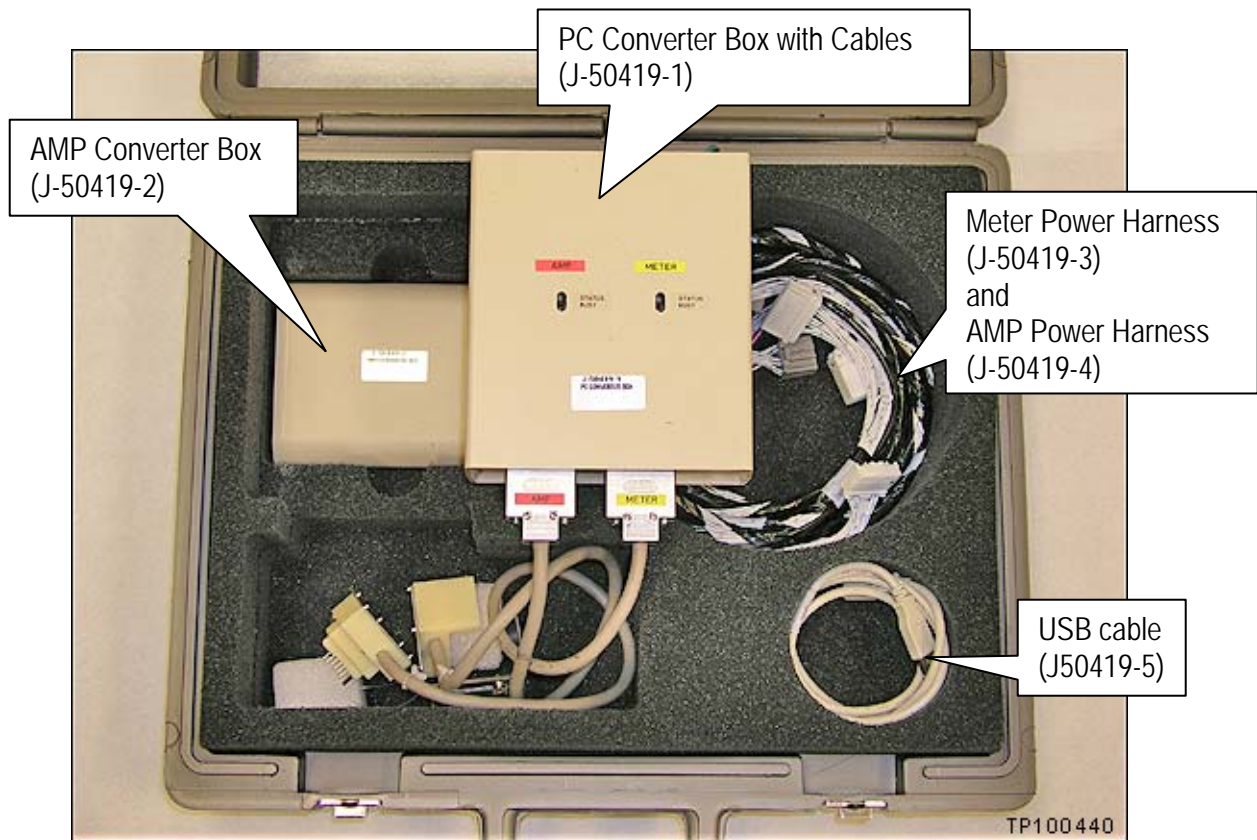
REQUIRED SPECIAL TOOL – Meter Reprogramming Kit (J-50419)

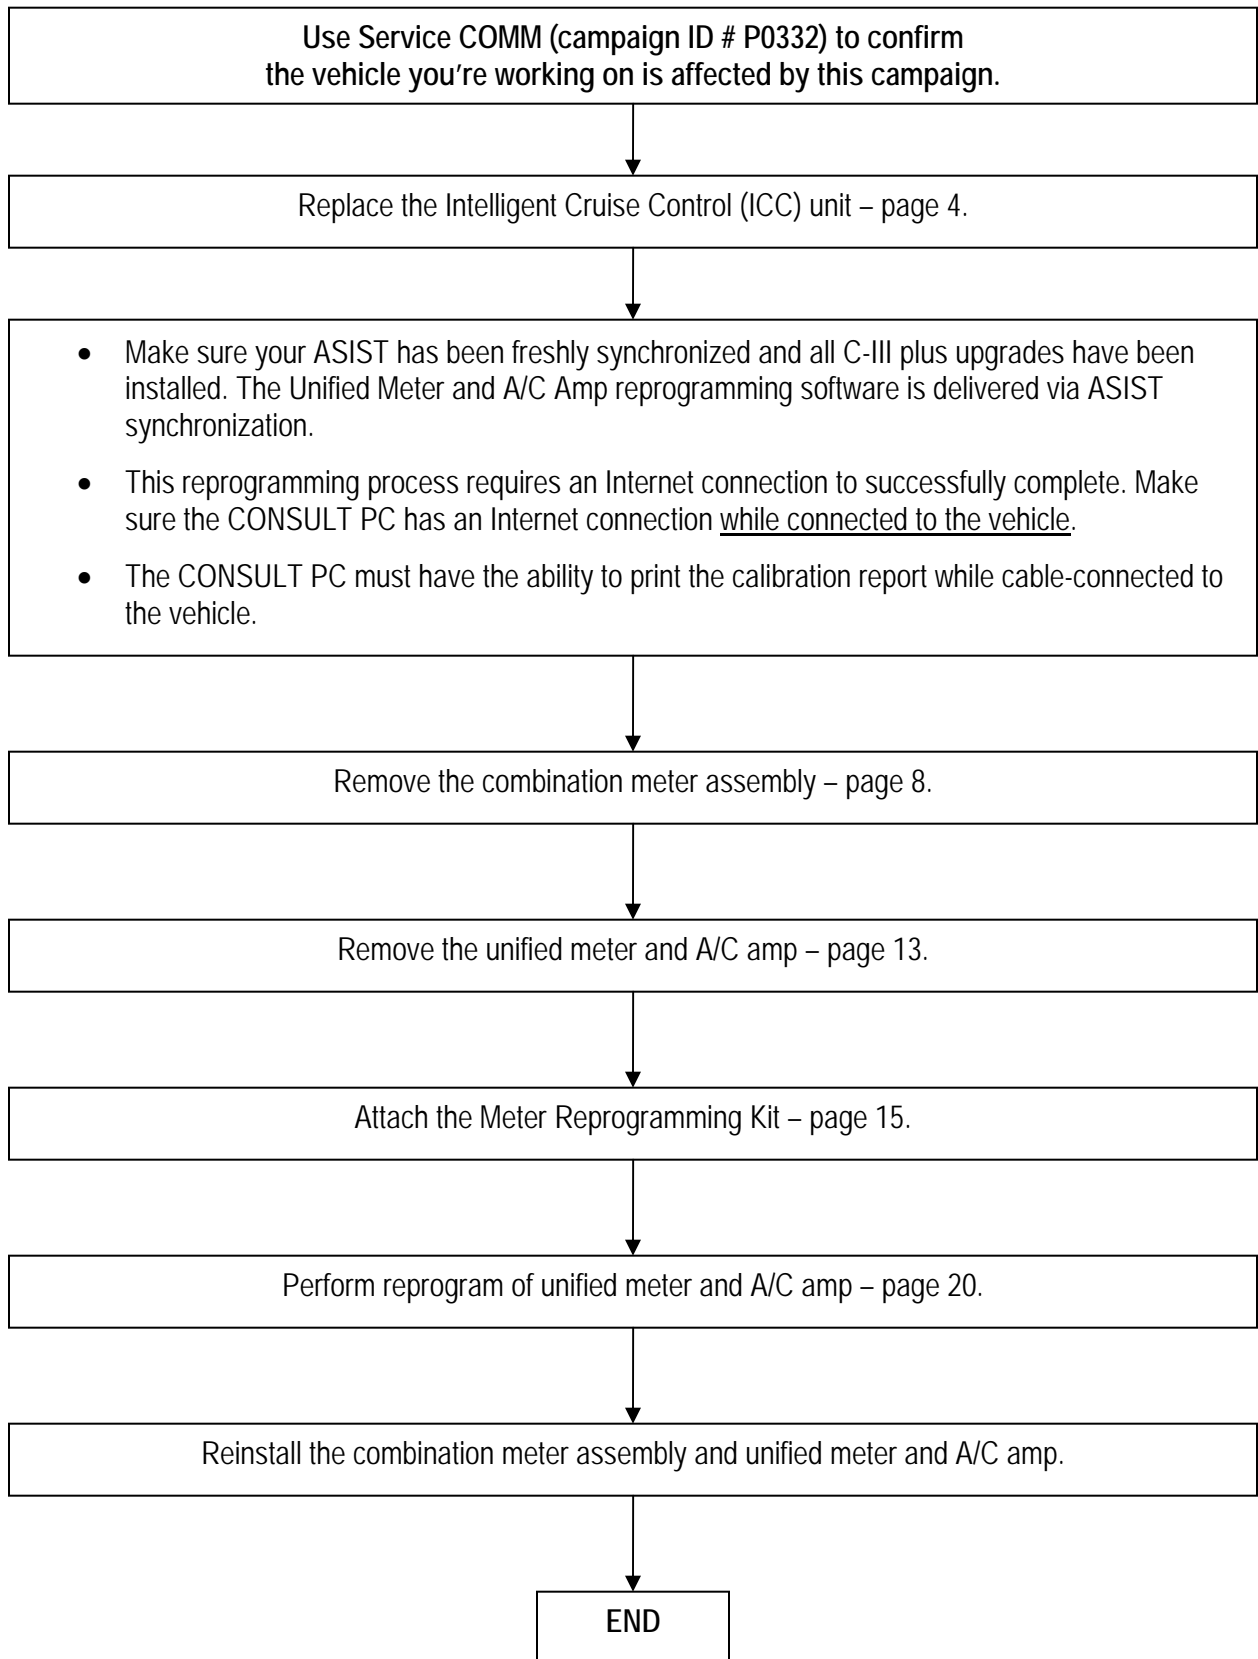
REPAIR OVERVIEW

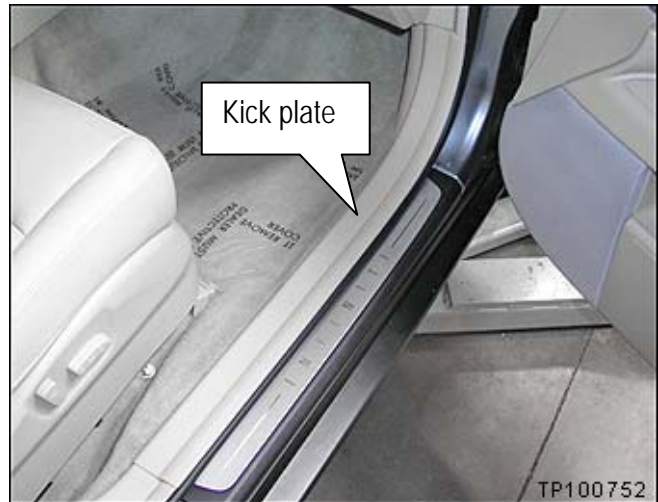
Figure A

2. Remove the front passenger kick plate.

- Snap loose to remove.
- Use a plastic trim tool as needed.

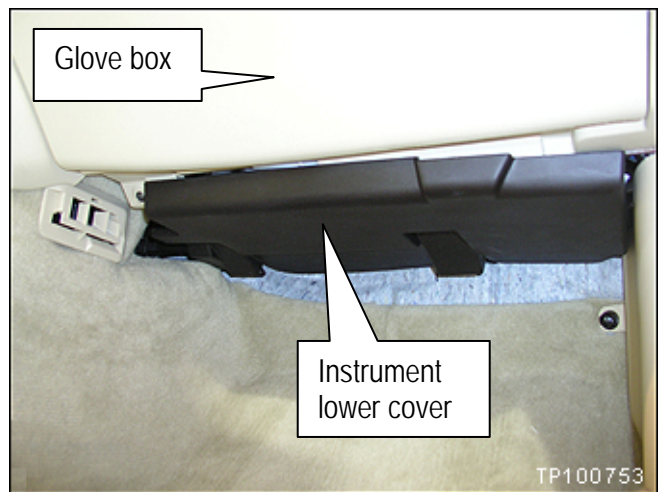
Figure B

3. Under the glove box, snap loose and remove the instrument lower cover.

- Use a plastic trim tool as needed.

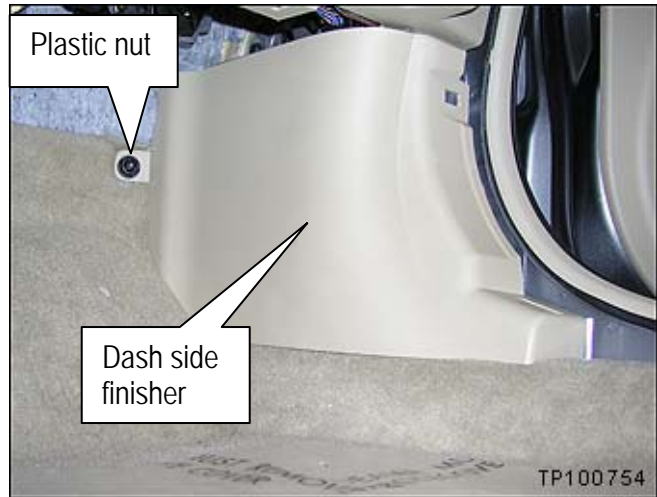
Figure C

4. Remove the dash side finisher.
 - Remove the plastic nut.
 - Snap the finisher loose and remove.

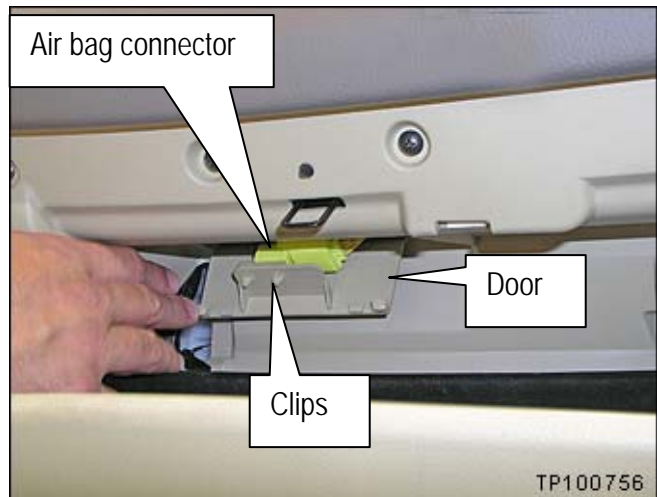
Figure D

5. Dismount the air bag connector shown in Figure D.
 - a. Snap open the door in the roof of the glove box.
 - b. Use a suitable tool to squeeze the clips and dismount the connector.

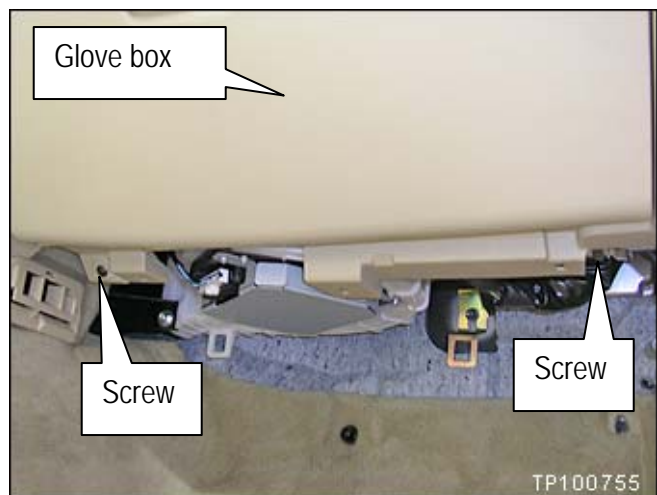
Figure E

6. Remove the 2 screws from the lower part of the glove box.

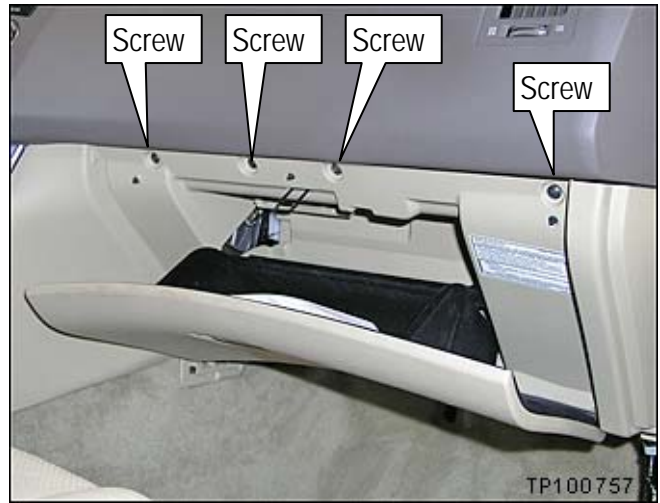
Figure F

7. Remove the 4 screws from the top of the glove box.

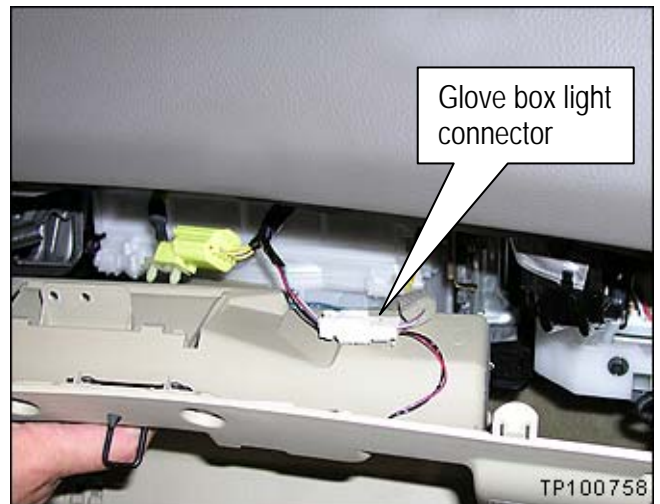
Figure G

8. Pull / snap loose the glove box assembly, and then disconnect the glove box light connector.

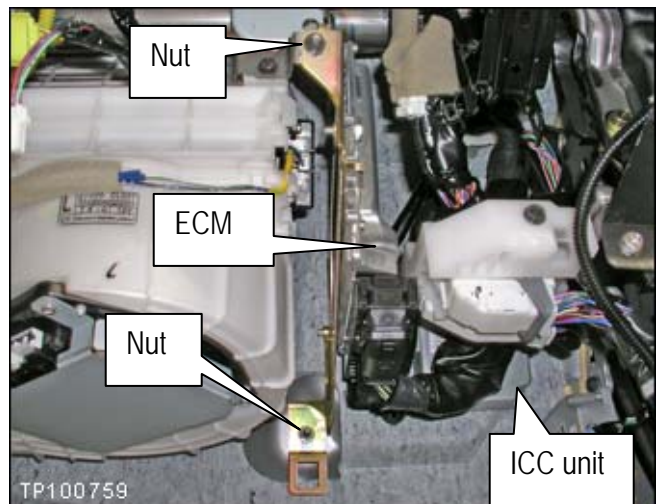
Figure H

9. Remove the 2 mounting nuts for the Engine Control Module (ECM).

NOTE: It is not necessary to disconnect the ECM electrical connector.

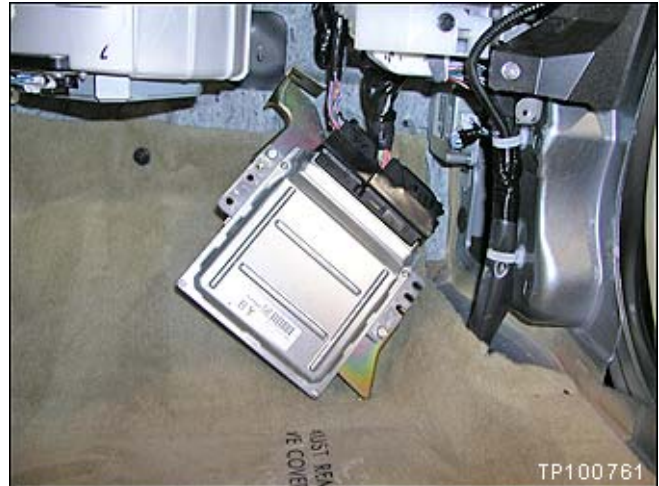
Figure I

10. The ECM can remain in this position while you replace the ICC unit.

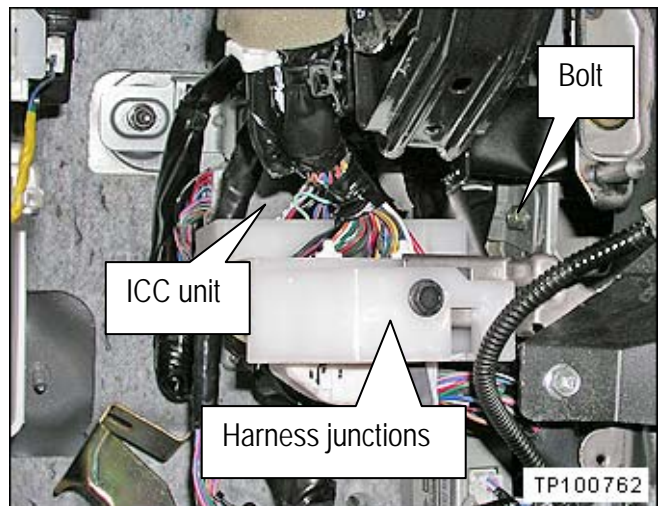
Figure J

11. Remove the ICC unit mounting nut and bolt.

NOTE: The ICC unit is behind the harness junctions.

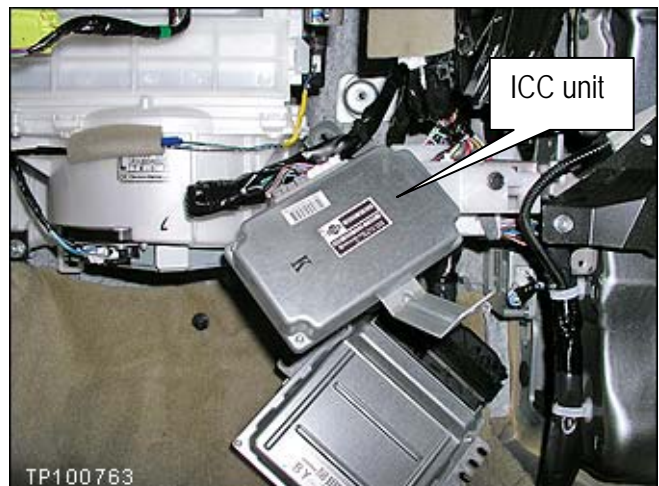
Figure K

12. Carefully maneuver the ICC unit from behind the harness junctions.

13. Replace the ICC unit with a **new** one listed in the Parts Information of this bulletin.

- Make the old ICC unit unusable by breaking the electrical connector.

14. Install the new unit and all other parts removed in reverse order.

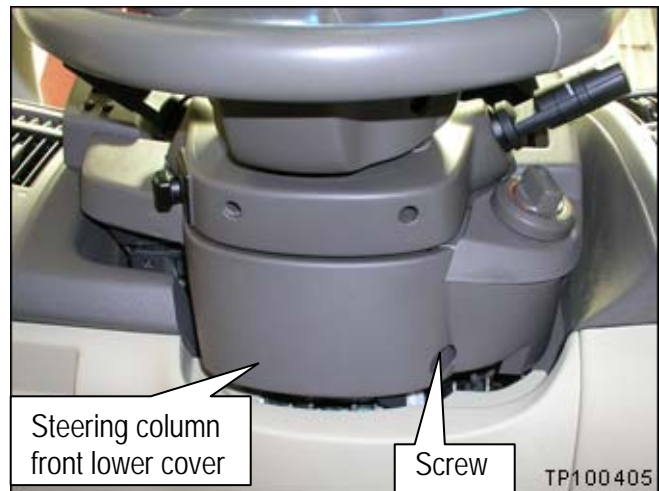
Figure 1

1. Remove the steering column front lower cover.
 - a. Remove screw shown in Figure 1.
 - b. Carefully pull down to snap loose and remove the cover.

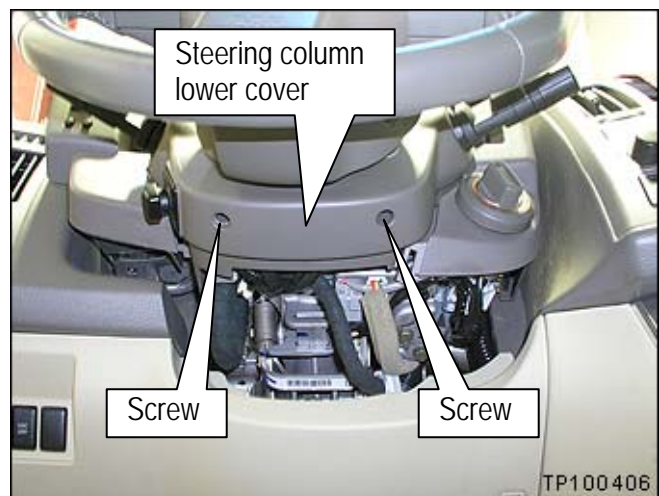
Figure 2

2. Remove the steering column lower cover.
 - a. Remove 2 screws shown in Figure 2.
 - b. Carefully pull down to snap loose and remove the cover.

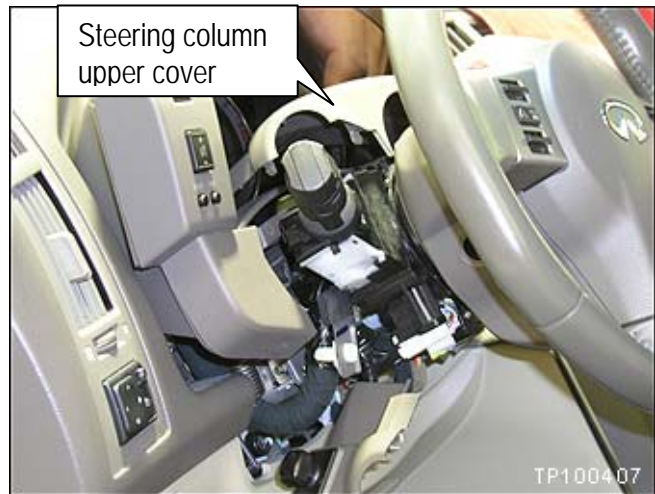
Figure 3

3. Remove the steering column upper cover.

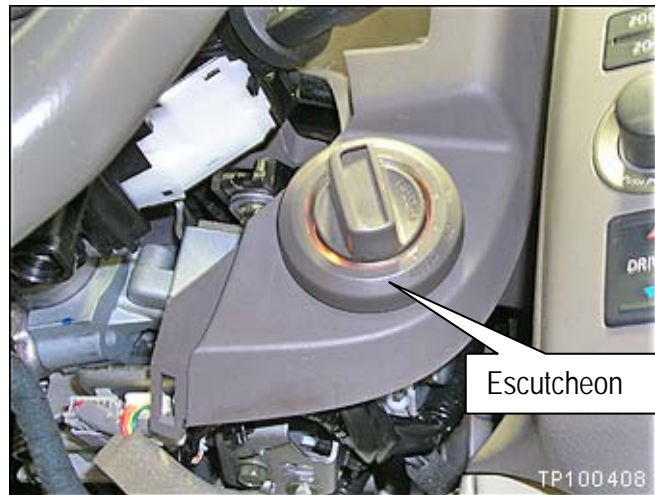
Figure 4

4. Remove the steering lock escutcheon.
 - Use a plastic trim tool if needed.
 - Pull the escutcheon to remove it.

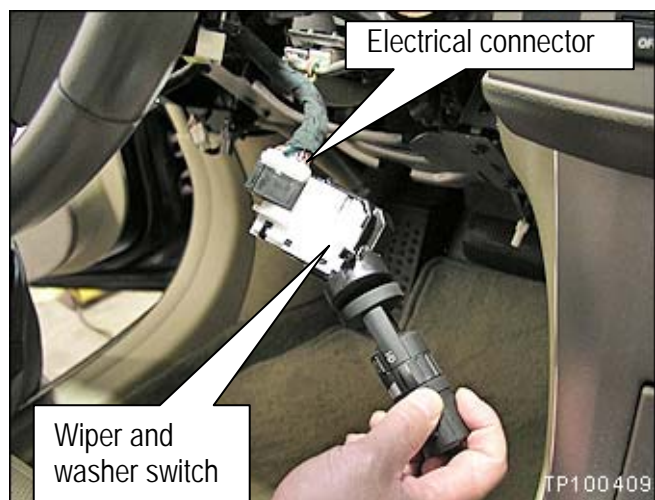
Figure 5

5. Remove / unclip the wiper and washer switch, and then disconnect the electrical connector.

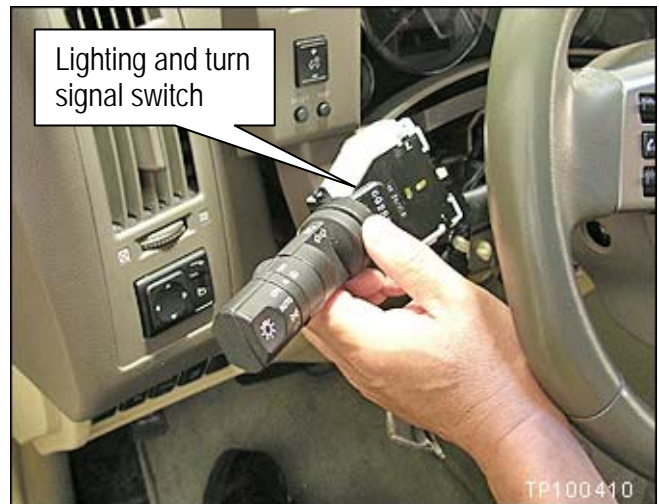
Figure 6

6. Remove / unclip the lighting and turn signal switch.

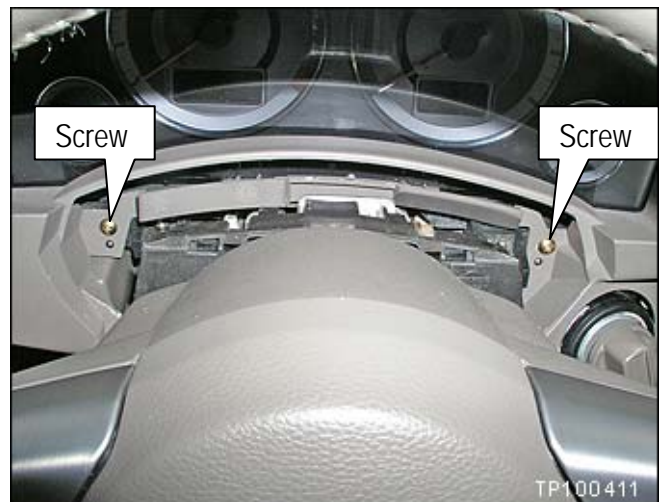
Figure 7

- a. Remove the 2 screws shown in Figure 7.

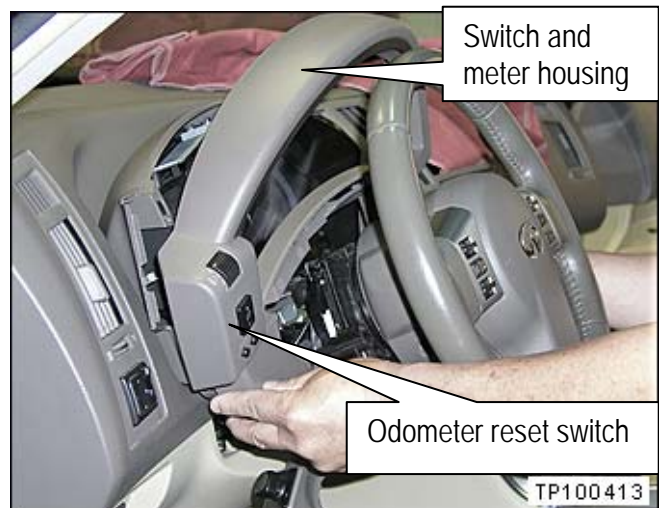
Figure 8

- b. Carefully unsnap the housing, and then move it to the left side of the steering column.

- Do not scratch the clear plastic meter lens.
- Use a cover if needed.

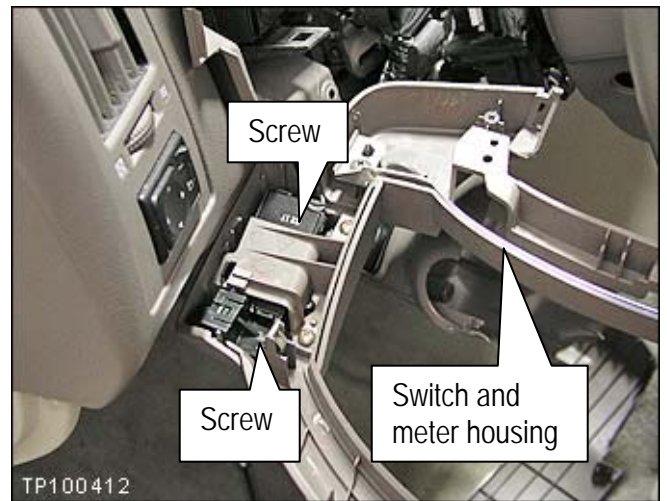
Figure 9

a. Remove the 2 screws shown in Figure 9.

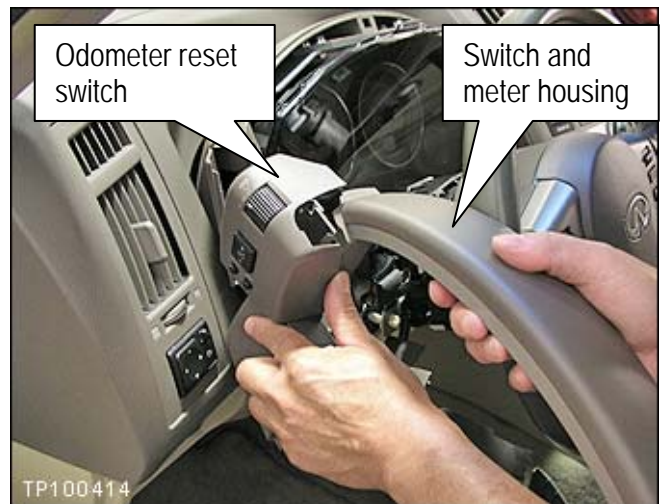
Figure 10

b. Carefully separate the switch from the housing.

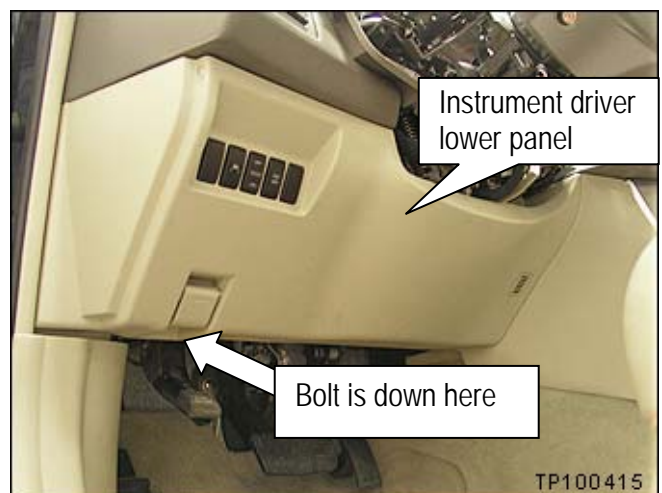
Figure 11

a. Remove the bolt under the hood release handle.

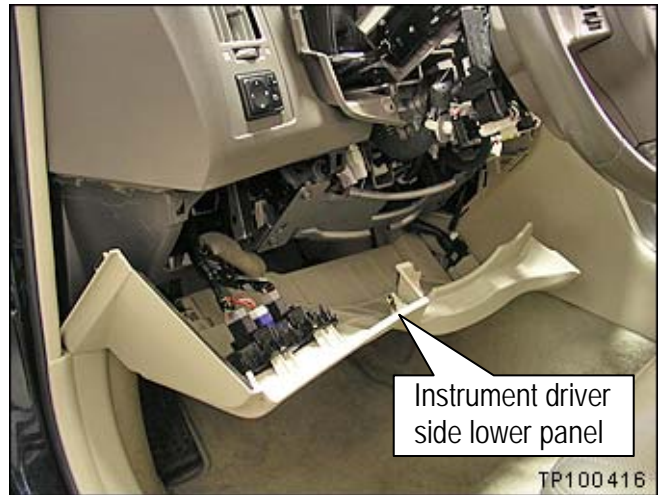
- b. Carefully pull the panel to unsnap the clips.

NOTE: The instrument drive side lower panel can stay in the position shown in Figure 12 while the rest of the procedure is completed.

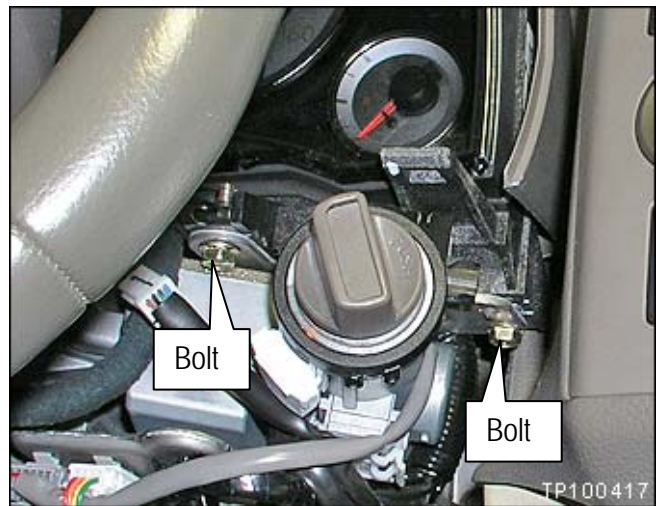
Figure 13

- a. On the lower right side of the meter assembly, remove the 2 bolts shown in Figure 13.

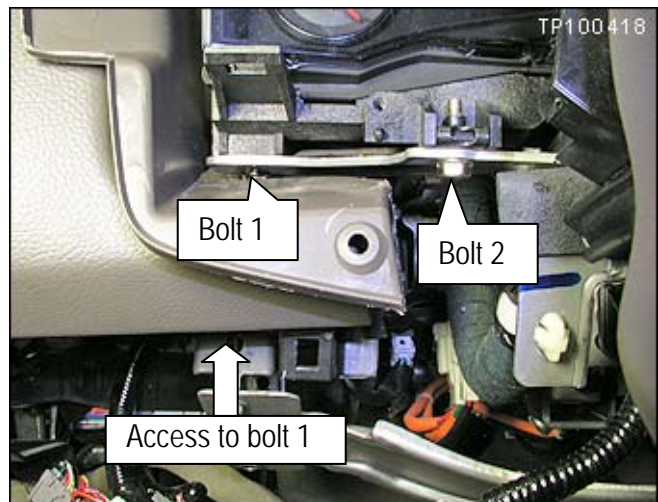
Figure 14

- b. On the lower left side of the meter assembly, remove the 2 bolts shown in Figure 14.

- You will need to access bolt 1 from under the instrument panel.
- There is a hole (covered by tape) in the soft portion of the panel that allows access to bolt 1.

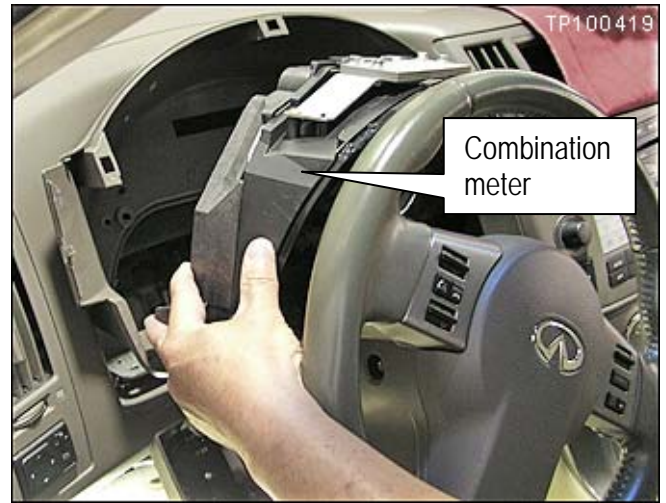
Figure 15

- c. Carefully pull the combination meter out far enough to access the harness connector.

- Do not scratch the clear plastic meter lens.
- Use a cover if needed.

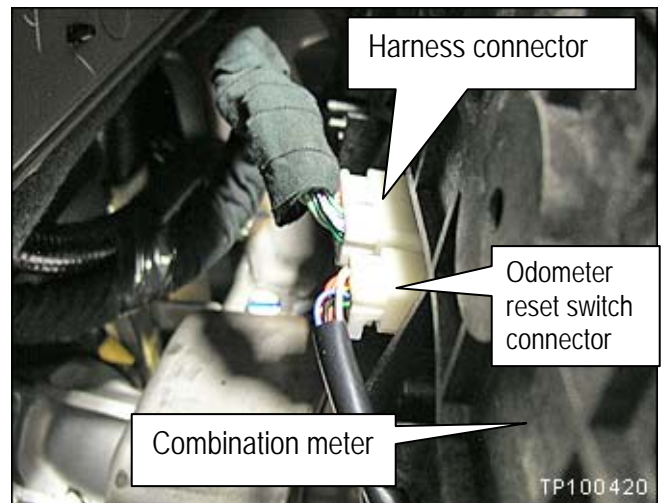
Figure 16

- d. Disconnect the harness connector shown in Figure 16.

NOTE: The odometer reset switch can remain connected.

- e. Carefully remove the combination meter assembly and place it in a safe area.

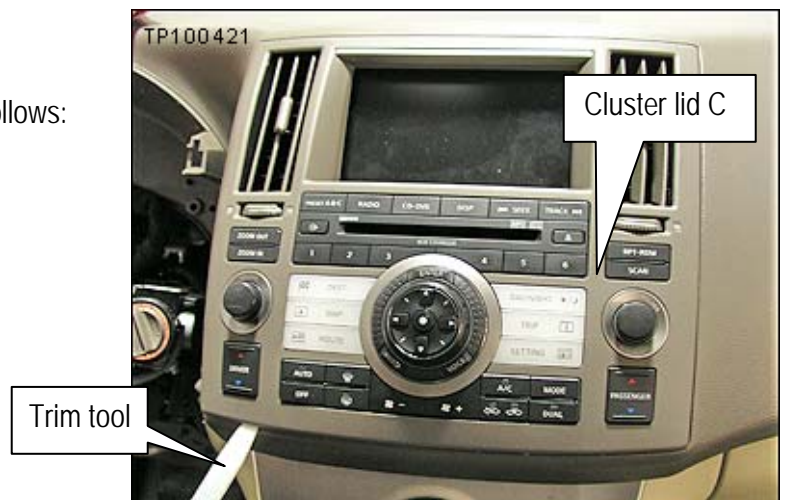
Figure 17

11. Snap loose and remove cluster lid C as follows:

- a. Use a plastic trim tool as needed.

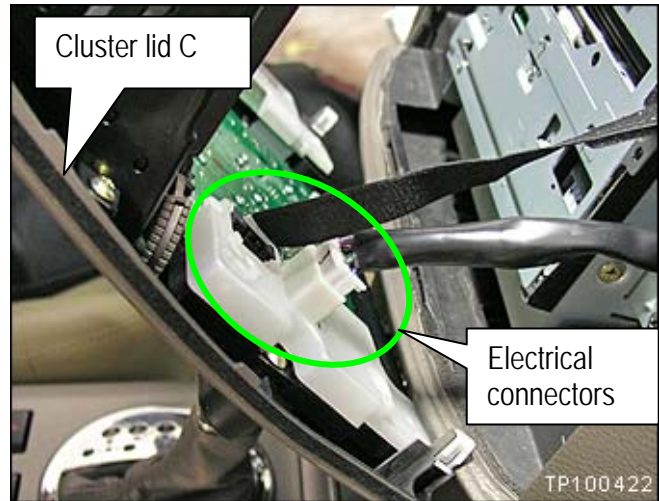
Figure 18

- b. Disconnect 2 electrical connectors from the right side of cluster lid C.

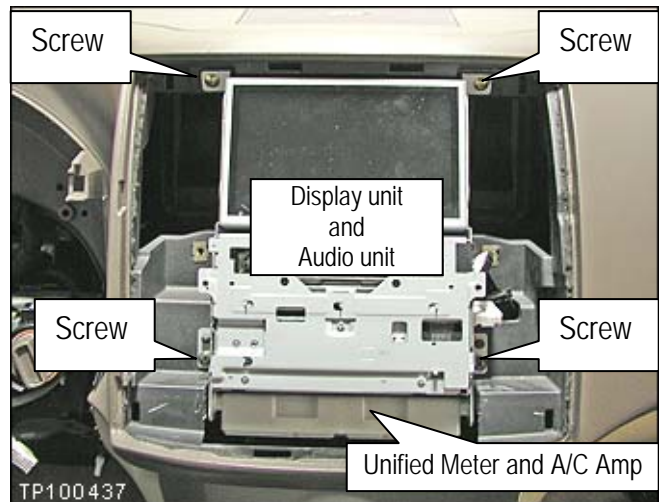
Figure 19

- a. Remove the 4 screws shown in Figure 19.

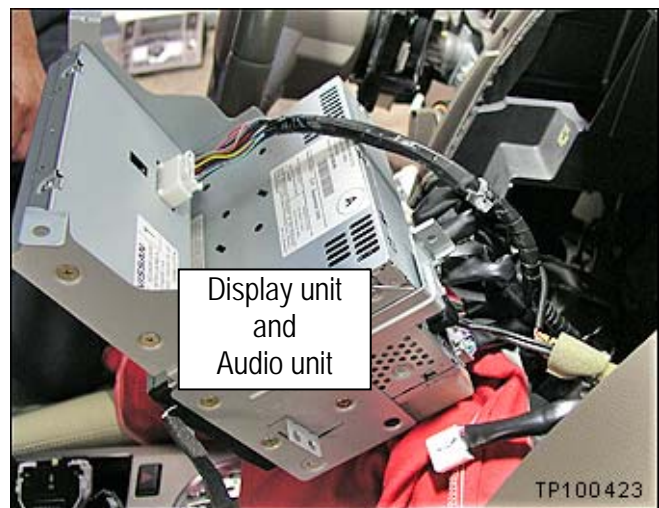
Figure 20

- b. Pull out the display and audio unit and disconnect all of their electrical connectors on the back side of the unit.
- c. Remove the display and audio unit, and then set it in a clean working area.

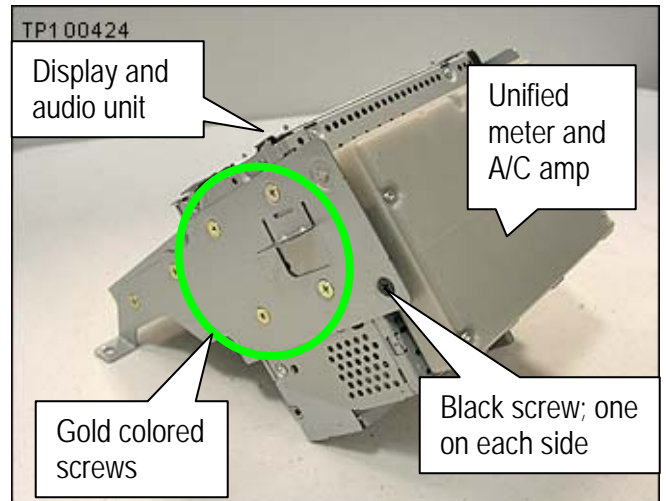
Figure 21

13. Separate the unified meter and A/C amp from the display and audio unit brackets.

- a. Remove 2 black screws.
 - One on each side of the unified meter and A/C amp.
- b. Loosen 4 gold colored screws on one side.
 - Loosen about 2 to 3 turns.

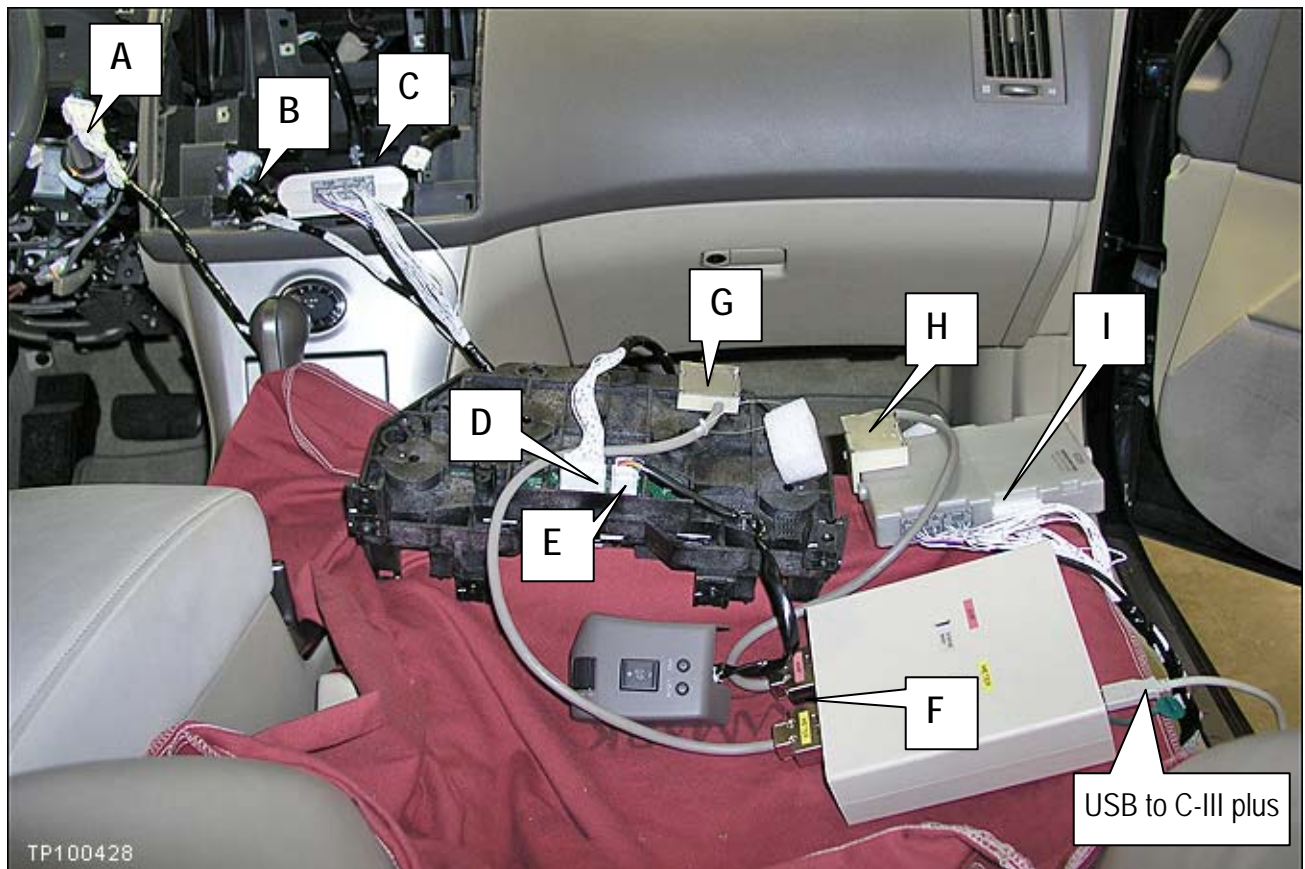
15. Attach the Meter Reprogramming Kit (J-50419) as shown in Figure 22.

- Detail (close up) of each attachment is found on the following pages with corresponding letter.
- Make sure all connections are securely connected.

NOTE: Do not connect C-III plus to the vehicle or the PC Converter box at this time.

- a. Turn the ignition OFF.
- b. Make sure the CONSULT PC is OFF.
- c. Disconnect and reconnect all of the reprogramming cables (see Figure 22 on page 15). Make sure all connectors are securely connected.
- d. Make sure the USB cables and A/C power supply are securely connected to the CONSULT PC.
- e. Make sure the plus VI is securely connected to the vehicle.
- f. Go back and restart with Step 1 above.

- a. Make sure the Internet connection is working.
- b. Turn the ignition OFF.
- c. Turn the CONSULT PC OFF.
- d. Disconnect and reconnect all of the reprogramming cables (see page 15, Figure 22). Make sure all connectors are securely connected.
- e. Make sure USB cable and A/C power supply are securely connected to the CONSULT PC.
- f. Go back to page 20 and restart with Step 1.

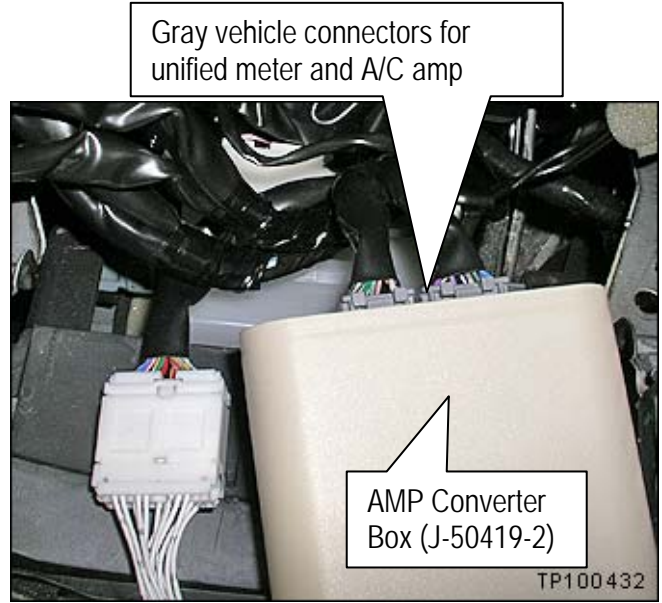
Figure 25

NOTE: The connectors on the front and rear of the Amp Converter Box (J-50419-2) are interchangeable (reversible). They can be plugged in on either side.

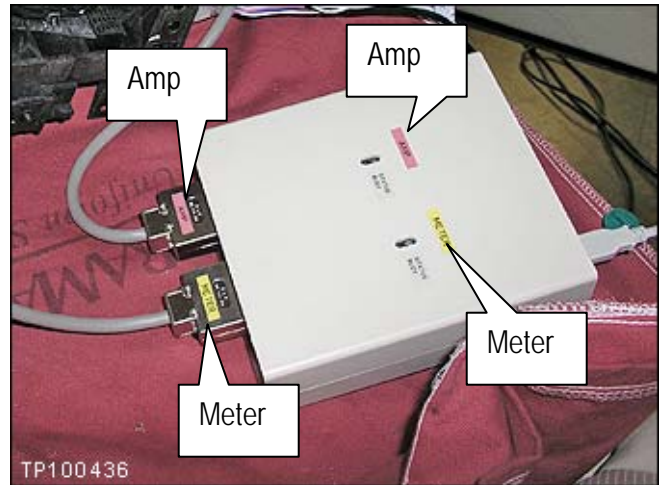
Figure 28

F

- Make sure the Amp Probe is connected to Amp side and the Meter Probe is connected to the Meter side of the PC Power Converter Box (J-50419-1).

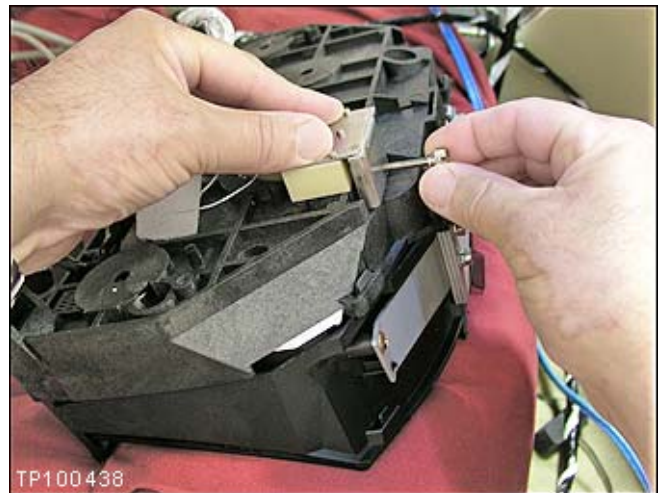
Figure 29

G

- Push and hold the Meter Probe into the back of the combination meter, and then tighten the lock screw.

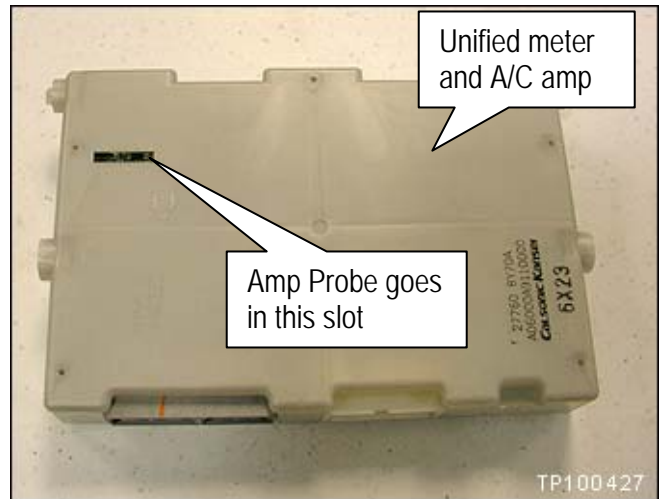
Figure 30

H

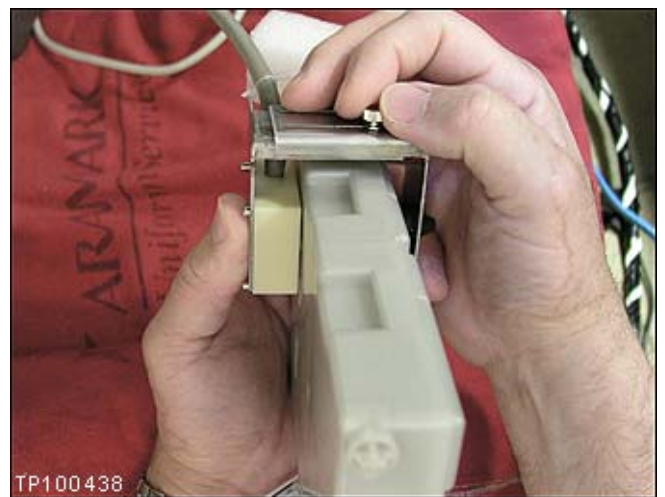
Figure 31

H

- Push and hold the Amp Probe in the amp probe slot, and then tighten the lock screw.

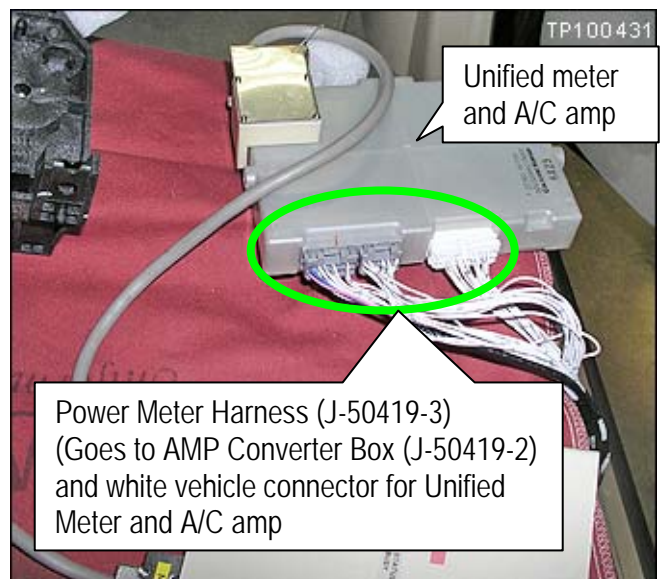
Figure 32

I

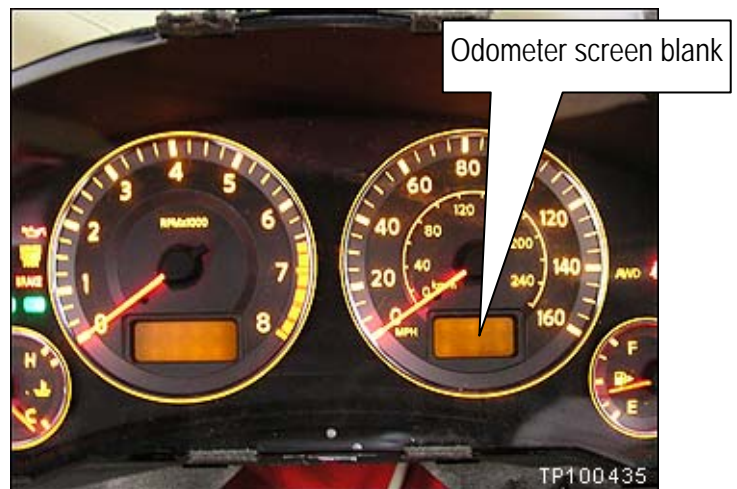
Figure 1a

1. Use the USB cable to connect the plus Vehicle Interface (plus VI) to the CONSULT PC, and then connect the plus VI to the vehicle.
2. Connect the AC Adapter to the CONSULT PC.
3. Make sure the CONSULT PC is connected to the PC Converter Box (J-50419-1) with the USB cable.
4. Turn the Ignition ON.

With the ignition ON, the odometer screen should be blank.

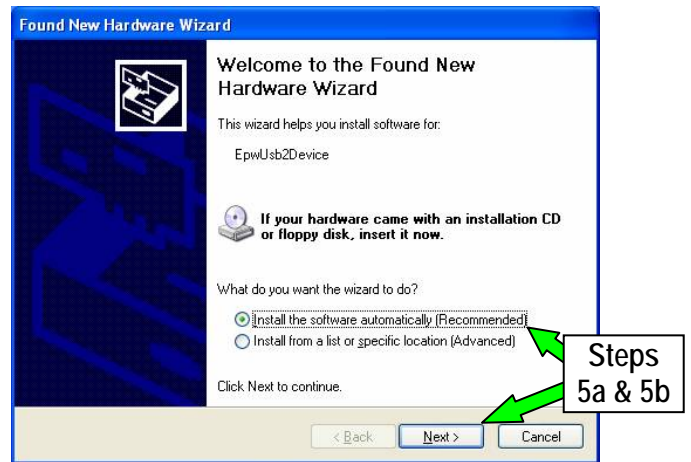
Figure 1b

5. Turn ON the CONSULT PC (do not launch / start C-III plus at this time).
- The first time the reprogramming kit (PC converter box) is attached to either of the C-III plus USB ports, the following screens (Figures 1b – 1d) will display.
 - If this is not the first time, these screens will not display – go to step 6.

a. Select **Install the software automatically (Recommended)**.

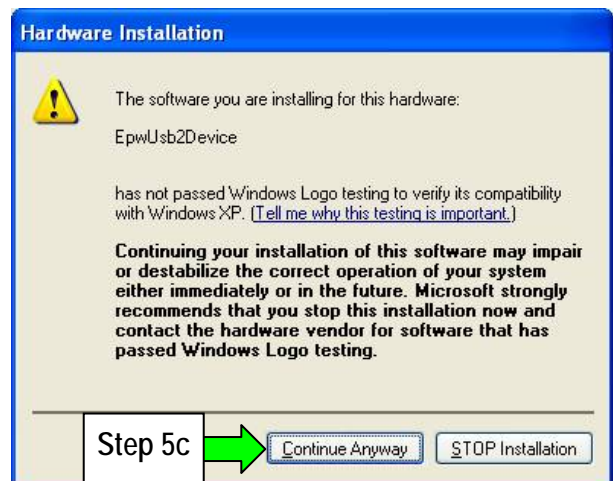
Figure 1c

c. Select **Continue Anyway**.

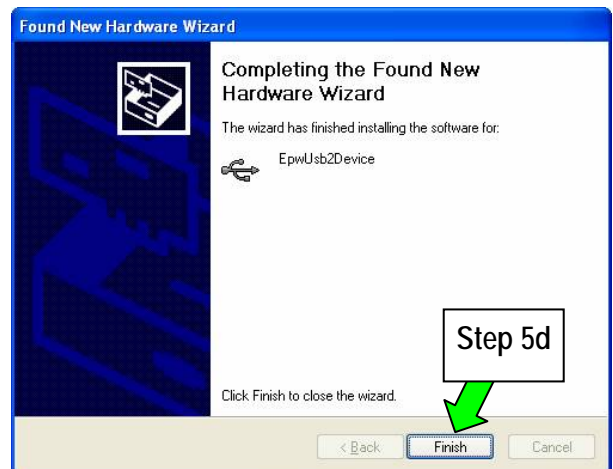
Figure 1d

d. Select **Finish**.

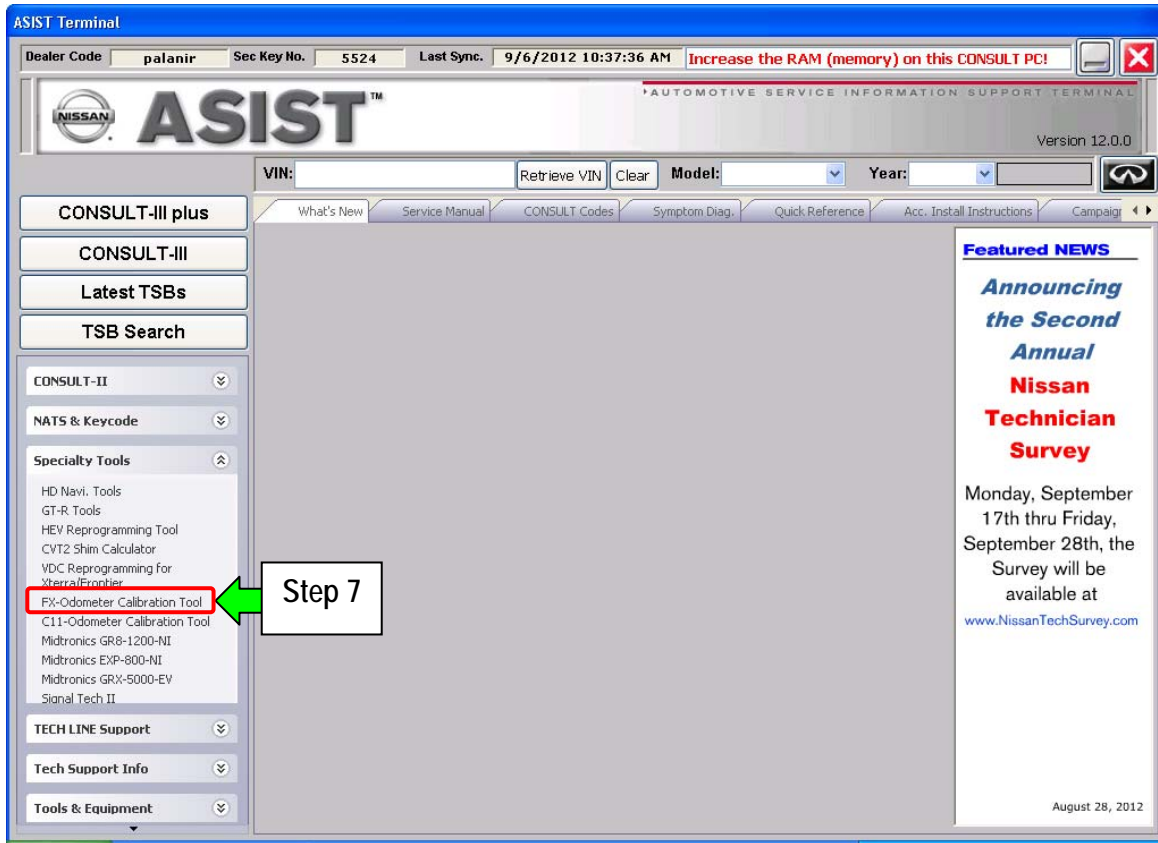
Figure 1e

6. Open / start ASIST.
7. Select **Specialty Tools**, and then select **FX-Odometer Calibration Tool**.

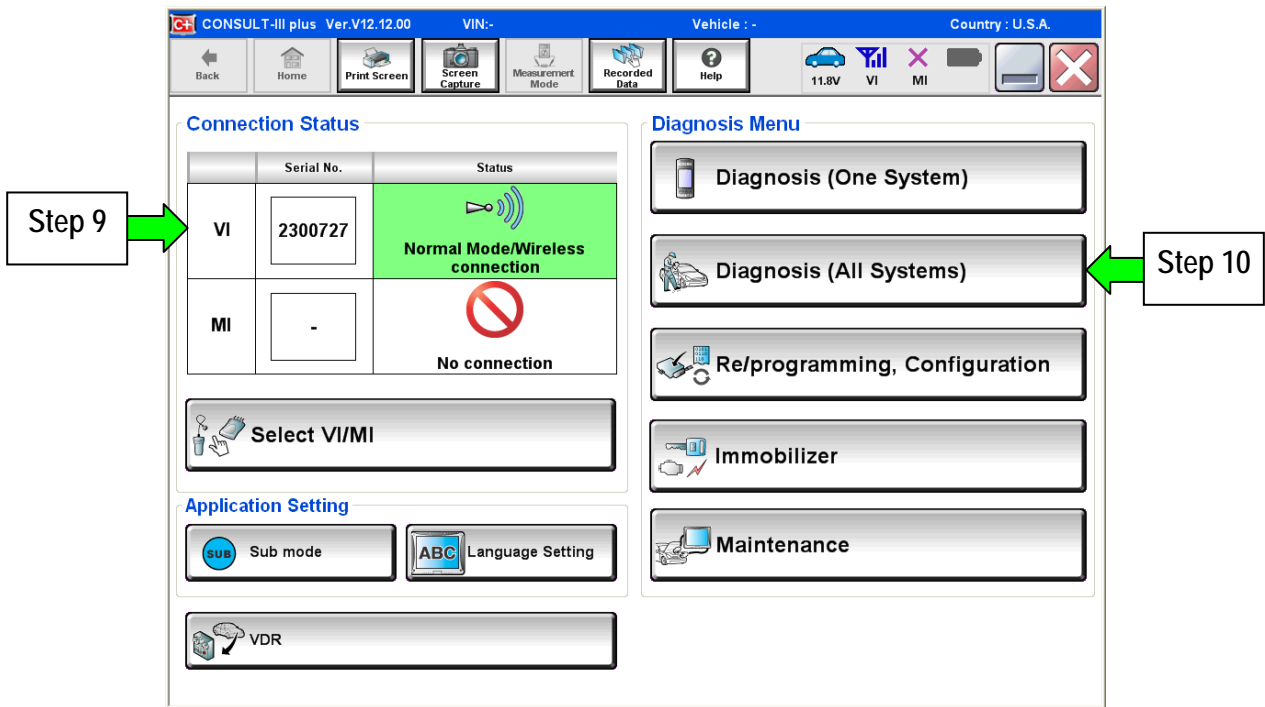
Figure 1f

9. After C-III plus has launched, wait for the plus VI to be recognized.
 - Serial number will display when the plus VI is recognized.
10. Select **Diagnosis (All Systems)**.

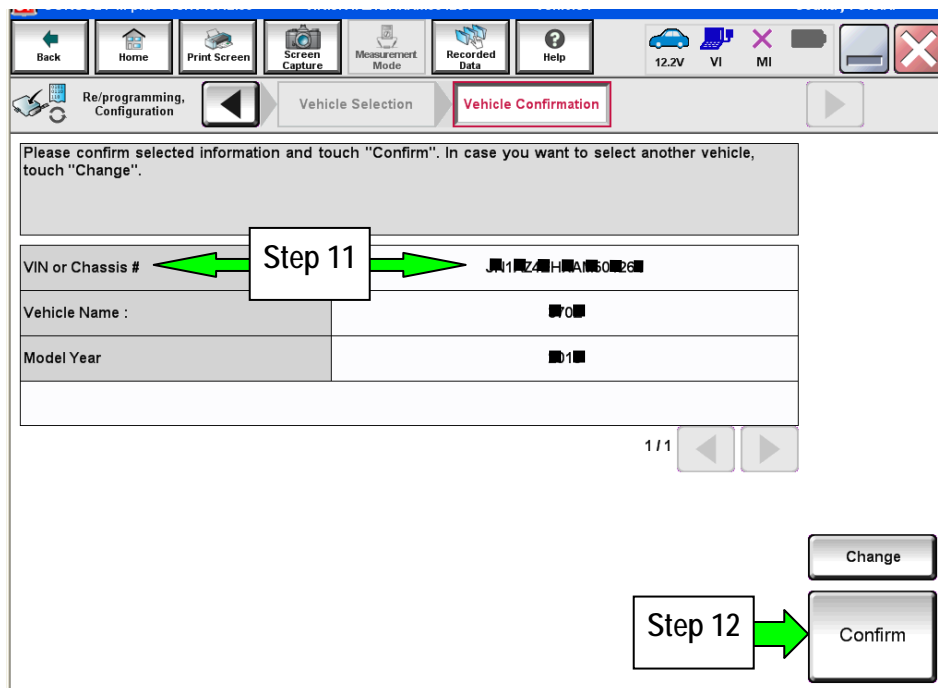
Figure 1g

11. Make sure **VIN or Chassis #** matches the vehicle's VIN.
12. Select **Confirm**.

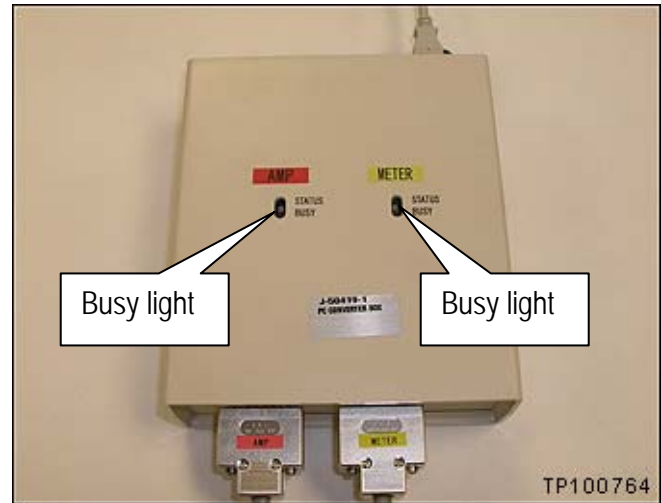
Figure 1h

15. Look at the "busy" lights on the converter box (see Figure 1h).

If both busy lights are not flashing, go to Step 17.

If either busy light is flashing:

If an error message is displayed and one or both of the busy lights on the converter box are flashing:

If the calibration fails to complete and the busy lights on the converter box are not flashing:
