ITB10-065a

**VOLUNTARY SERVICE CAMPAIGN
2007 – 2008 FX WITH ICC
SPEEDOMETER AND ODOMETER PROGRAMMING ERROR**

CAMPAIGN ID#: P0332

APPLIED VEHICLES: 2007 – 2008 FX (S50) with Intelligent Cruise Control (ICC)

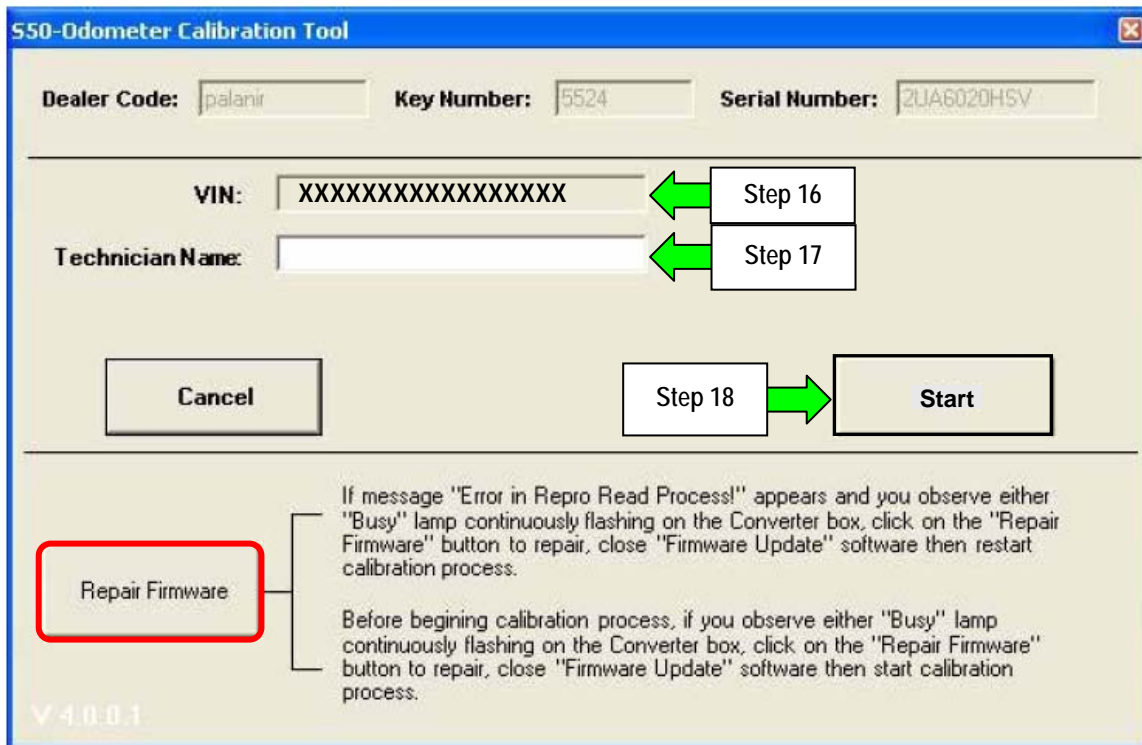
- a. Select "Repair Firmware" (see Figure 1i below).
- b. Follow the on screen instructions for Firmware Repair.
- c. Close the Odometer Calibration Tool – click on the X in the upper right corner of the window (see Figure 1i).
- d. Go back to Step 7 on page 22.

16. Going back to your CONSULT PC, the **VIN** will automatically display (see Figure 1i).

17. Enter the **Technician Name** (see Figure 1i).

- a. Close the error message.
 - The display window will return to the Odometer Calibration Tool (see previous page, Figure 1i).
- b. Select "Repair Firmware" (see previous page, Figure 1i).
- c. Follow the on screen instructions for Firmware Repair.
- d. Close the Odometer Calibration Tool - click on the X in the upper right corner of the window (see previous page, Figure 1i).
- e. Go back to Step 7 on page 22.

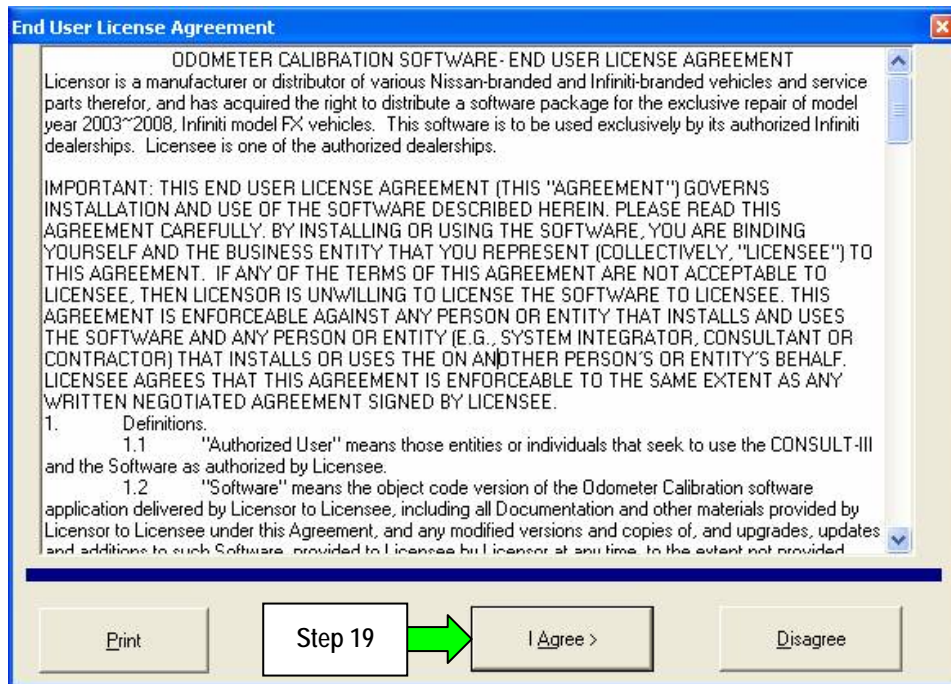
Figure 1j

19. Select I Agree.

- After selecting **I Agree**, the reprogramming / calibration process will begin automatically and take only a few seconds to complete.

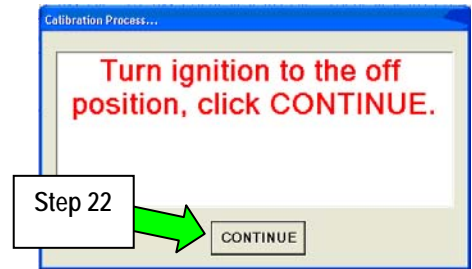
20. When the calibration process has completed successfully, the message in Figure 1k will display.

21. Turn the ignition OFF and select **Continue**.

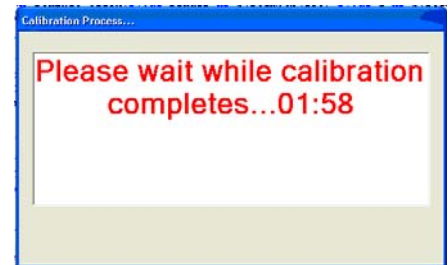
- The screen in Figure 1L will display with a 2 minute countdown.

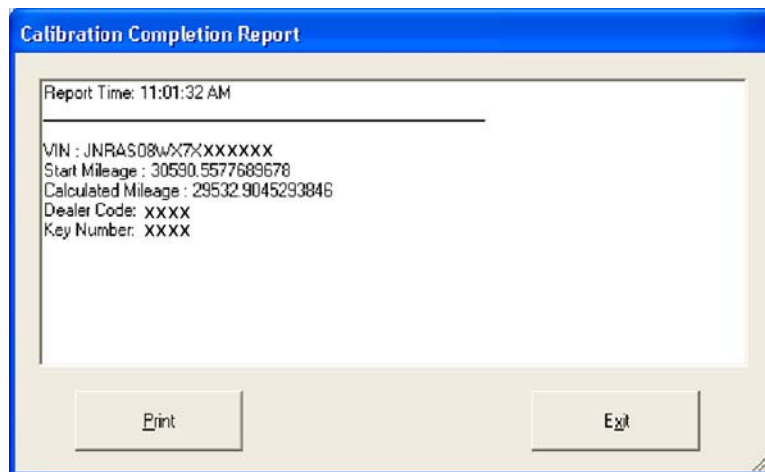
Figure 1m

23. After waiting 2 minutes, the **Calibration Completion Report** will display (Figure 1m).

24. Print the **Calibration Completion Report** and attach it to the repair order for warranty documentation.

NOTE: The Calculated Mileage on the above Calibration report must be used to update the mileage in Infiniti Net.
