ITB10-065

**VOLUNTARY SERVICE CAMPAIGN
2007 – 2008 FX WITH ICC
SPEEDOMETER AND ODOMETER PROGRAMMING ERROR**

CAMPAIGN ID #: P0332**APPLIED VEHICLES:** 2007 – 2008 FX (S50) with Intelligent Cruise Control (ICC)

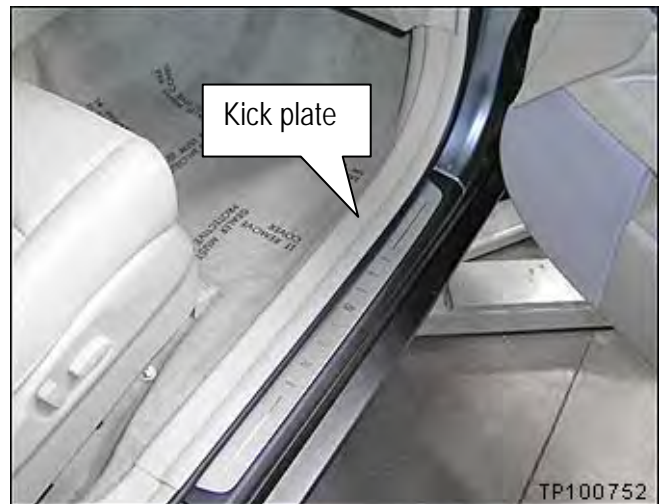
Figure A

1. Turn the Ignition OFF.
2. Remove the front passenger kick plate.
 - Snap loose to remove.
 - Use a plastic trim tool as needed.

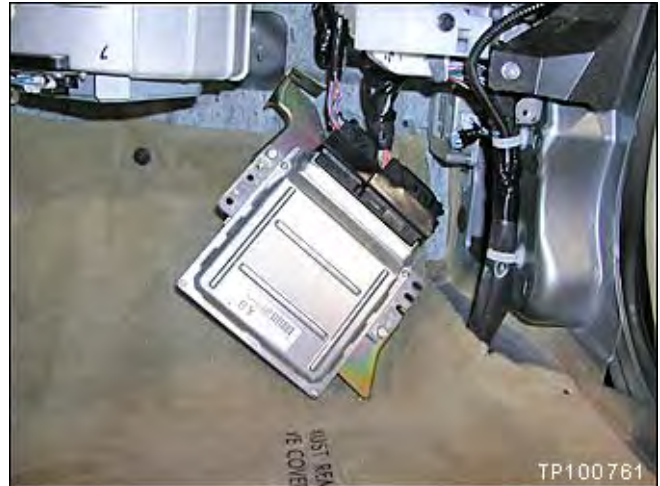
Figure I

10. The ECM can remain in this position while you replace the ICC unit.

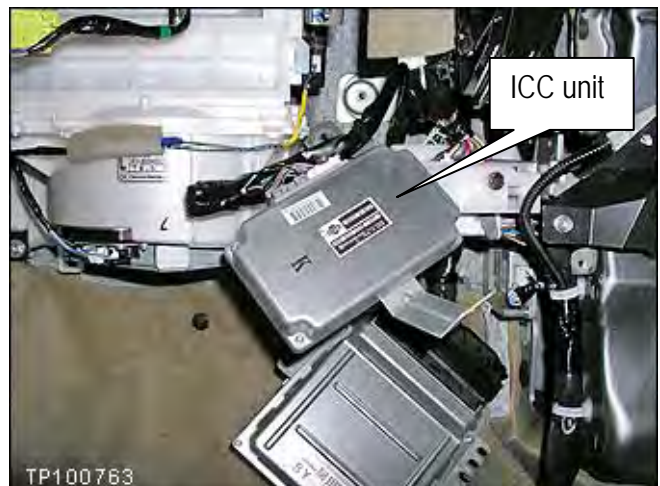
Figure K

12. Carefully maneuver the ICC unit from behind the harness junctions.

13. Replace the ICC unit with a **new** one listed in the Parts Information of this bulletin.

14. Install the new unit and all other parts removed in reverse order.

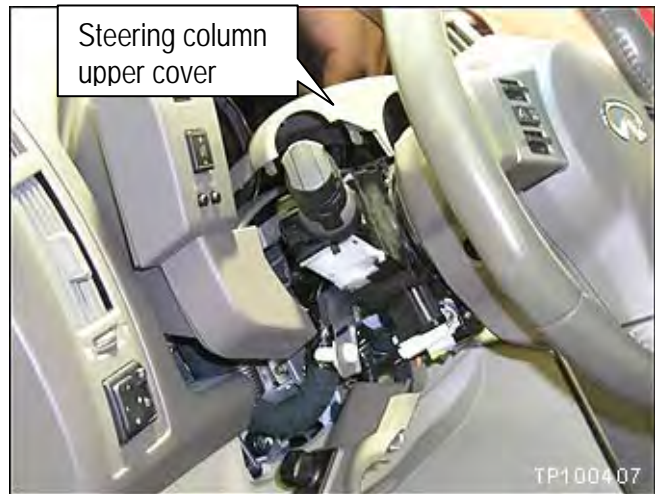
Figure 3

3. Remove the steering column upper cover.

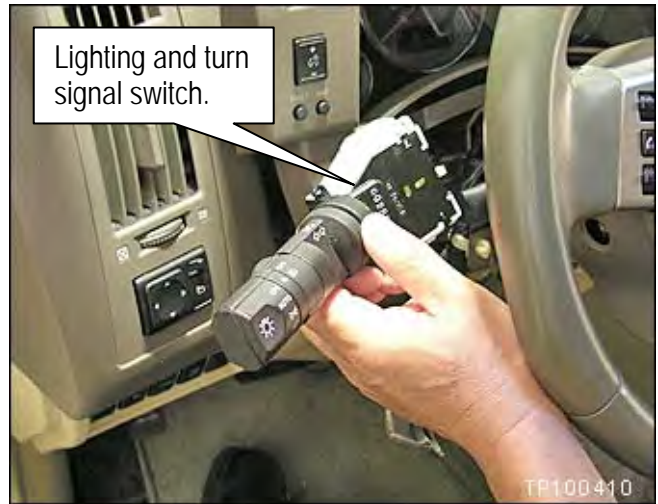
Figure 6

6. Remove / unclip the lighting and turn signal switch.

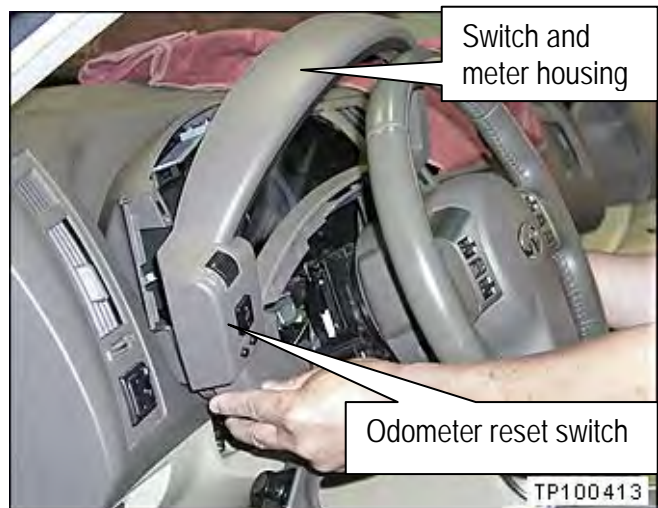
Figure 8

- b. Carefully unsnap the housing and move it to the left side of the steering column.

- Do not scratch the clear plastic meter lens.
- Use a cover if needed.

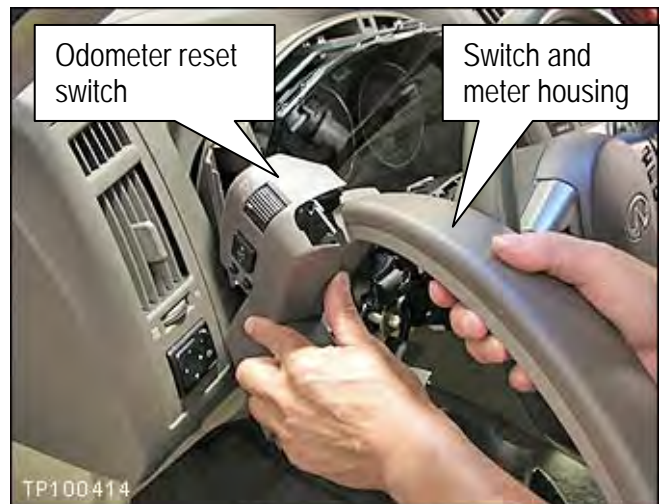
Figure 10

b. Carefully separate the switch from the housing.

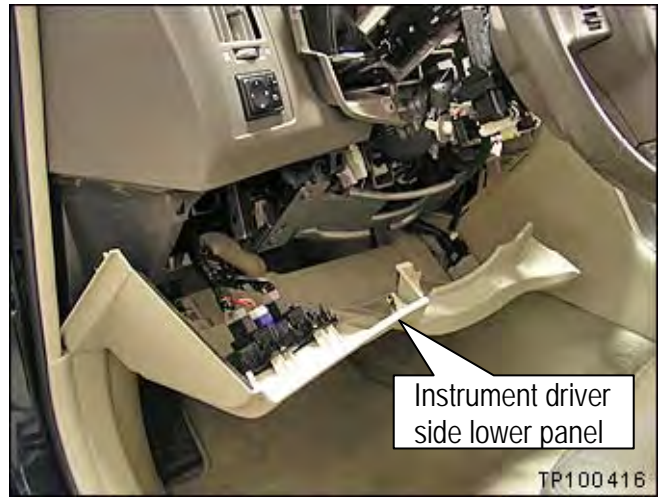
- b. Carefully pull the panel to unsnap the clips.

NOTE: The instrument drive side lower panel can stay in the position shown in Figure 12 while the rest of the procedure is completed.

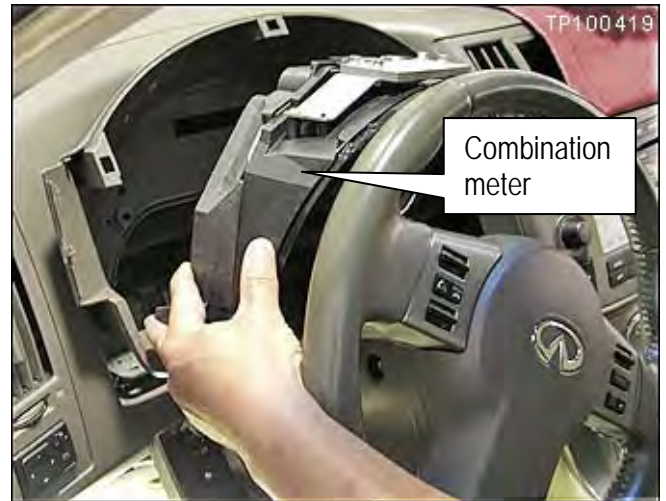
Figure 15

- c. Carefully pull the combination meter out far enough to access the harness connector.

- Do not scratch the clear plastic meter lens.
- Use a cover if needed.

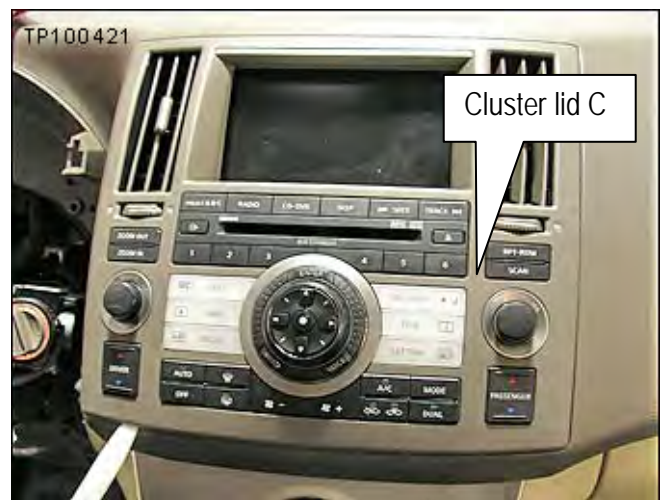
Figure 17

11. Snap loose and remove cluster lid C as follows:

- a. Use a plastic trim tool as needed.

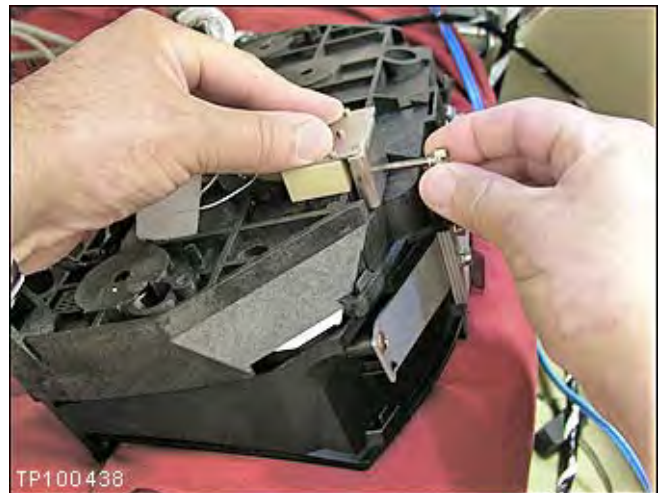
Figure 29

G

- Push and hold the Meter Probe into the back of the combination meter and tighten the lock screw.

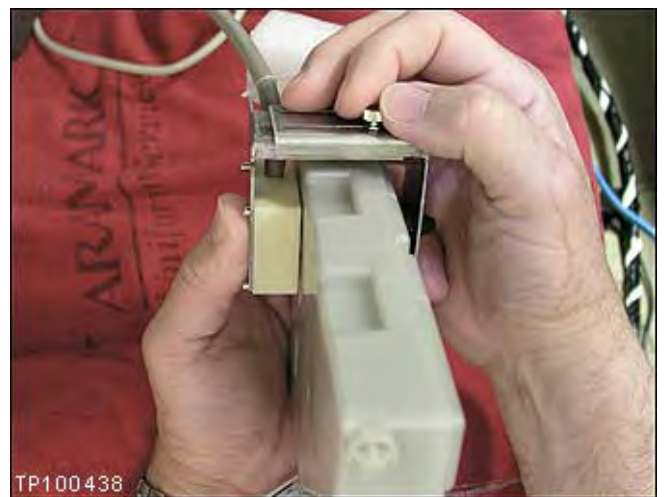
Figure 31

H

- Push and hold the Amp Probe in the amp probe slot and tighten the lock screw.

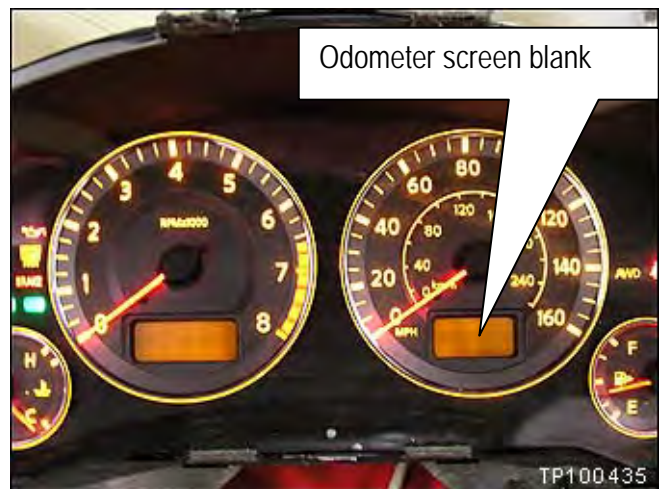
Figure 1a

1. Use the USB cable to connect the Vehicle Interface (VI) to the C-III computer and then connect the VI to the vehicle.
2. Connect the AC Adapter to the C-III computer.
3. Make sure the C-III computer is connected to the PC Converter Box (J-50419-1) with the USB cable.
4. Turn the Ignition ON.

With the ignition ON the odometer screen should be blank.

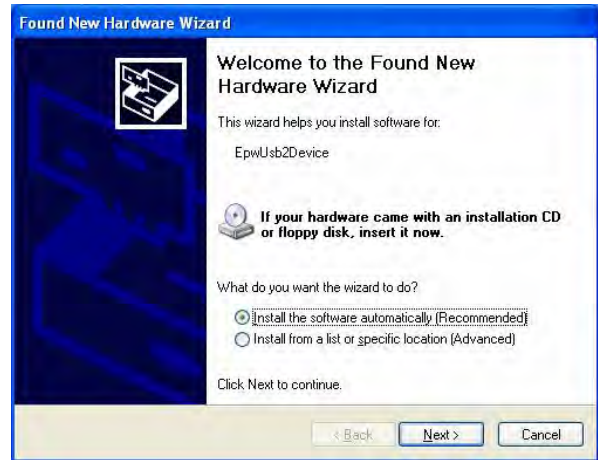
Figure 1b

5. Turn ON the C-III computer (**do not launch / start C-III at this time**).
 - The first time the reprogramming kit (PC converter box) is attached to either of the C-III USB ports, the following screens (Figures 1b – 1d) will display.
 - If this is not the first time, these screens will not display – go to step 6.

a. Select **Install the software automatically (Recommended)**.

b. Select **Next**

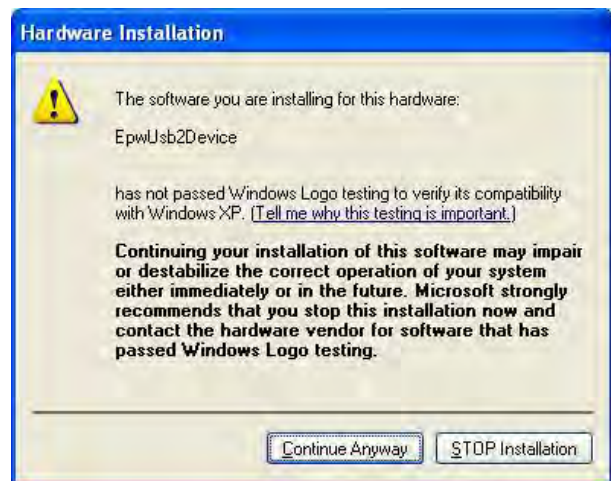
Figure 1c

c. Select **Continue Anyway**

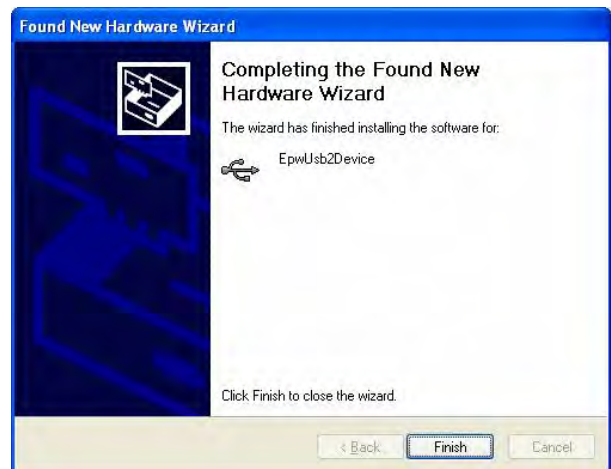
Figure 1d

d. Select **Finish**

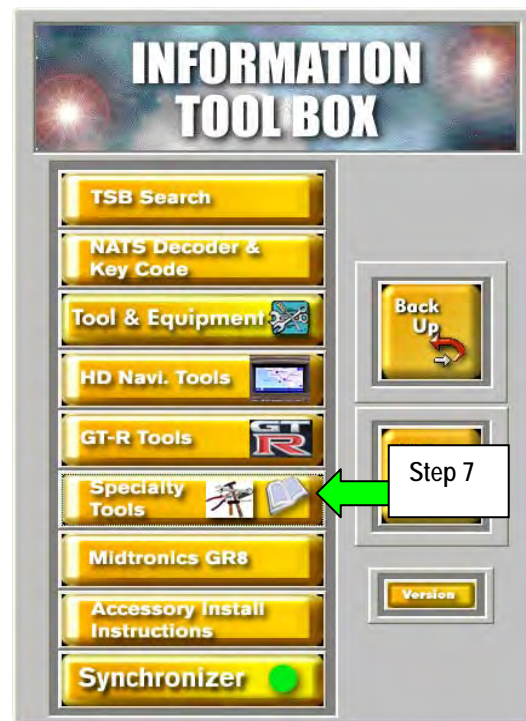
Figure 1e

7. Select Information Tool Box and then Specialty Tools.

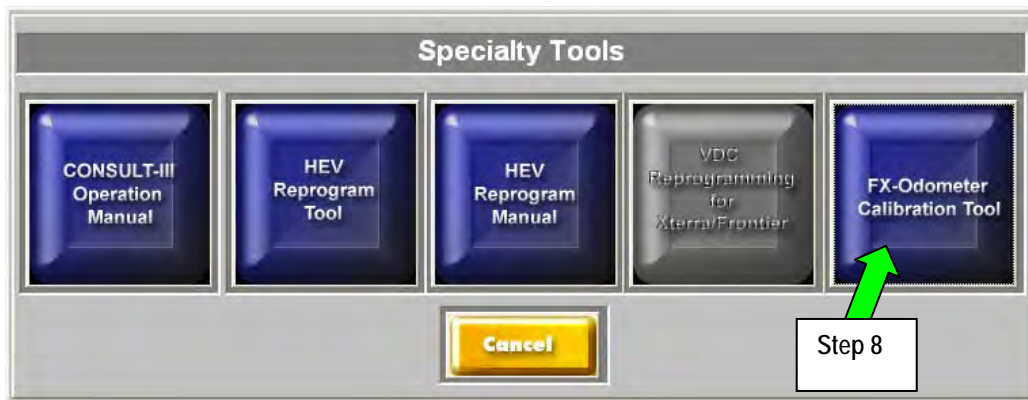
Figure 1f

8. Select FX-Odometer Calibration Tool.

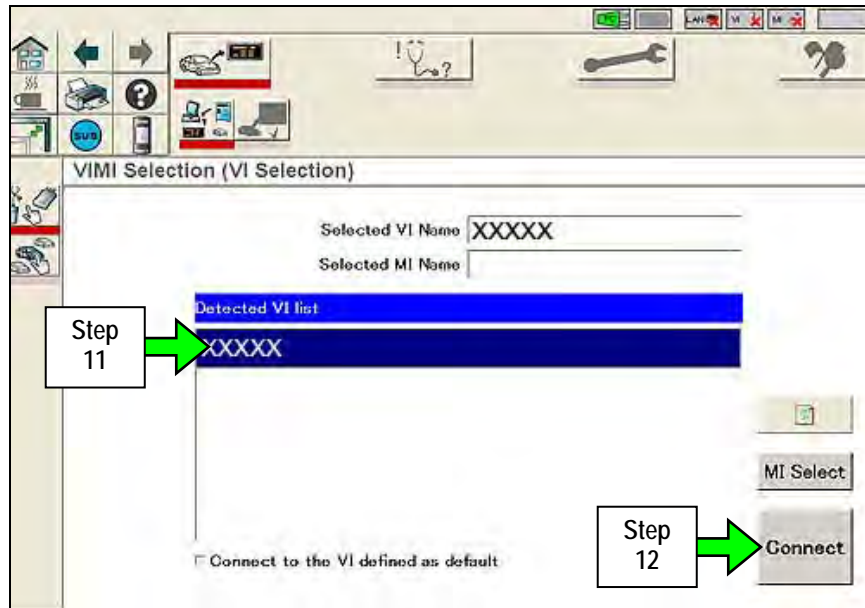
Figure 1g

10. Wait for the “Detecting VI/MI in progress” message to clear.

11. Select the “Detected VI” from the list.

12. Select **Connect**.

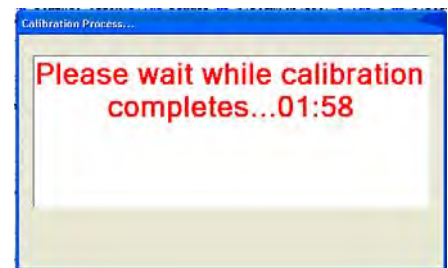
23. With the ignition OFF, wait for 2 minutes.

- The screen in Figure 1l will display with a 2 minute countdown.
