YEAR/MODEL	Date Of Issue	Bulletin Number	Service Campaign
All Transit Connect Electric	28Feb12	TSB501359	<input type="checkbox"/> NO <input checked="" type="checkbox"/> YES

MY12 Software Update

Updated vehicle software has been developed with several advancements: improved ESS & DMoC diagnostics, improved drivability, additional market configuration options, and additional performance configuration options.

All MY2011 & MY12 NA & EU Pre-Production & Production Transit Connect Electric (TCE) vehicles.

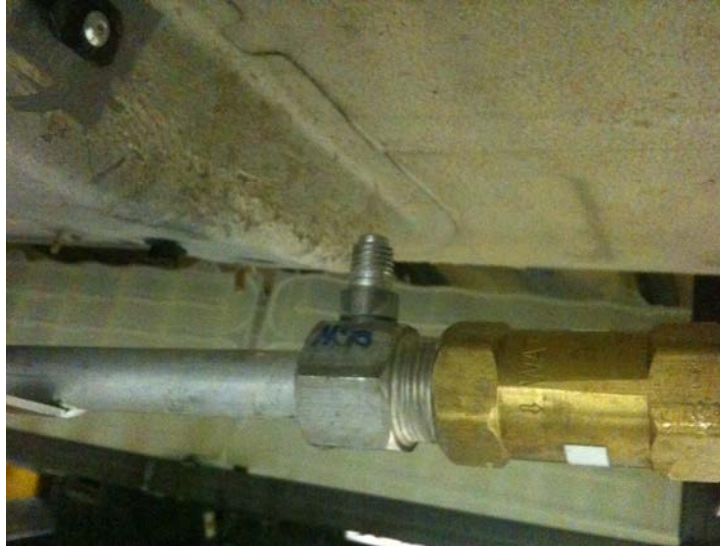
2. Install a trickle-charger on the 12V battery and connect the laptop to a/c power.
3. Perform the Coolant Fill and ESS Heater Test function with the TDT (TCE Diagnostic Tool) according to the following procedure:
 - a. Ensure the vehicle is not charging (EVSE not plugged in).
 - b. Top-up the Powertrain coolant degas bottle if required.
 - c. Have additional coolant available to maintain the coolant level as the fill procedure is run.
 - d. Turn the key to the 'On' position (do not start the vehicle).
 - a. From the VCU tab, enable Diagnostic Mode.
 - b. From the Functions top-menu, select Coolant Fill and ESS Heater Test:

- i. When ready, click on the 'Start' button and follow the on-screen prompting.
- ii. When prompted, open the Schrader air-bleed valve in tee near ESS coolant inlet.

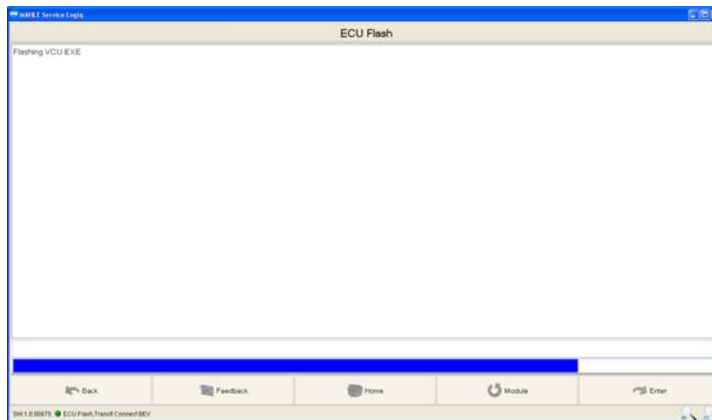
- h. Select “TCE VCU Flash”. VCU will be programmed automatically, **press “Enter” when programming is complete:**

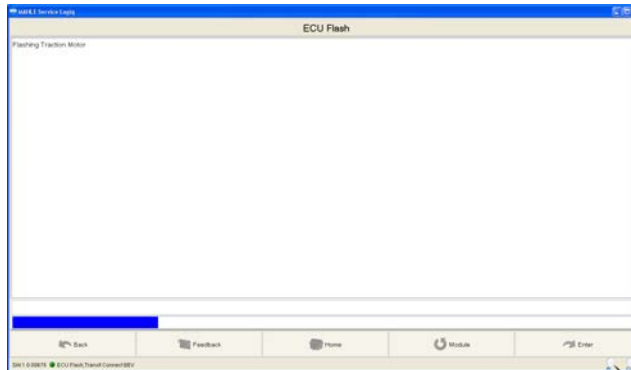
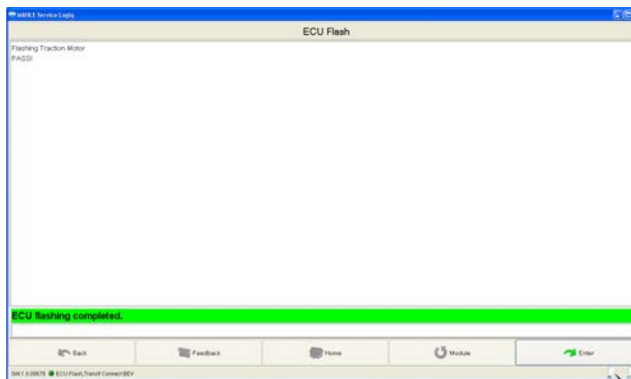
- a. Turn the key to the 'On' position (do not start the vehicle).
- b. Select "DMoC Flash". DMOc will be programmed automatically, **press "Enter" when programming is complete:**

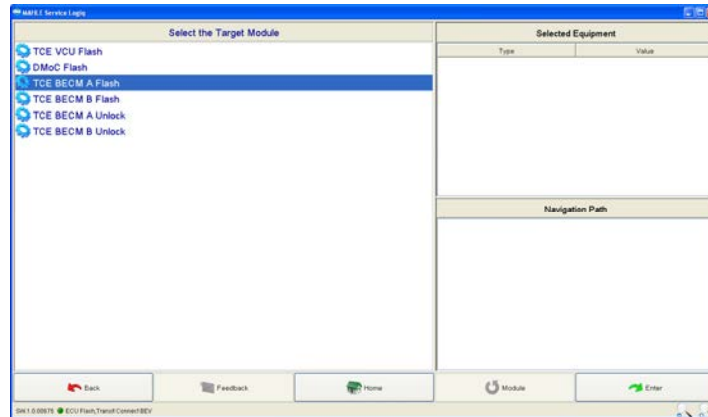
- a. Turn the key to the 'On' position (do not start the vehicle).
- b. Select "TCE BECM A Flash". BECM A will be programmed automatically – follow any on-screen prompts and **press "Enter" when programming is complete:**
